**Photos of repairs, conservation and restoration**

**Work Scheduled for 2008 - 2009**

**Updated April 17, 2009**

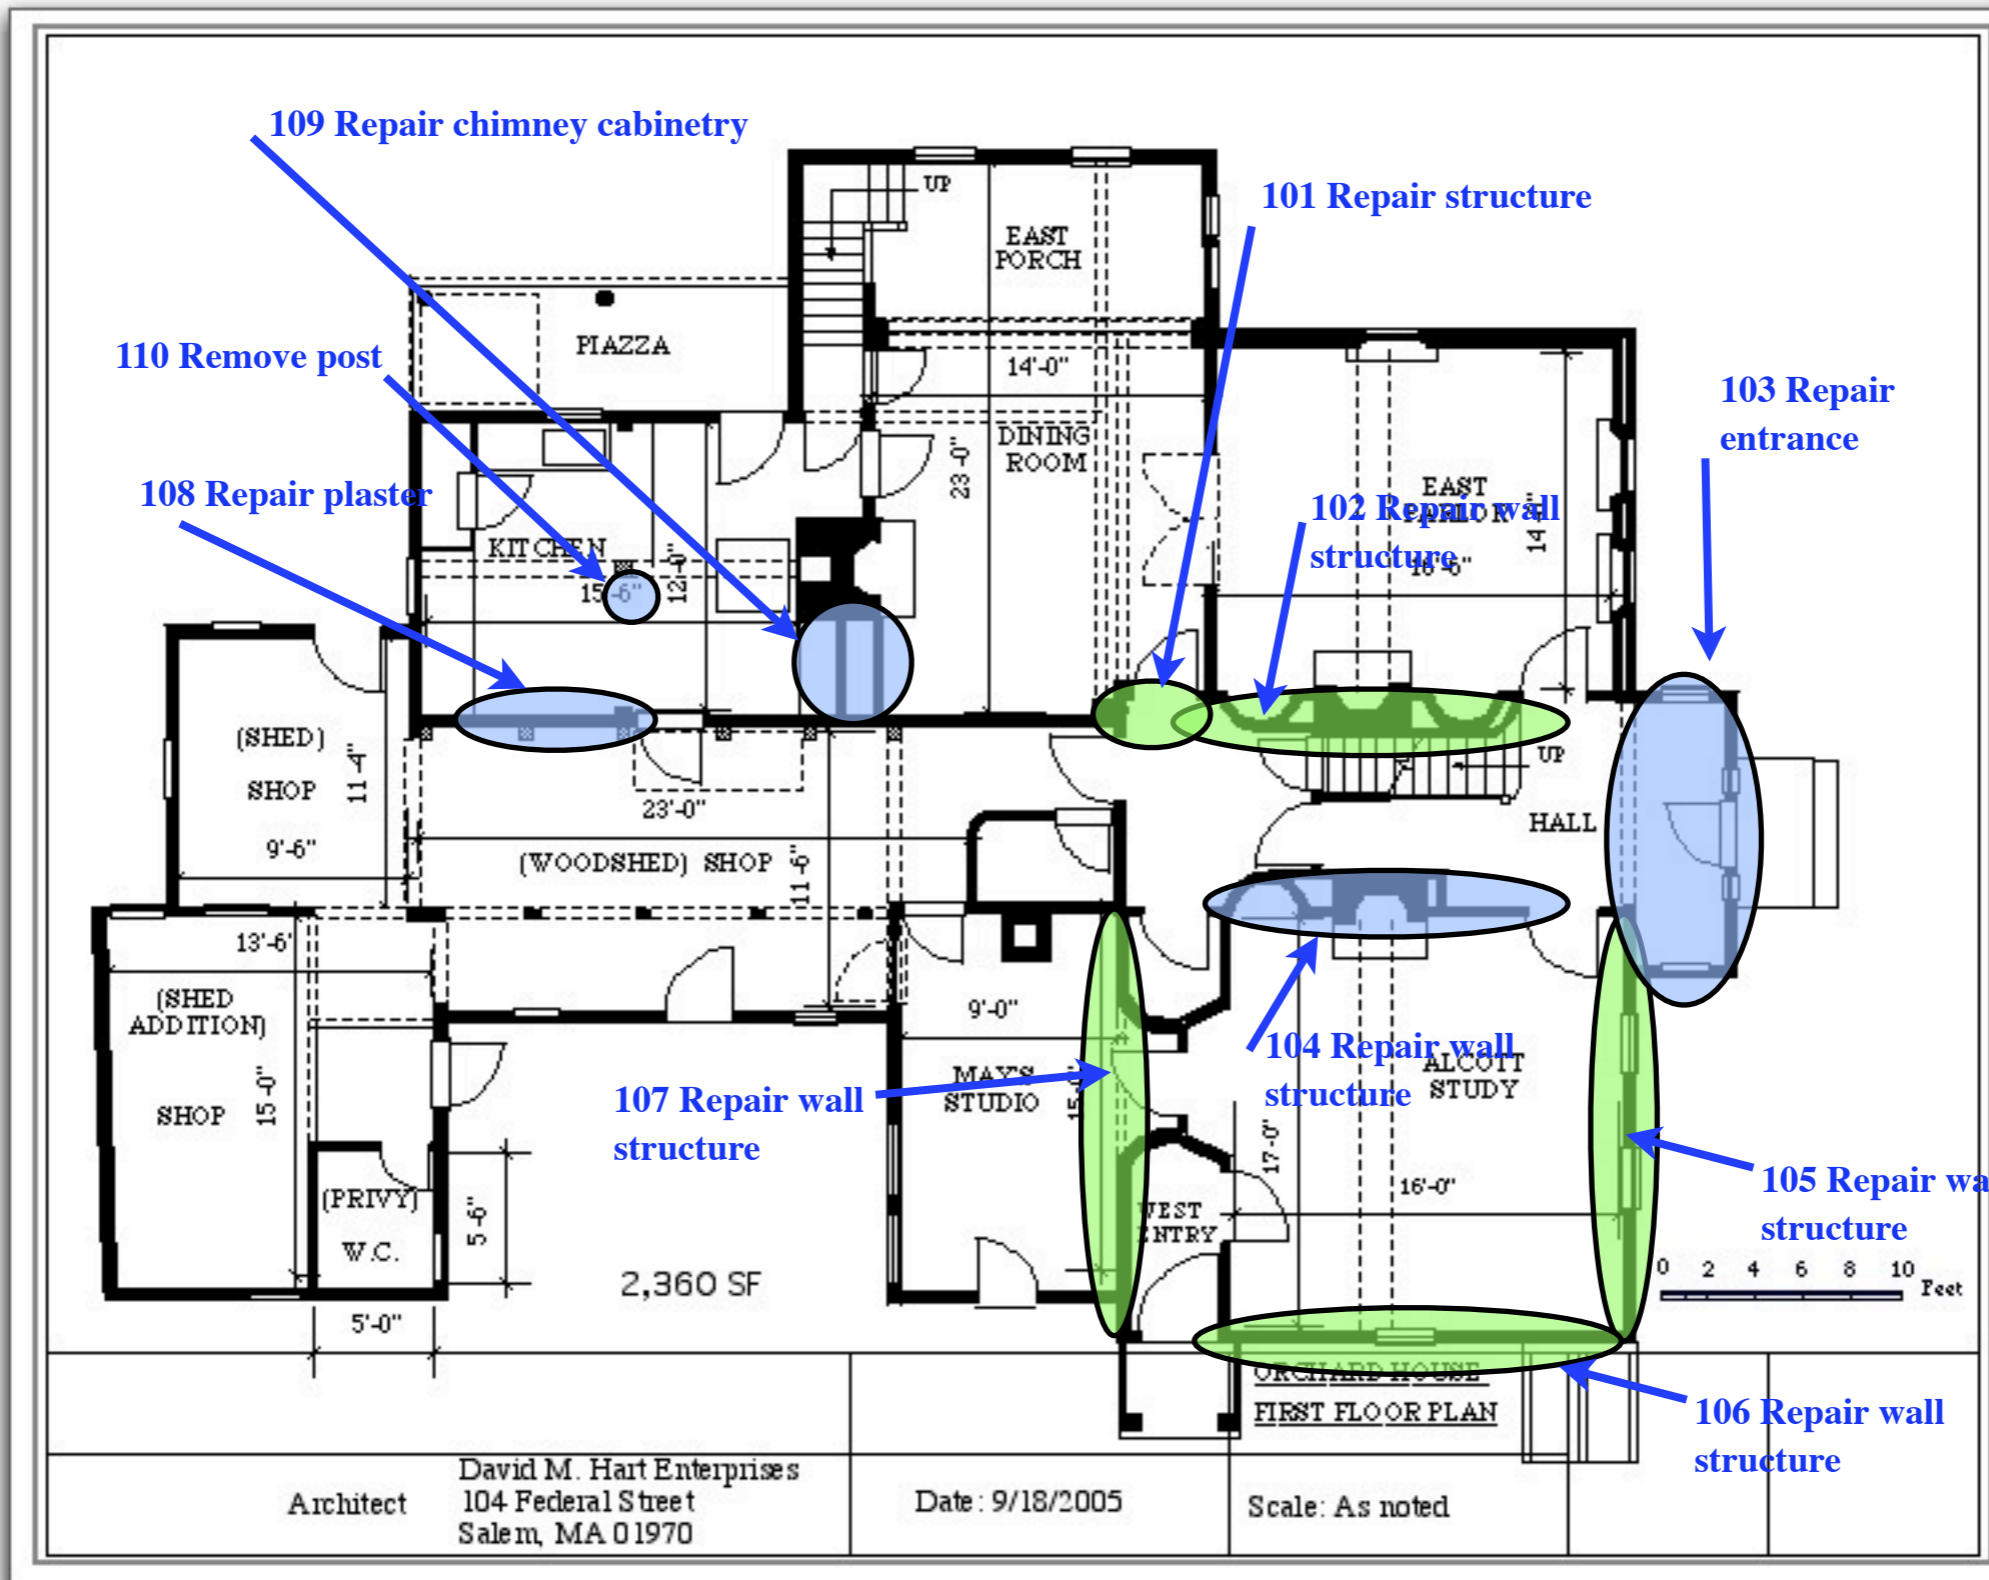
First Floor

Location of needed repairs and restoration of finishes

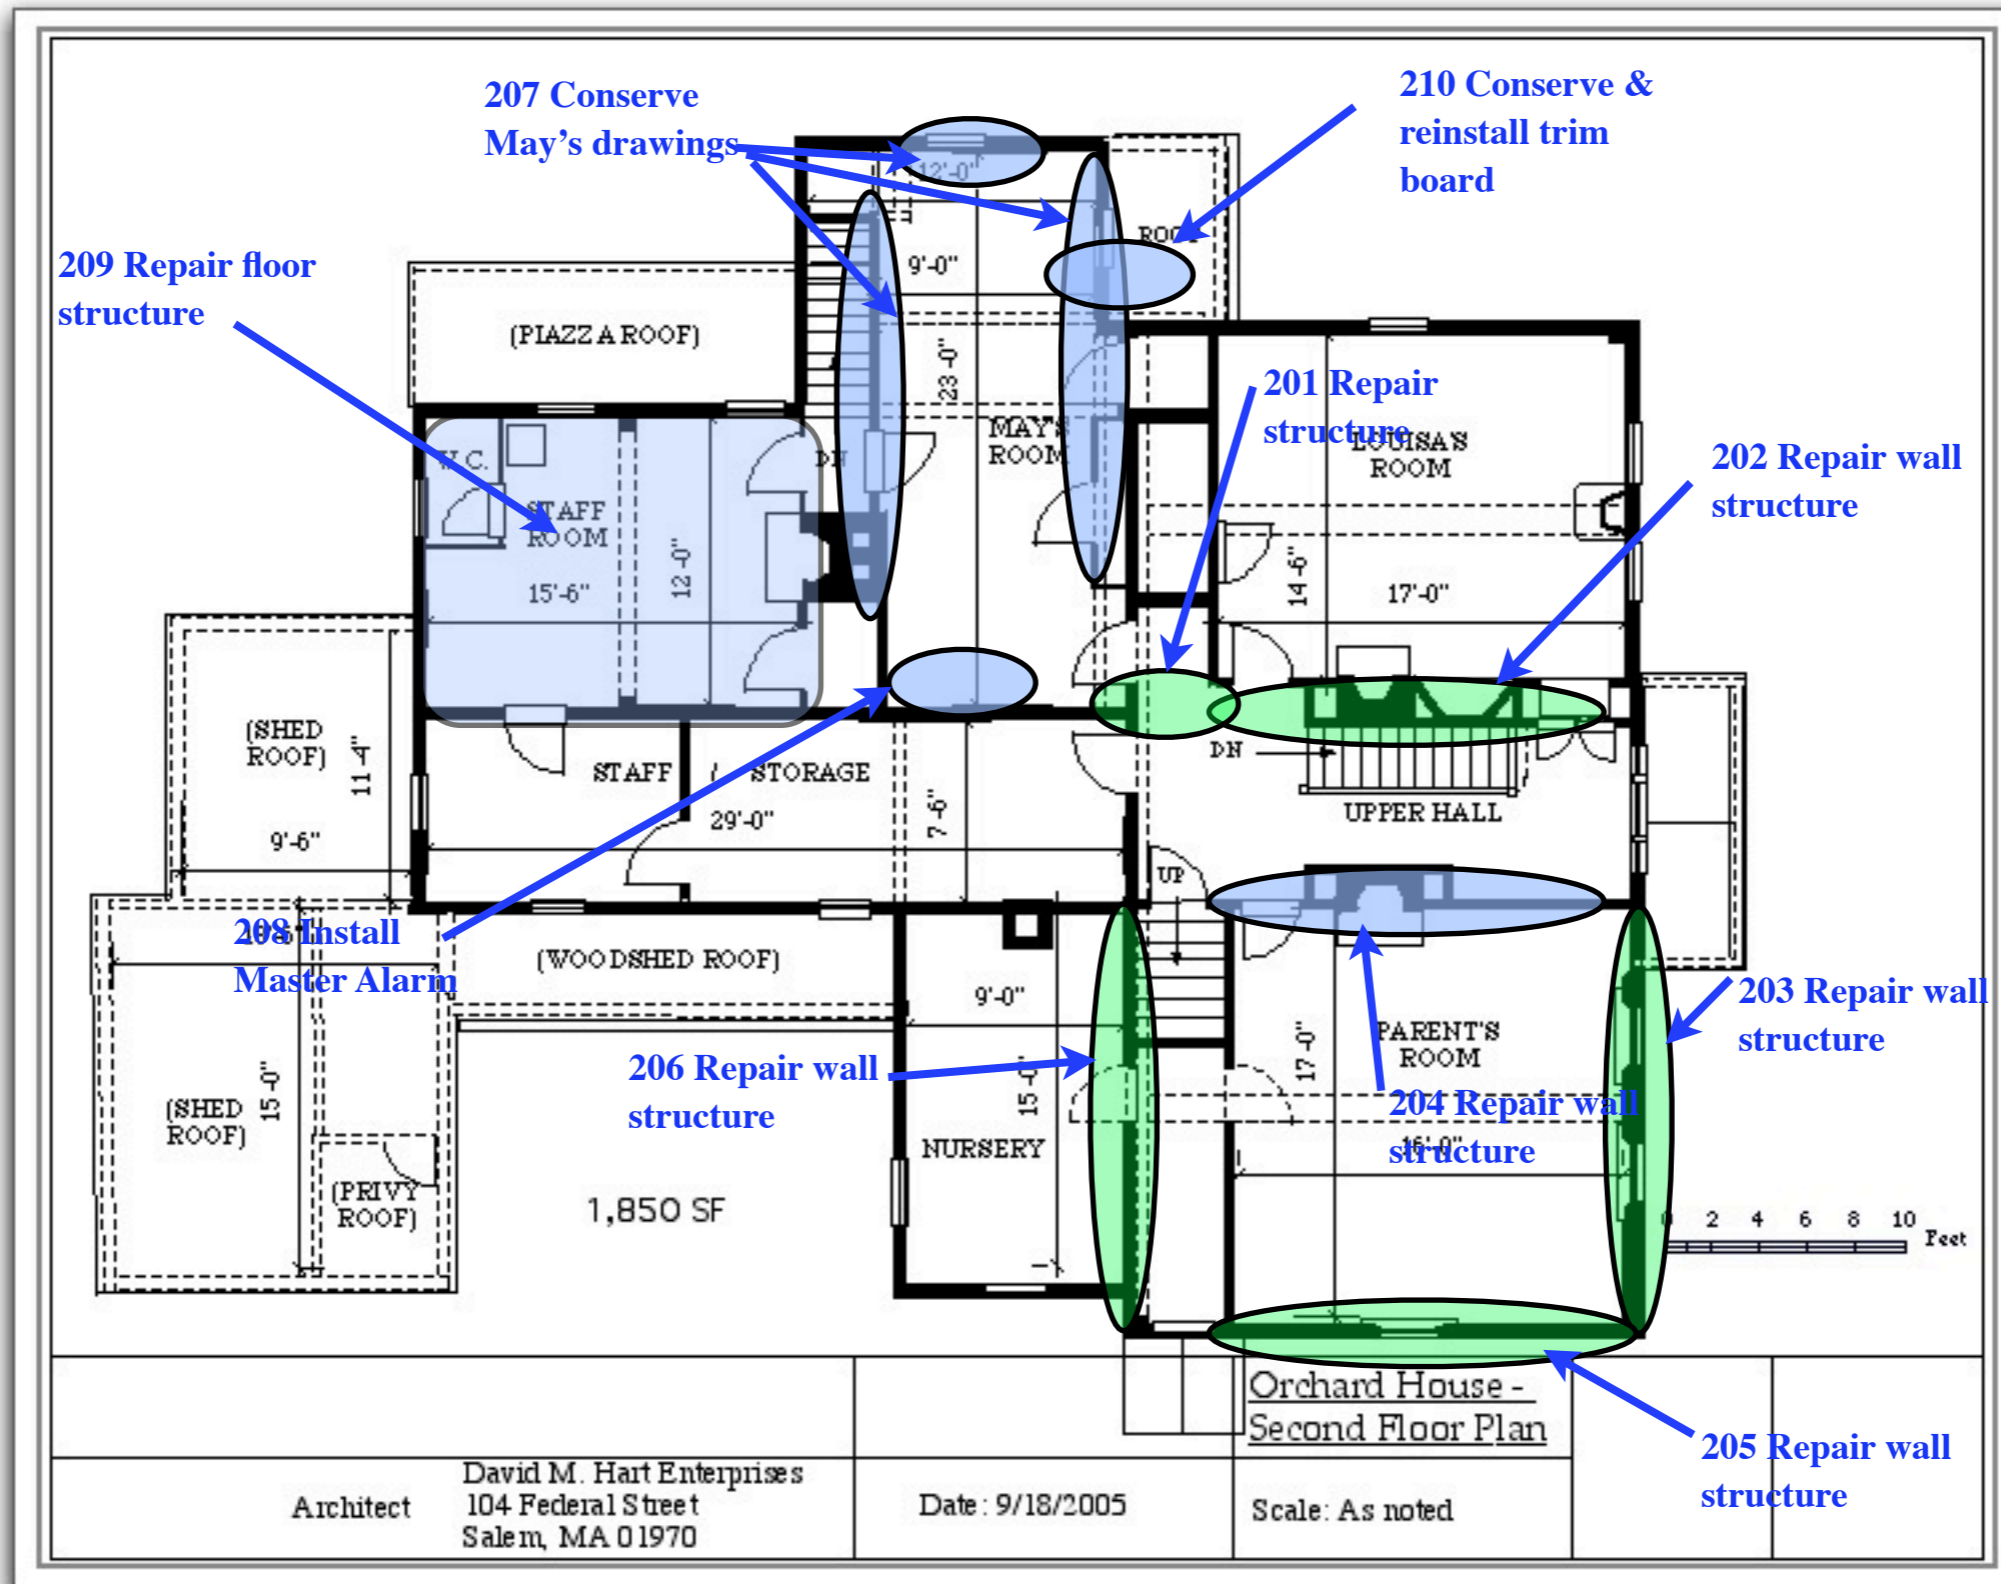
Second Floor

Location of needed repairs and restoration of finishes

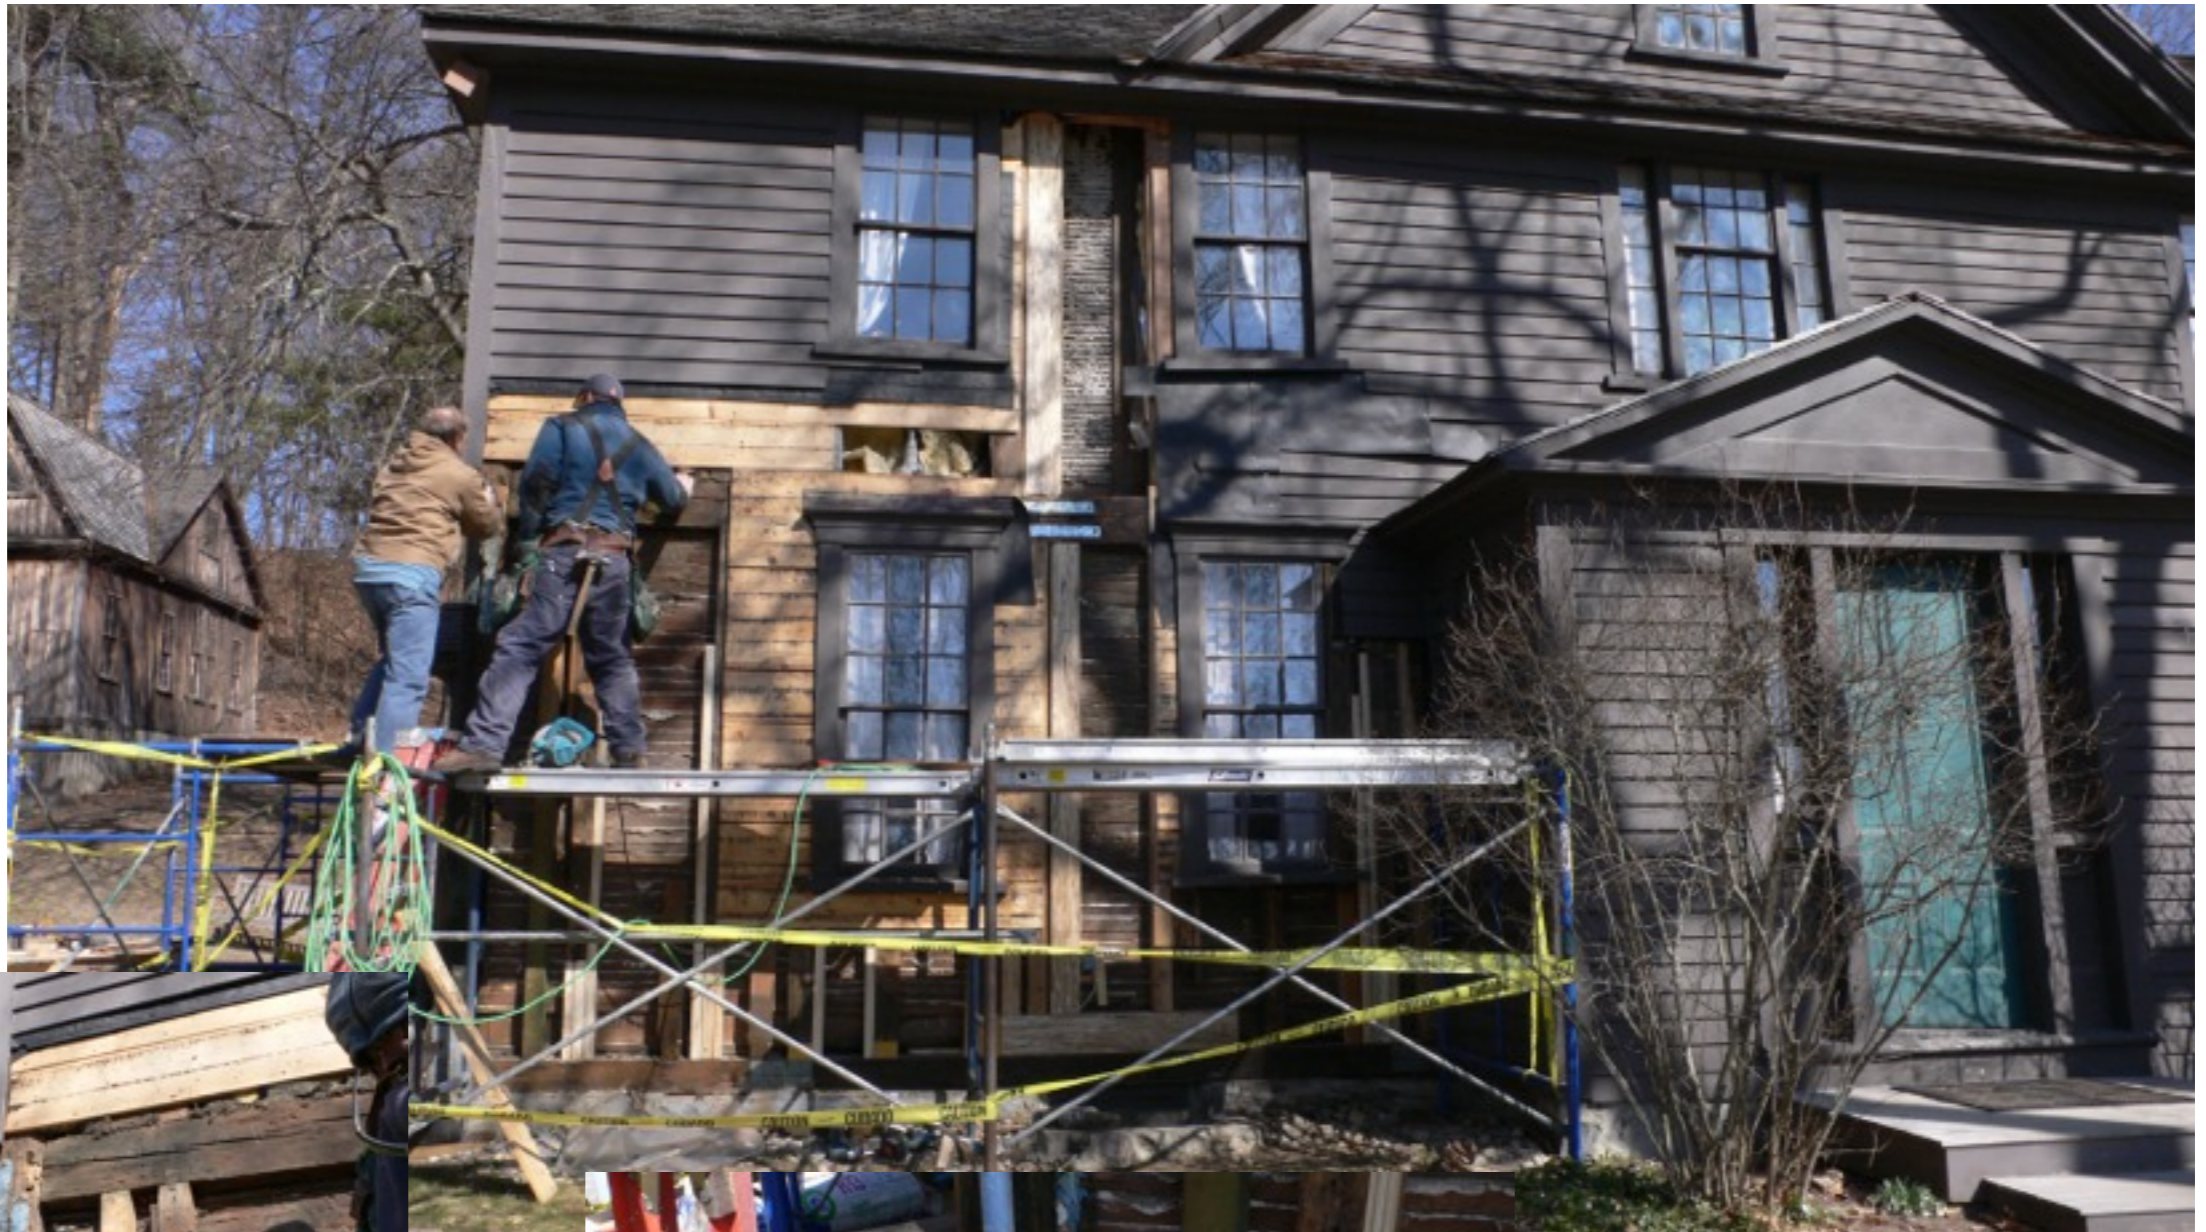
L1090745

Wall structure  
opened up for  
examination and  
repair.

South facade

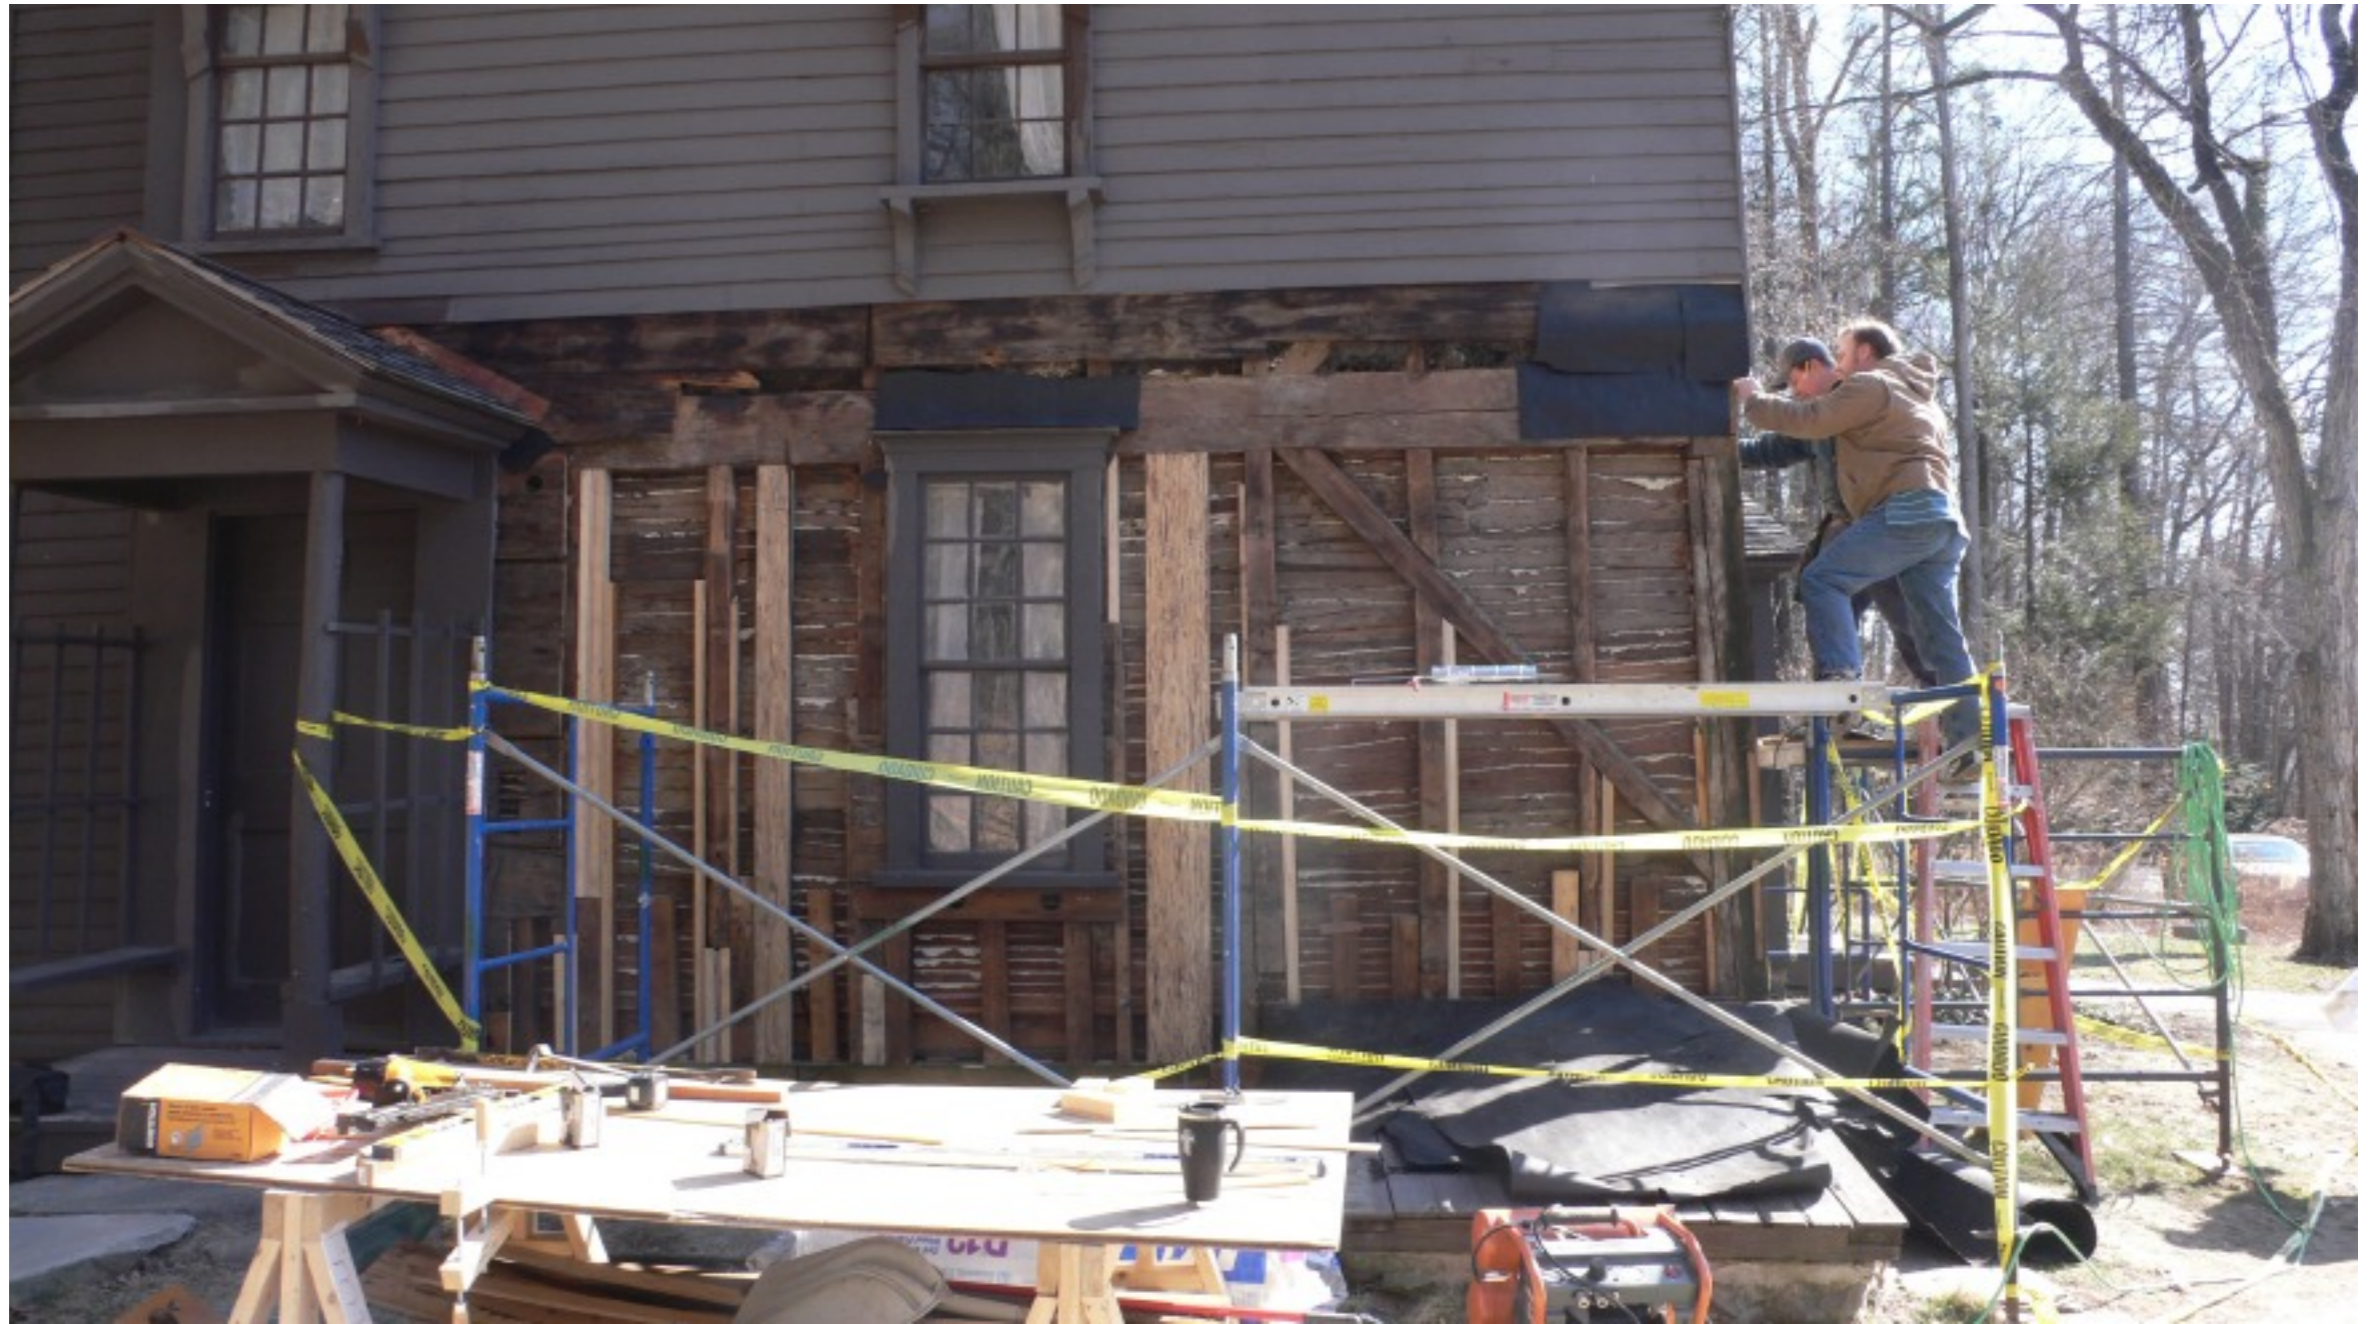
**L1090747**

**Wall structure opened up for  
examination and repair.**

**West facade**

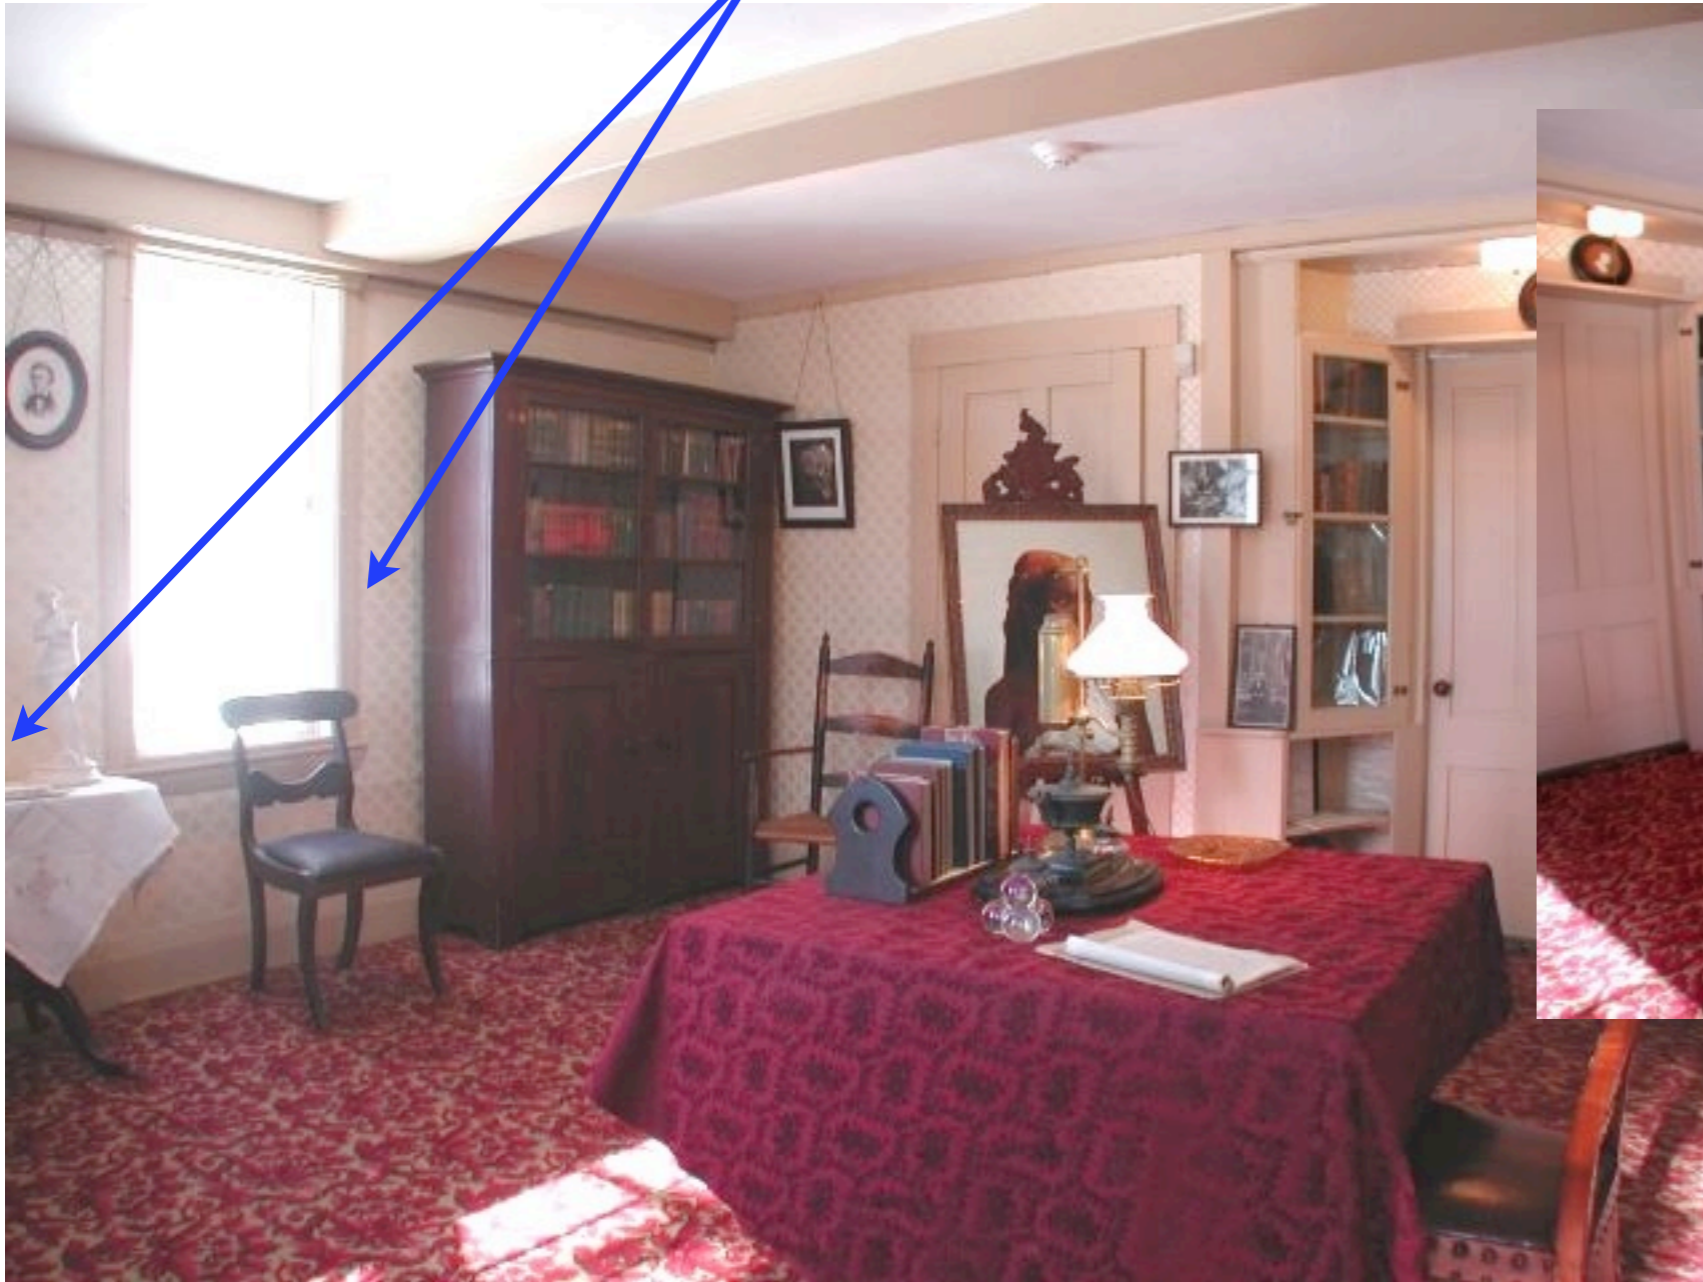
DSCN2224

Structure inside south and west walls needs repairs

Views of Alcott's Study

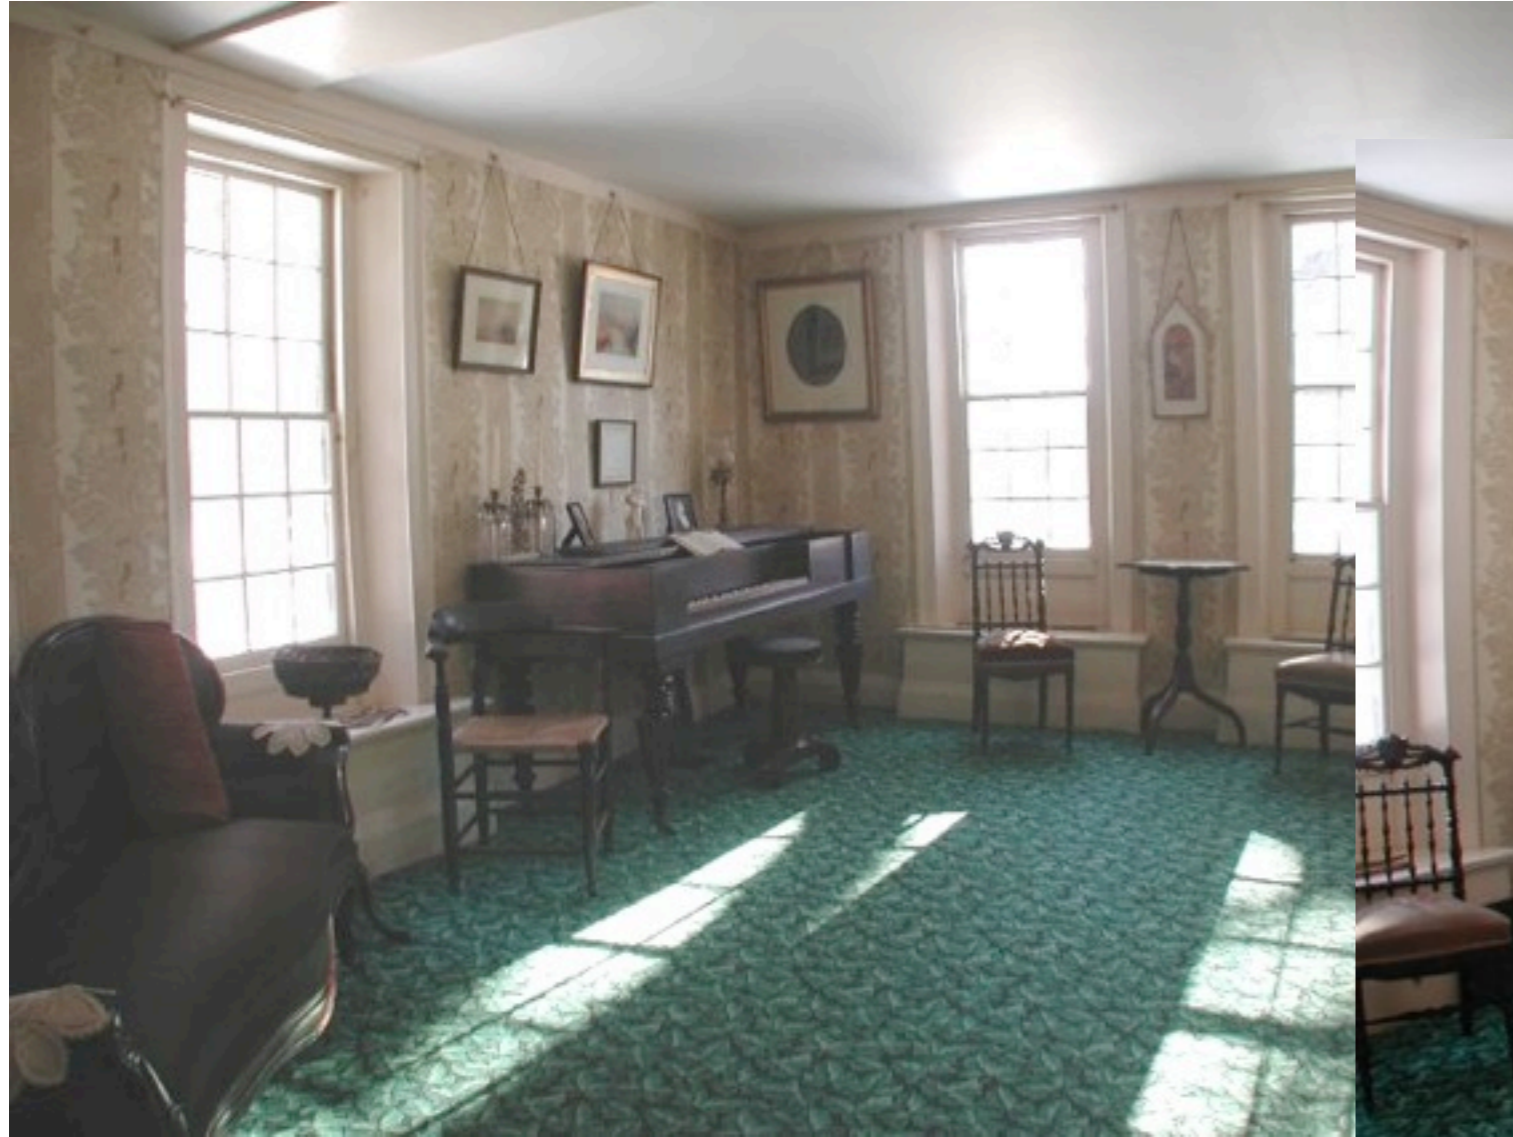
DSCN2232

Structure inside east wall needs repairs

Views of parlor

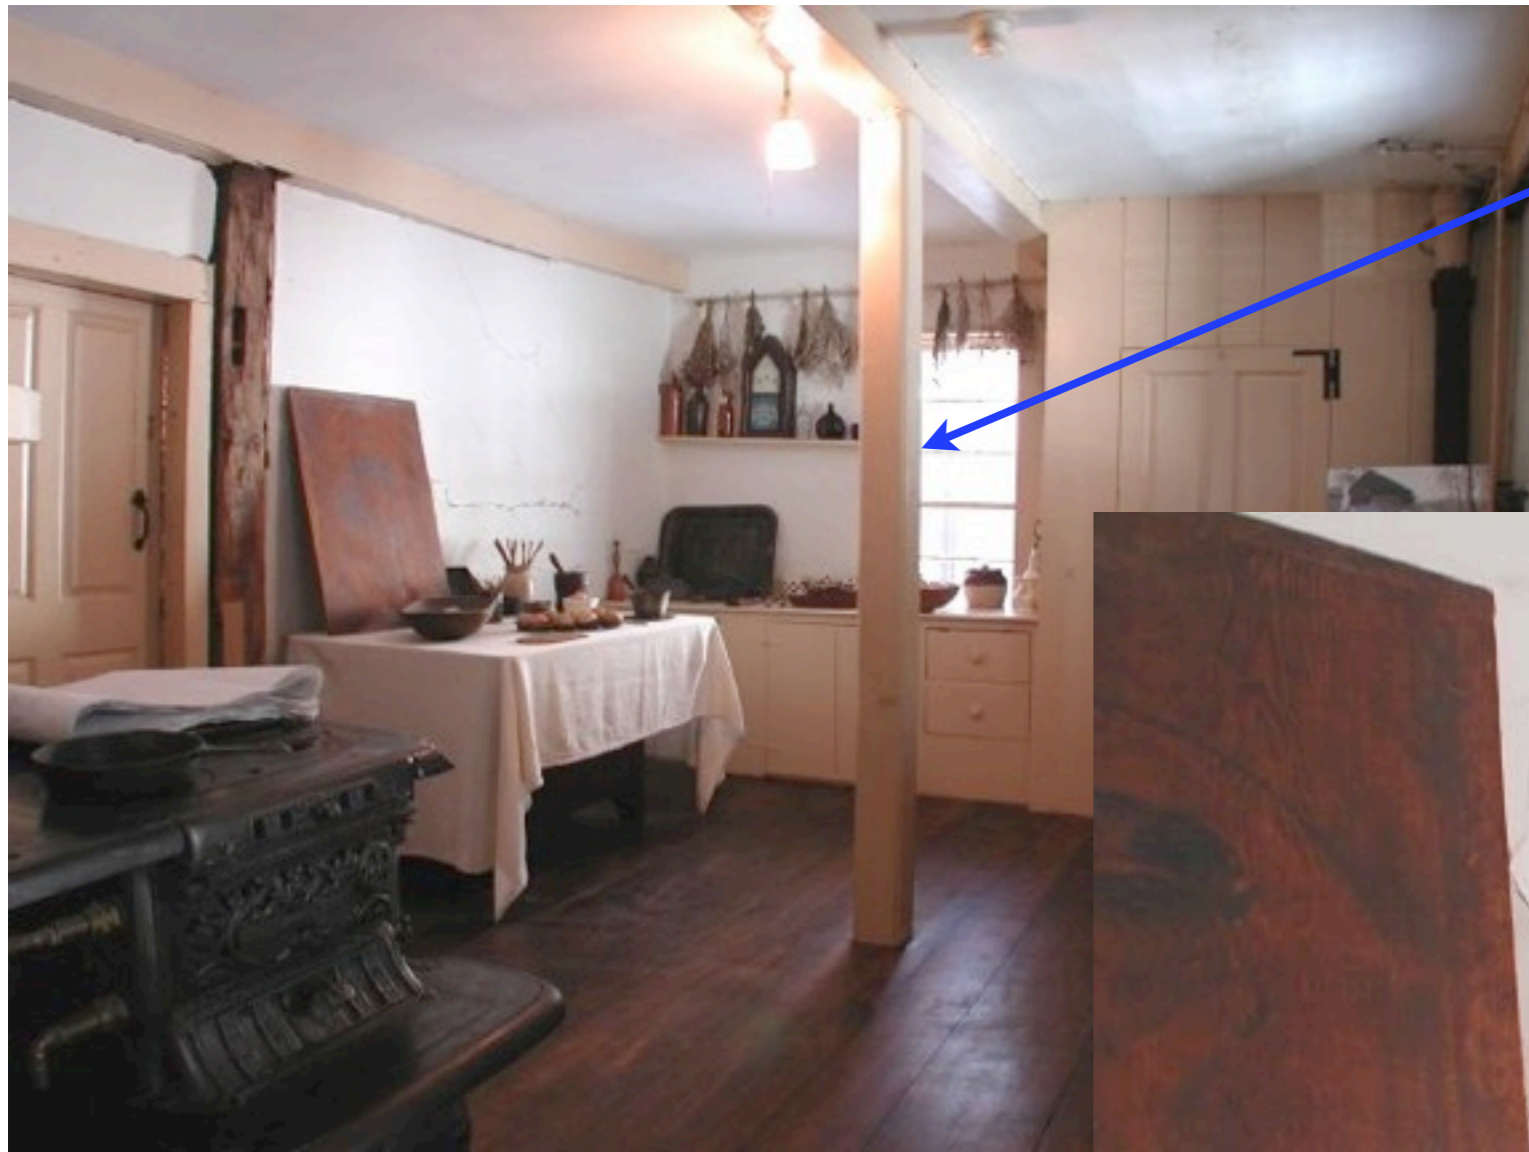
DSCN2237

“Temporary” post to be removed and ceiling structure reinforced

Plaster repairs needed

Views of Kitchen

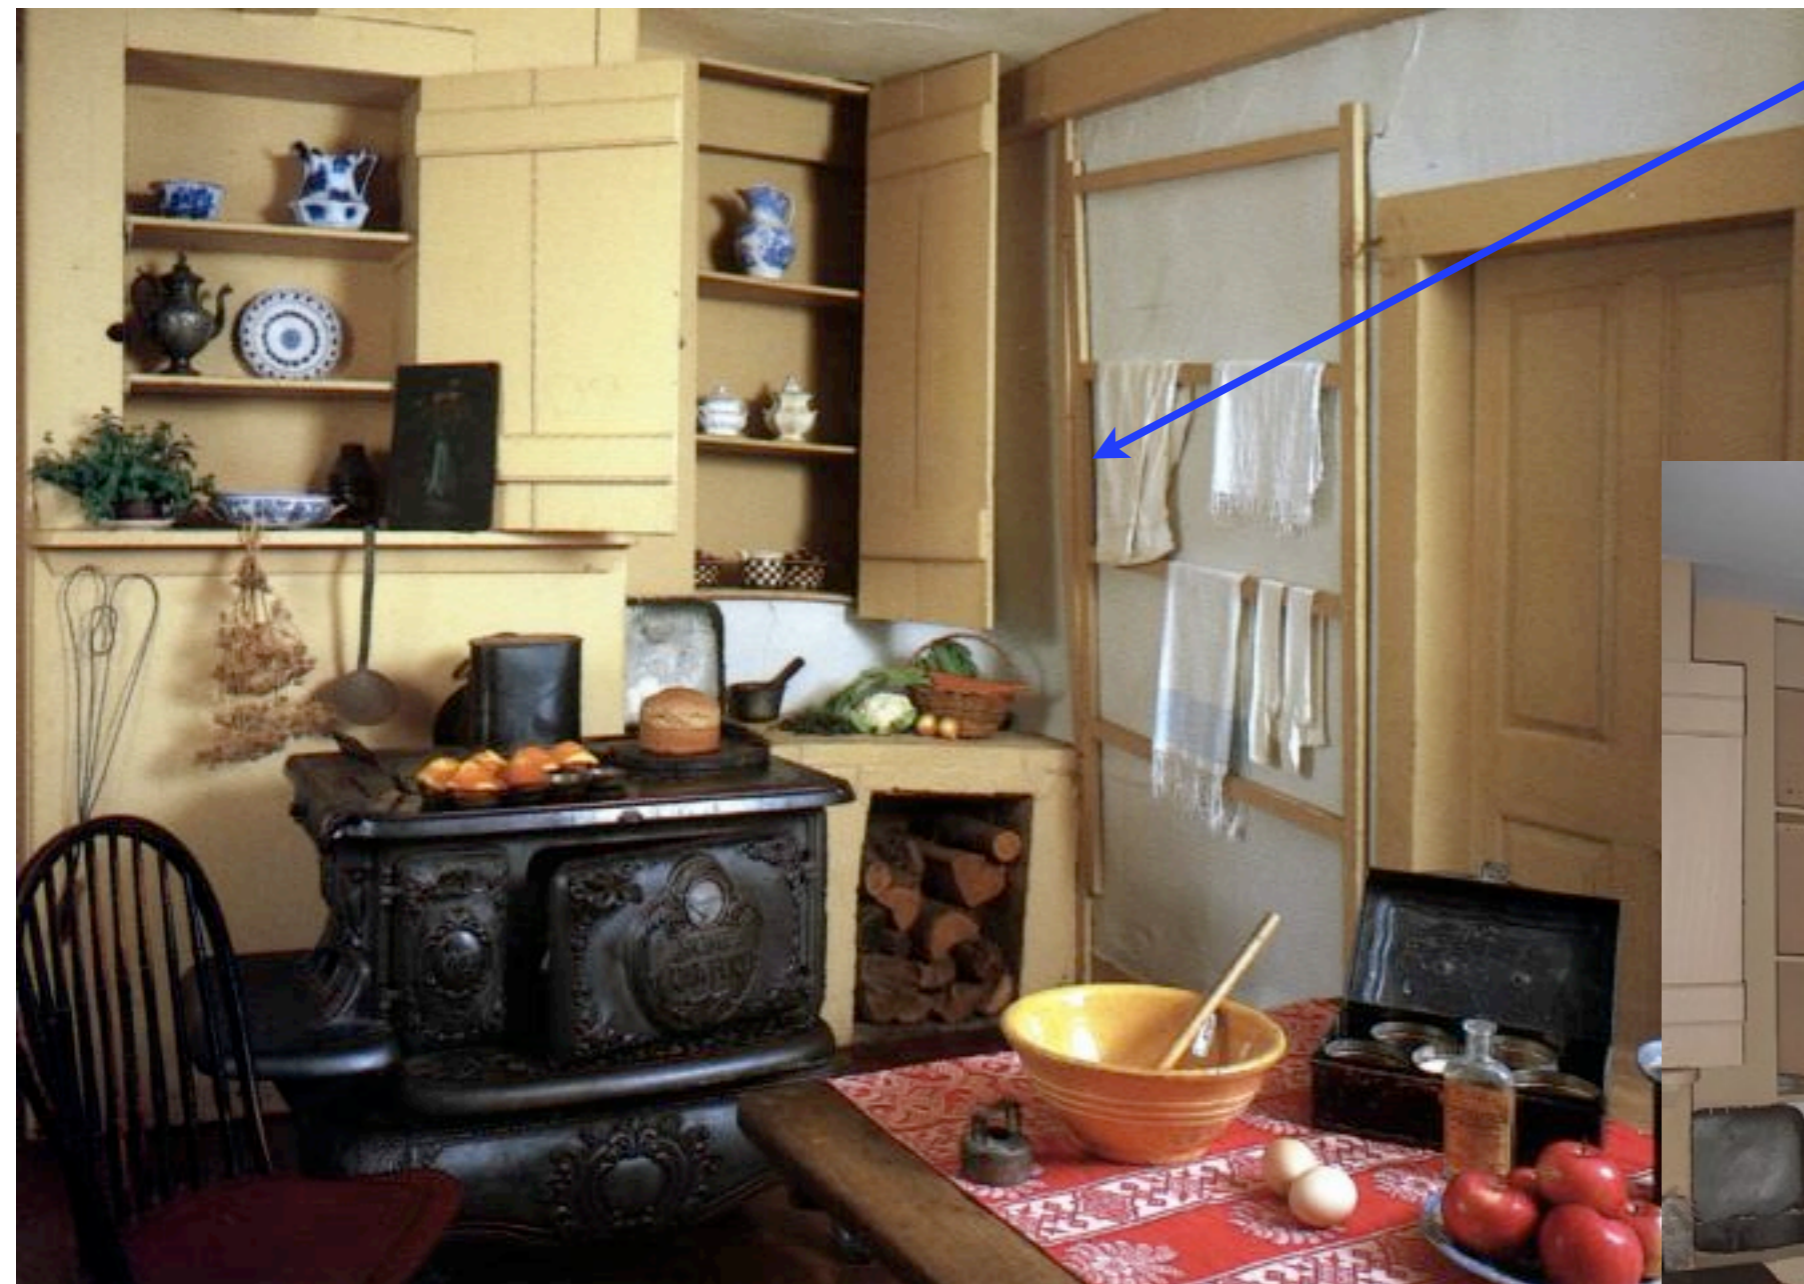
**Kitchen3**

This photo is “during” restoration and needs are to repair plaster

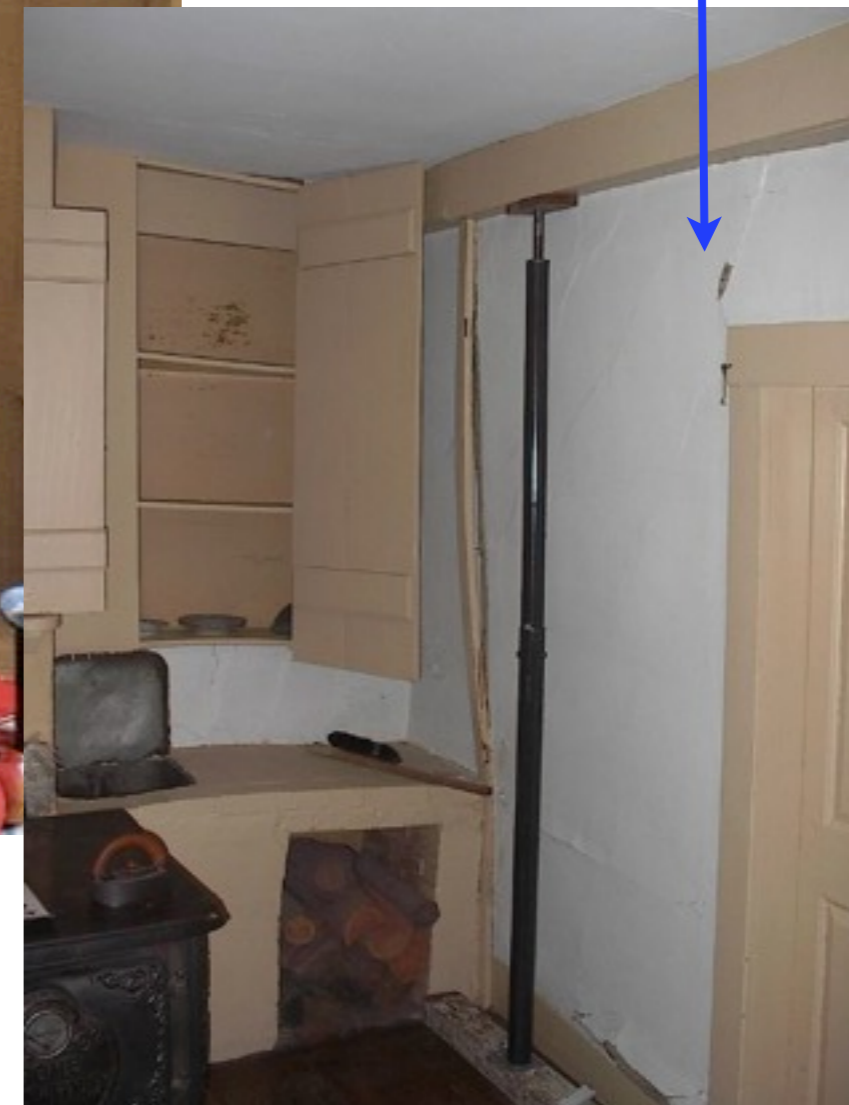
**KitchenDryingRack**

This photo is “before” restoration and needs are to carefully reconstruct the drying rack and cabinetry

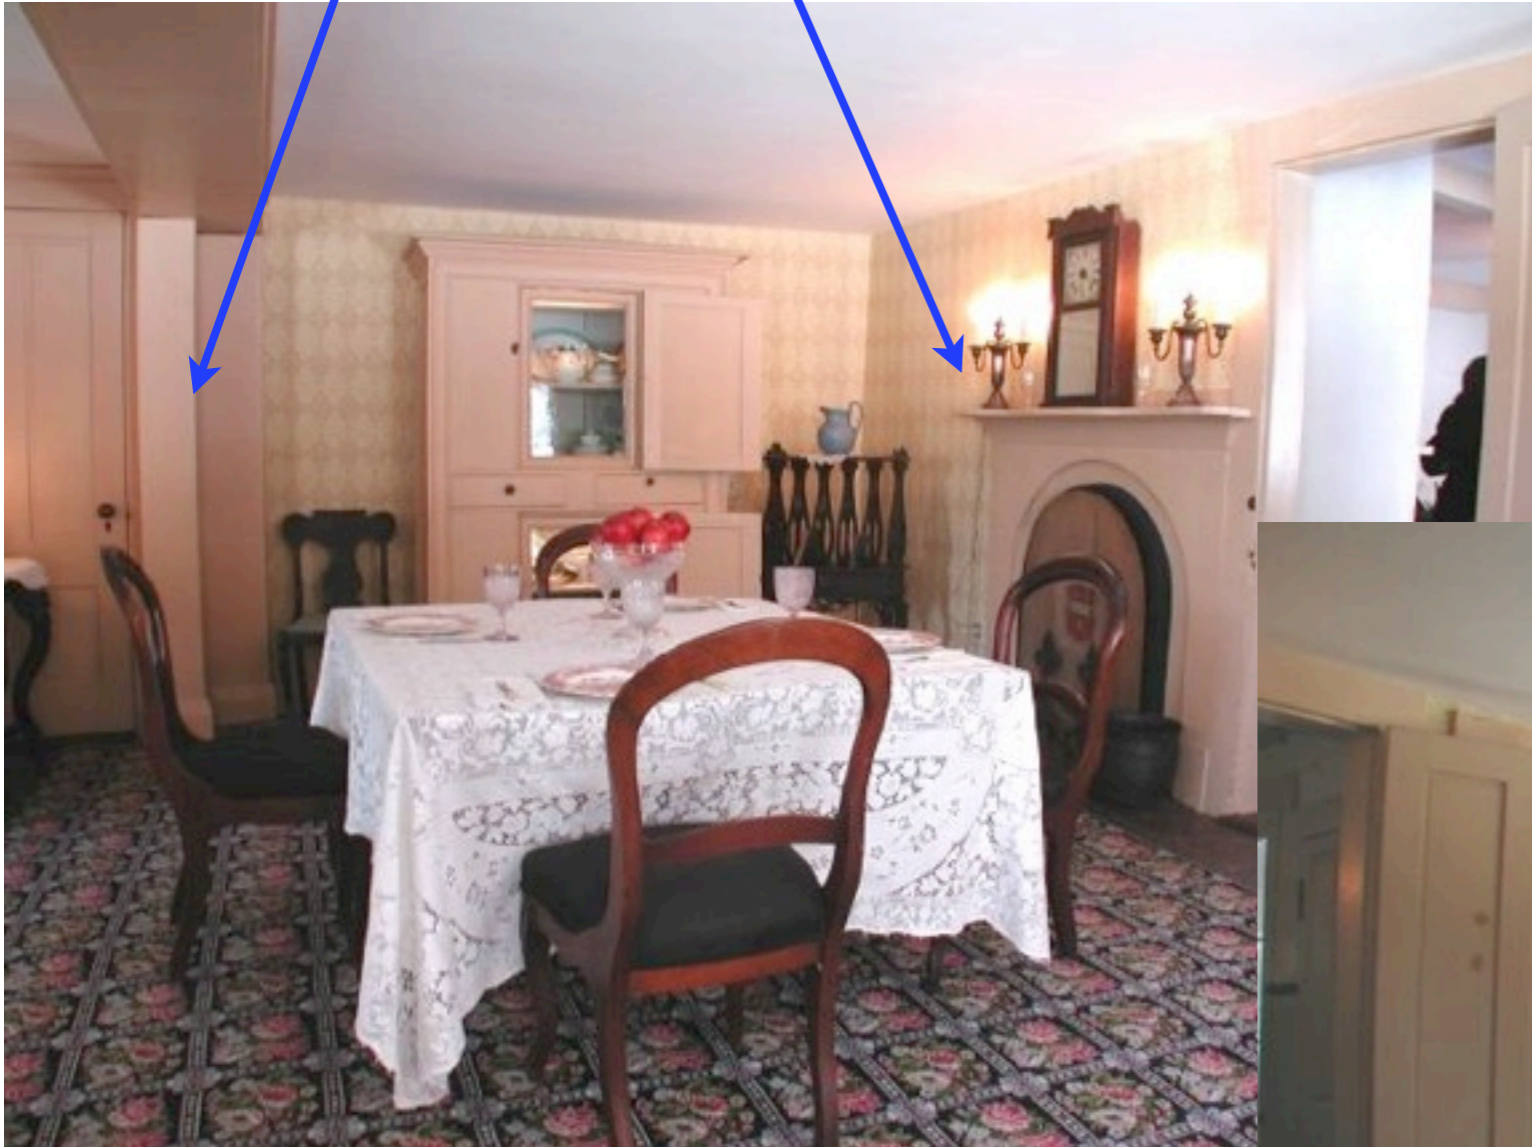
DSCN2240

Repair structural system

Views of dining room
