**Photos of repairs, conservation and restoration**

**Work Scheduled for 2008 - 2009**

**Updated April 17, 2009**

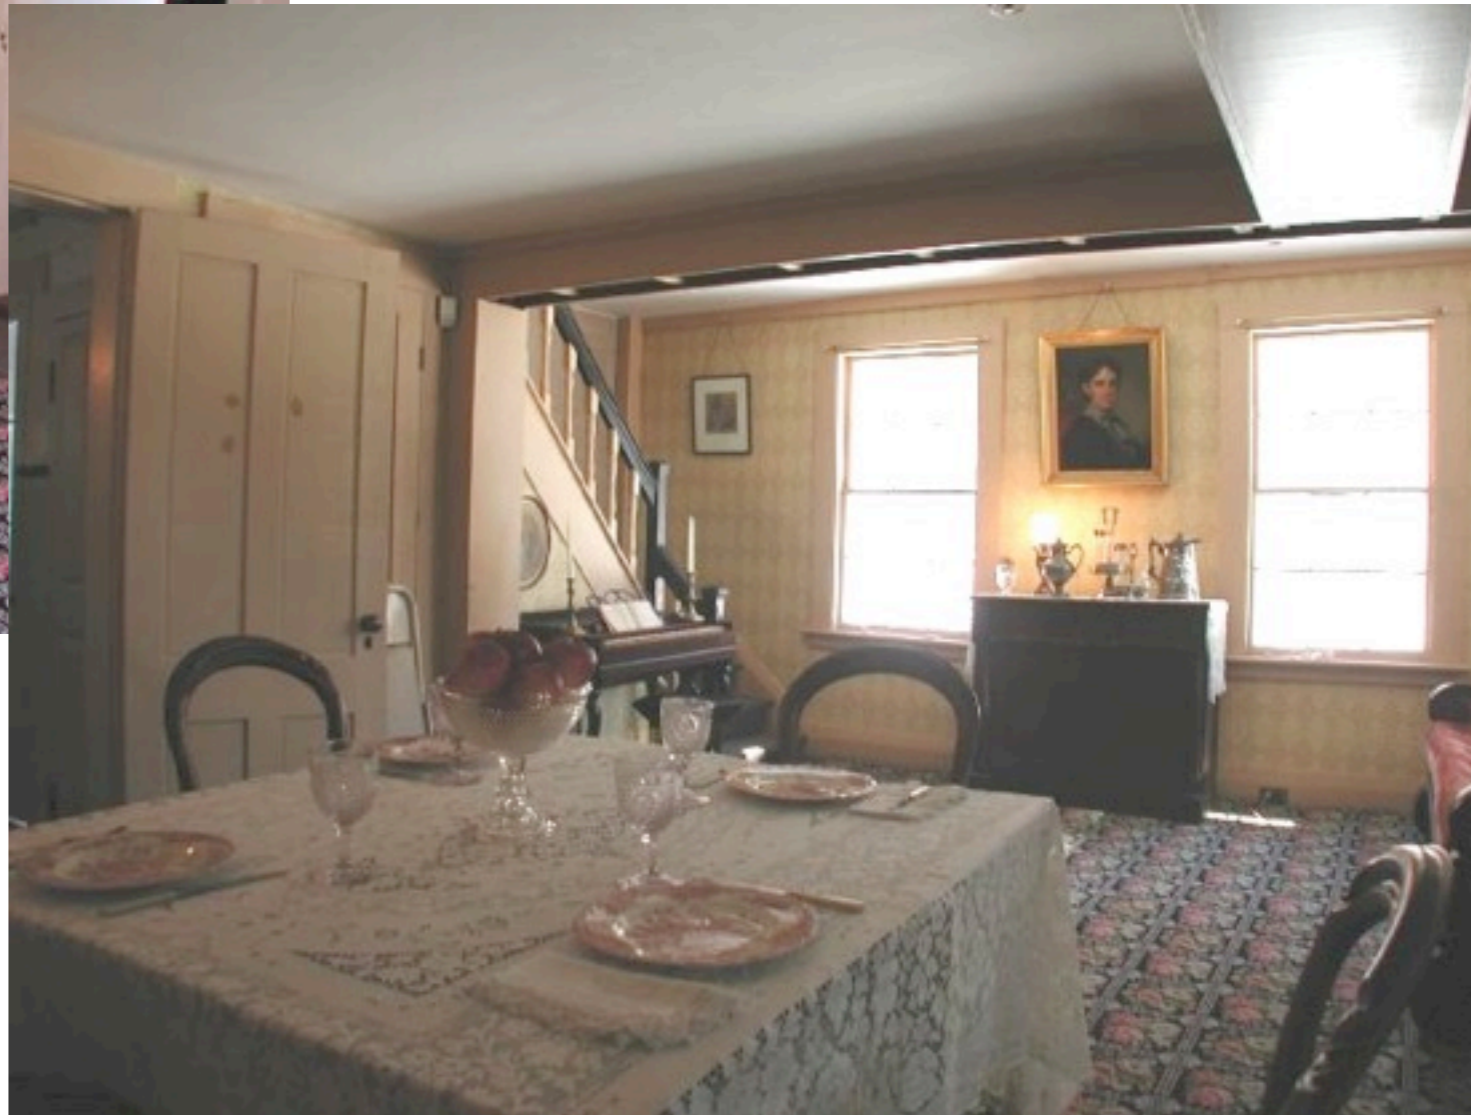
DSCN2239

Views of dining room

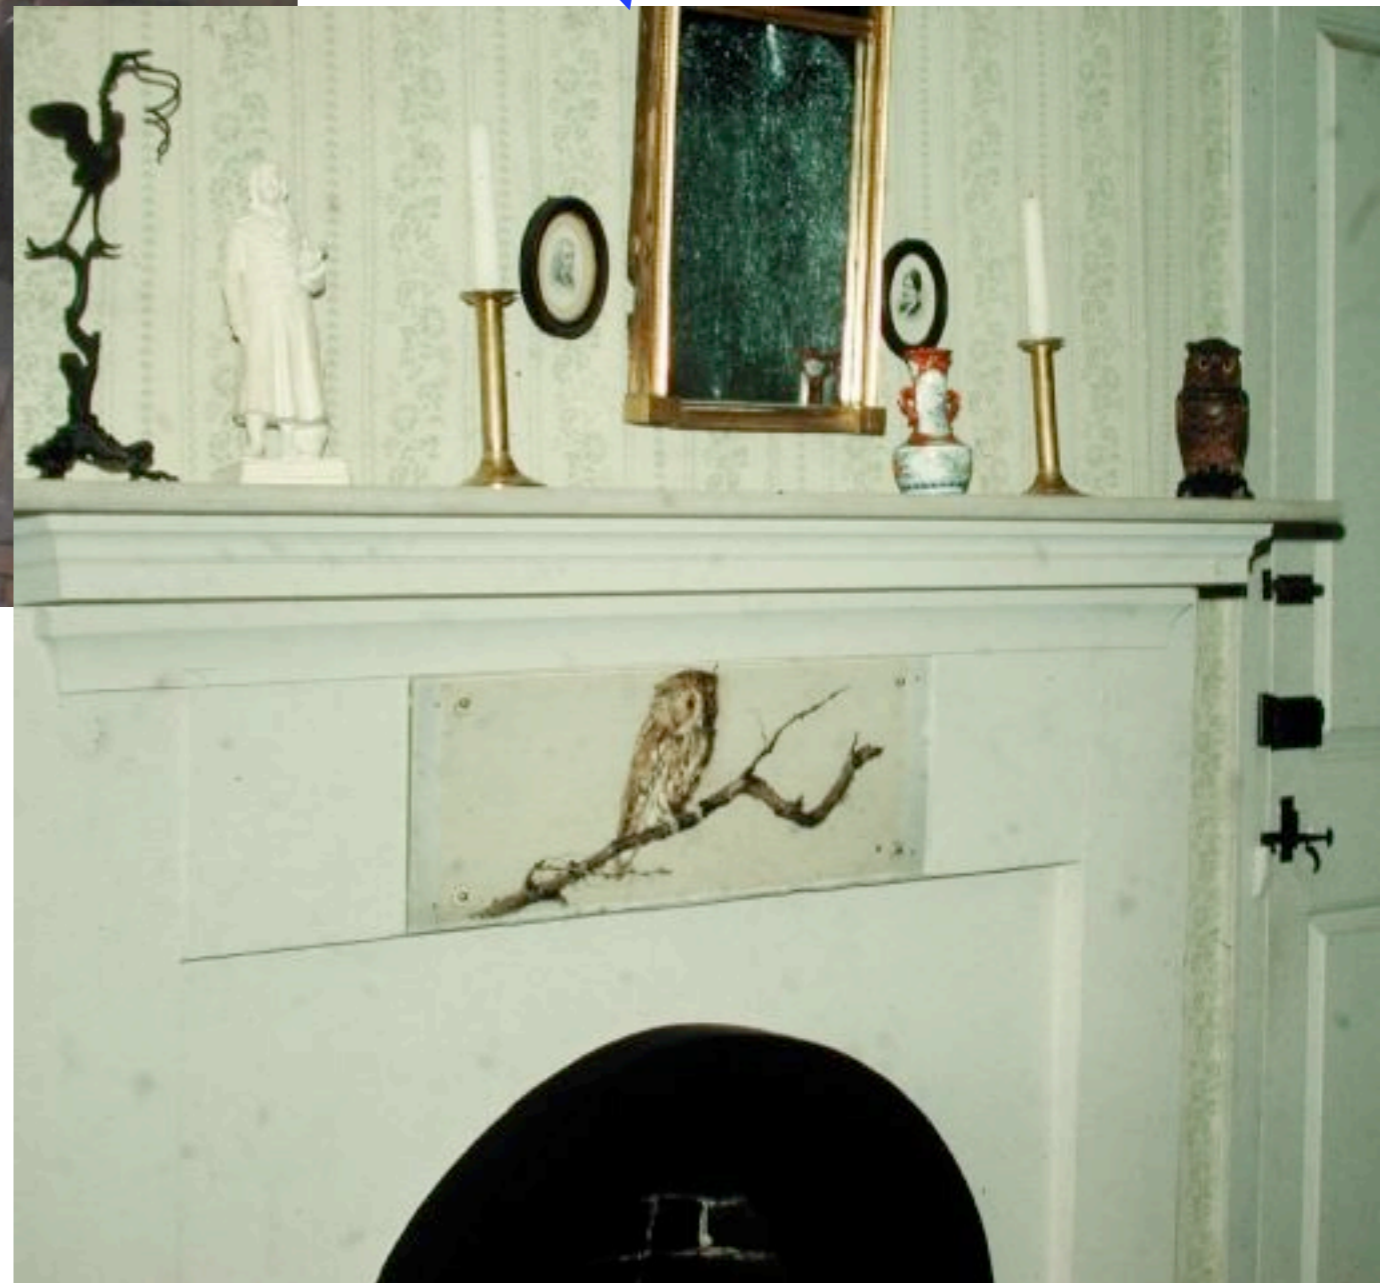
DSCN2252

Structure inside partition needs repairs

Views of Louisa May's Room

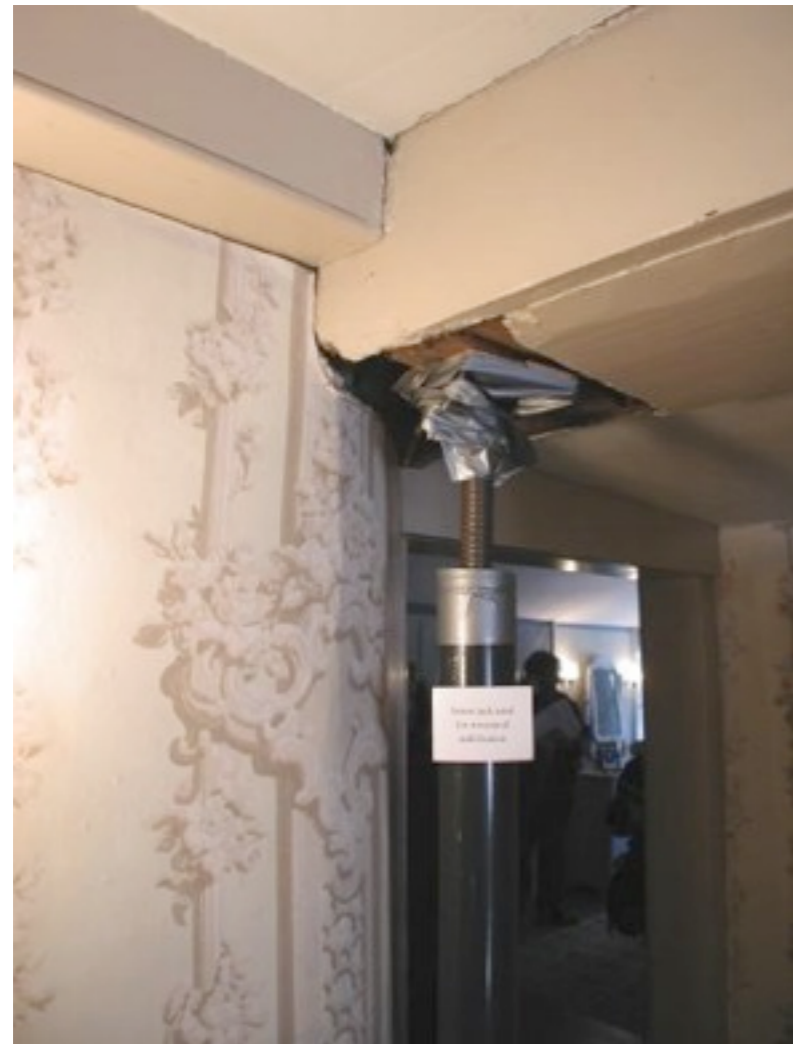
**DSCN2257**

**Structure needs repair, steel column removed and finishes restored**

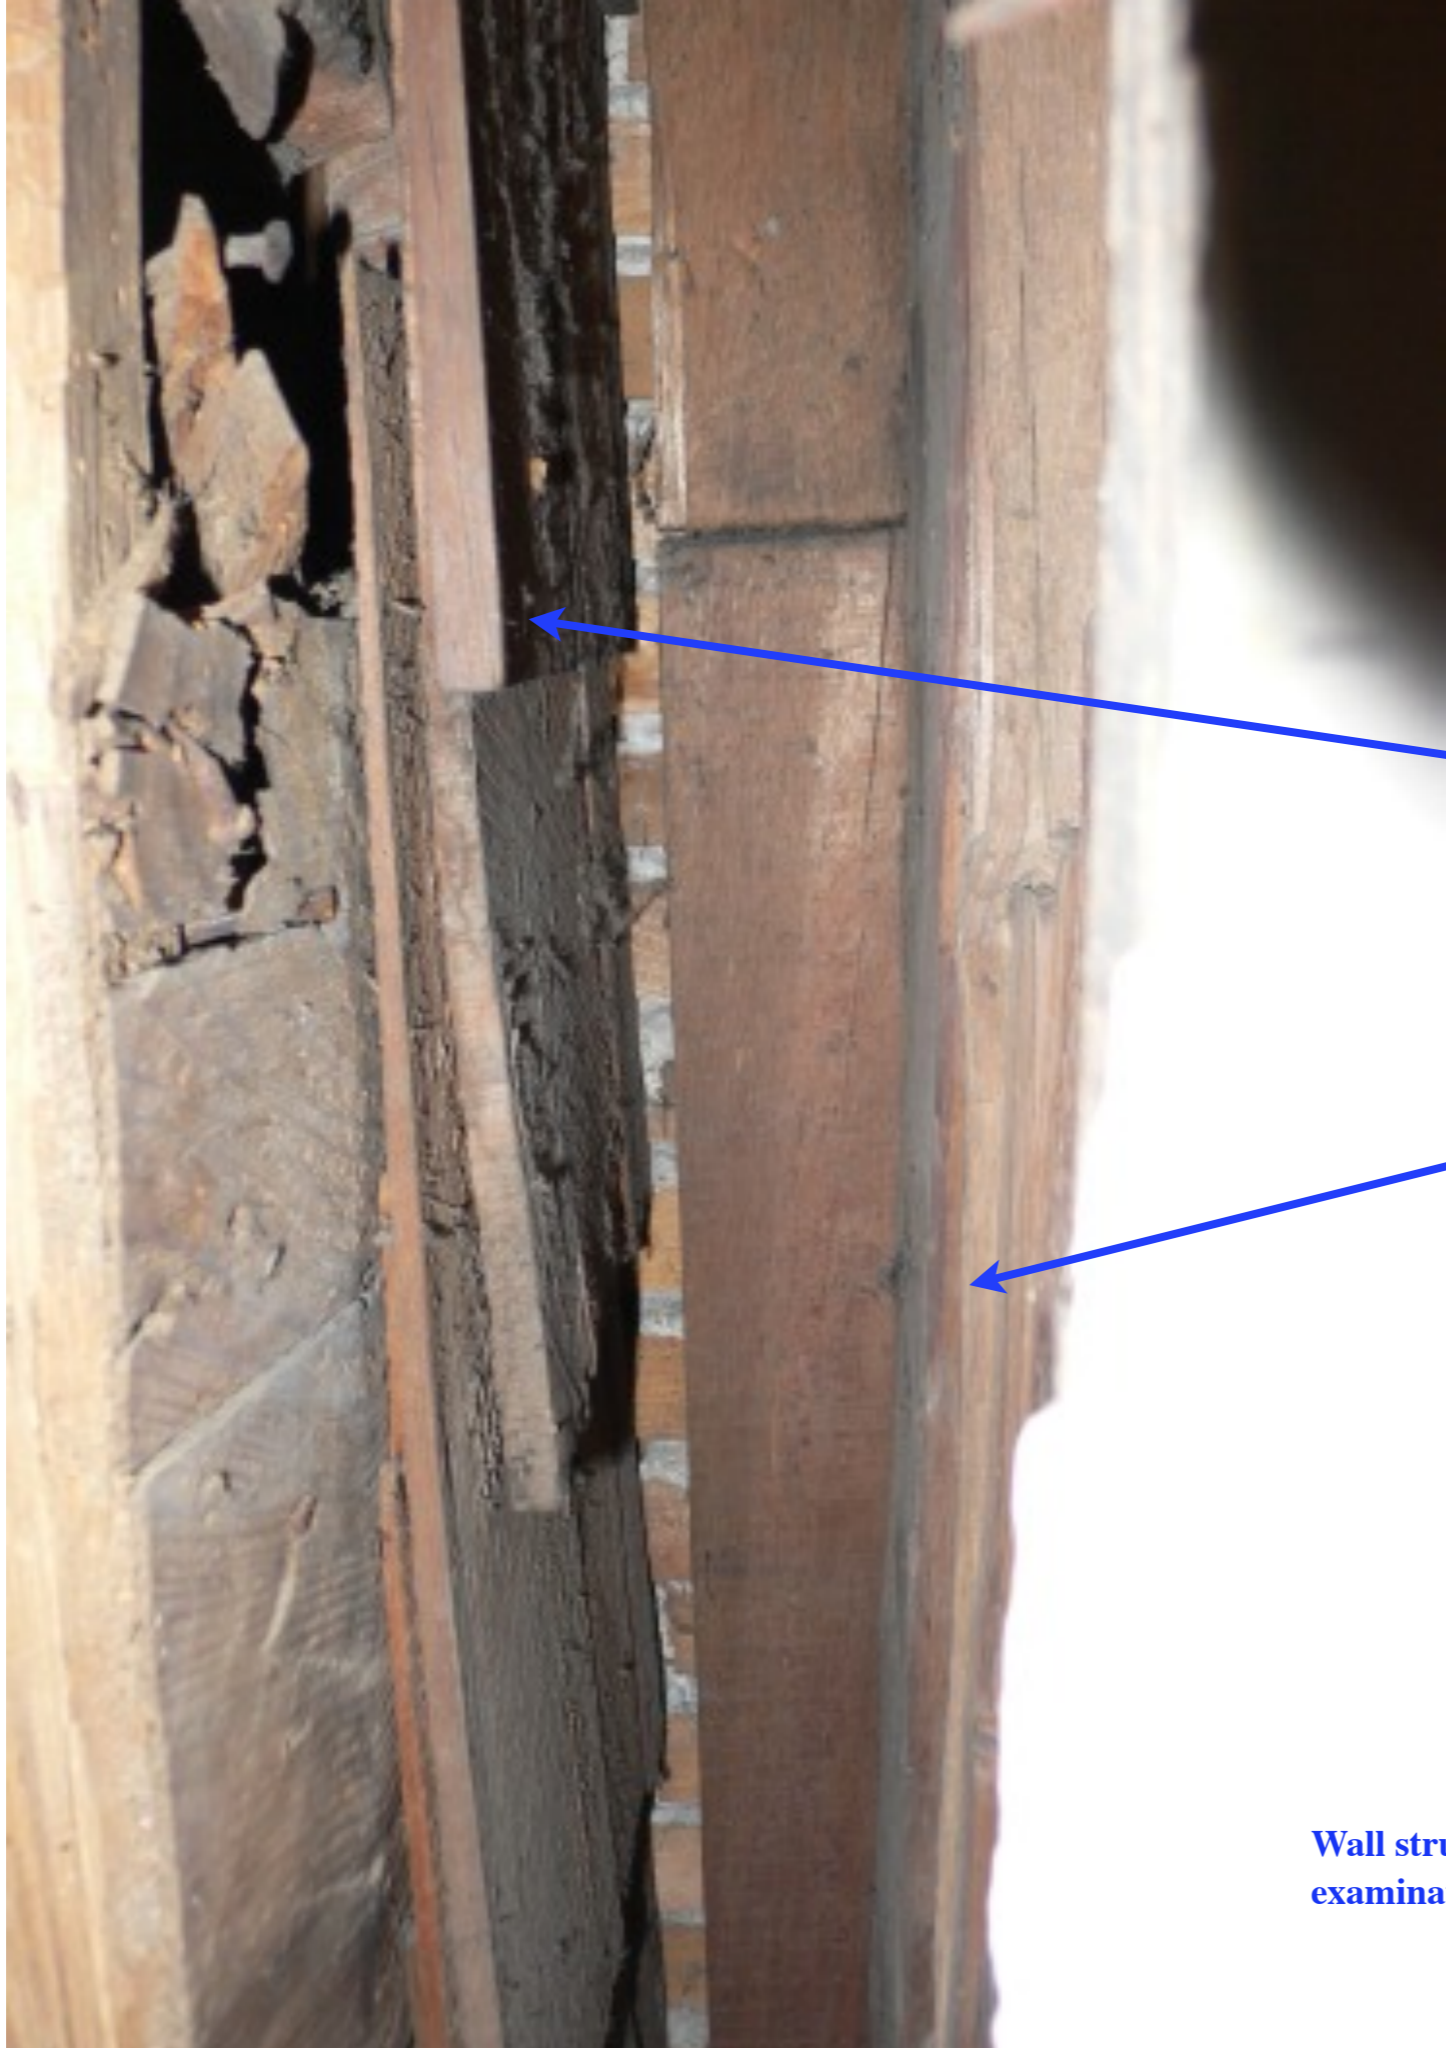
**L1090797**

**Early shingles on north wall of “Mansion House” attached with old “cut nails”.**

**This photo shows the structure of the walls between to “Mansion House” and the “Tenant House”**

**Wall structure opened up for examination and repair.**
