**First Congregational Church
Nantucket, MA
Exterior Tower Repairs, Restoration and Conservation**

Study photos

August 22, 2007

**DMH Enterprises, Architects
104 Federal Street
Salem, MA 01970
617-745-2172**

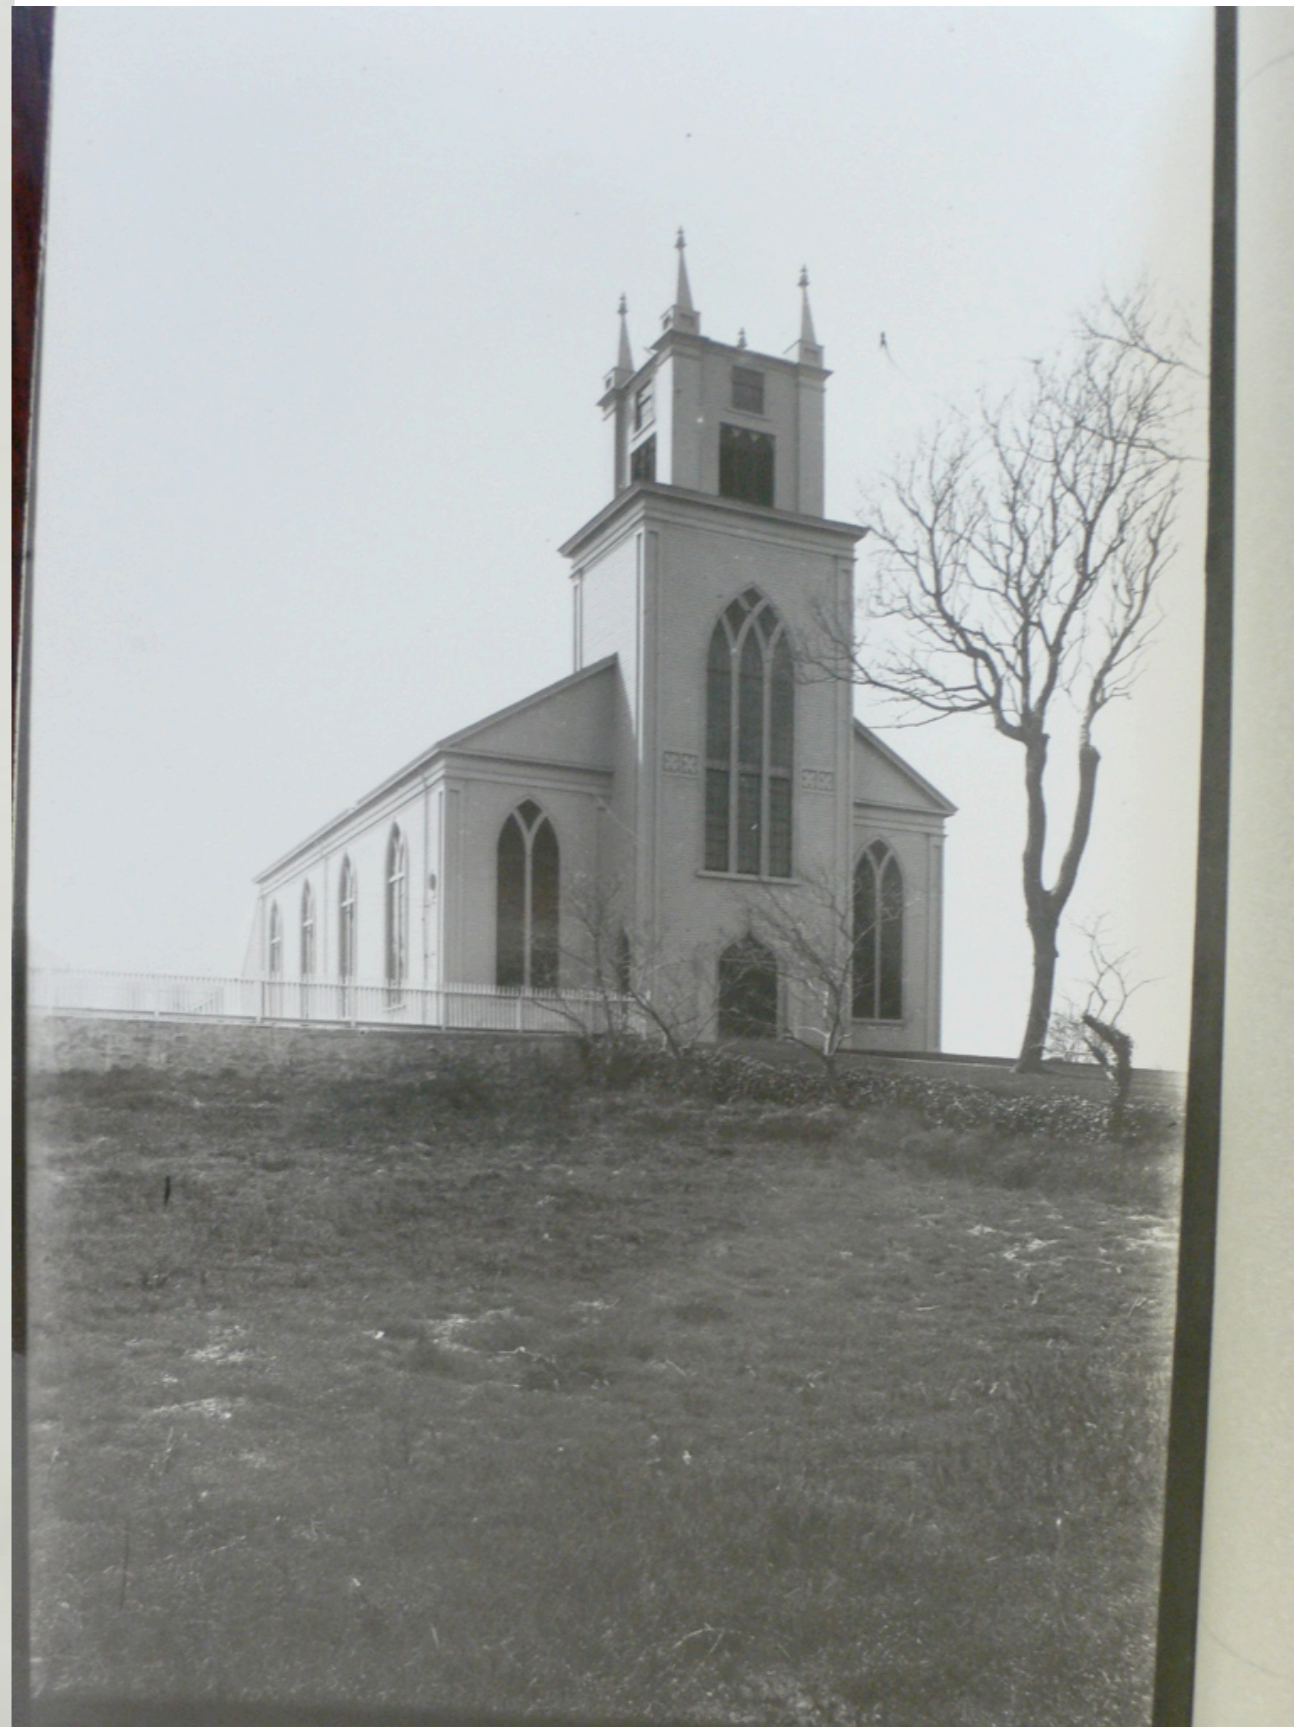
Later - note door surround has changed

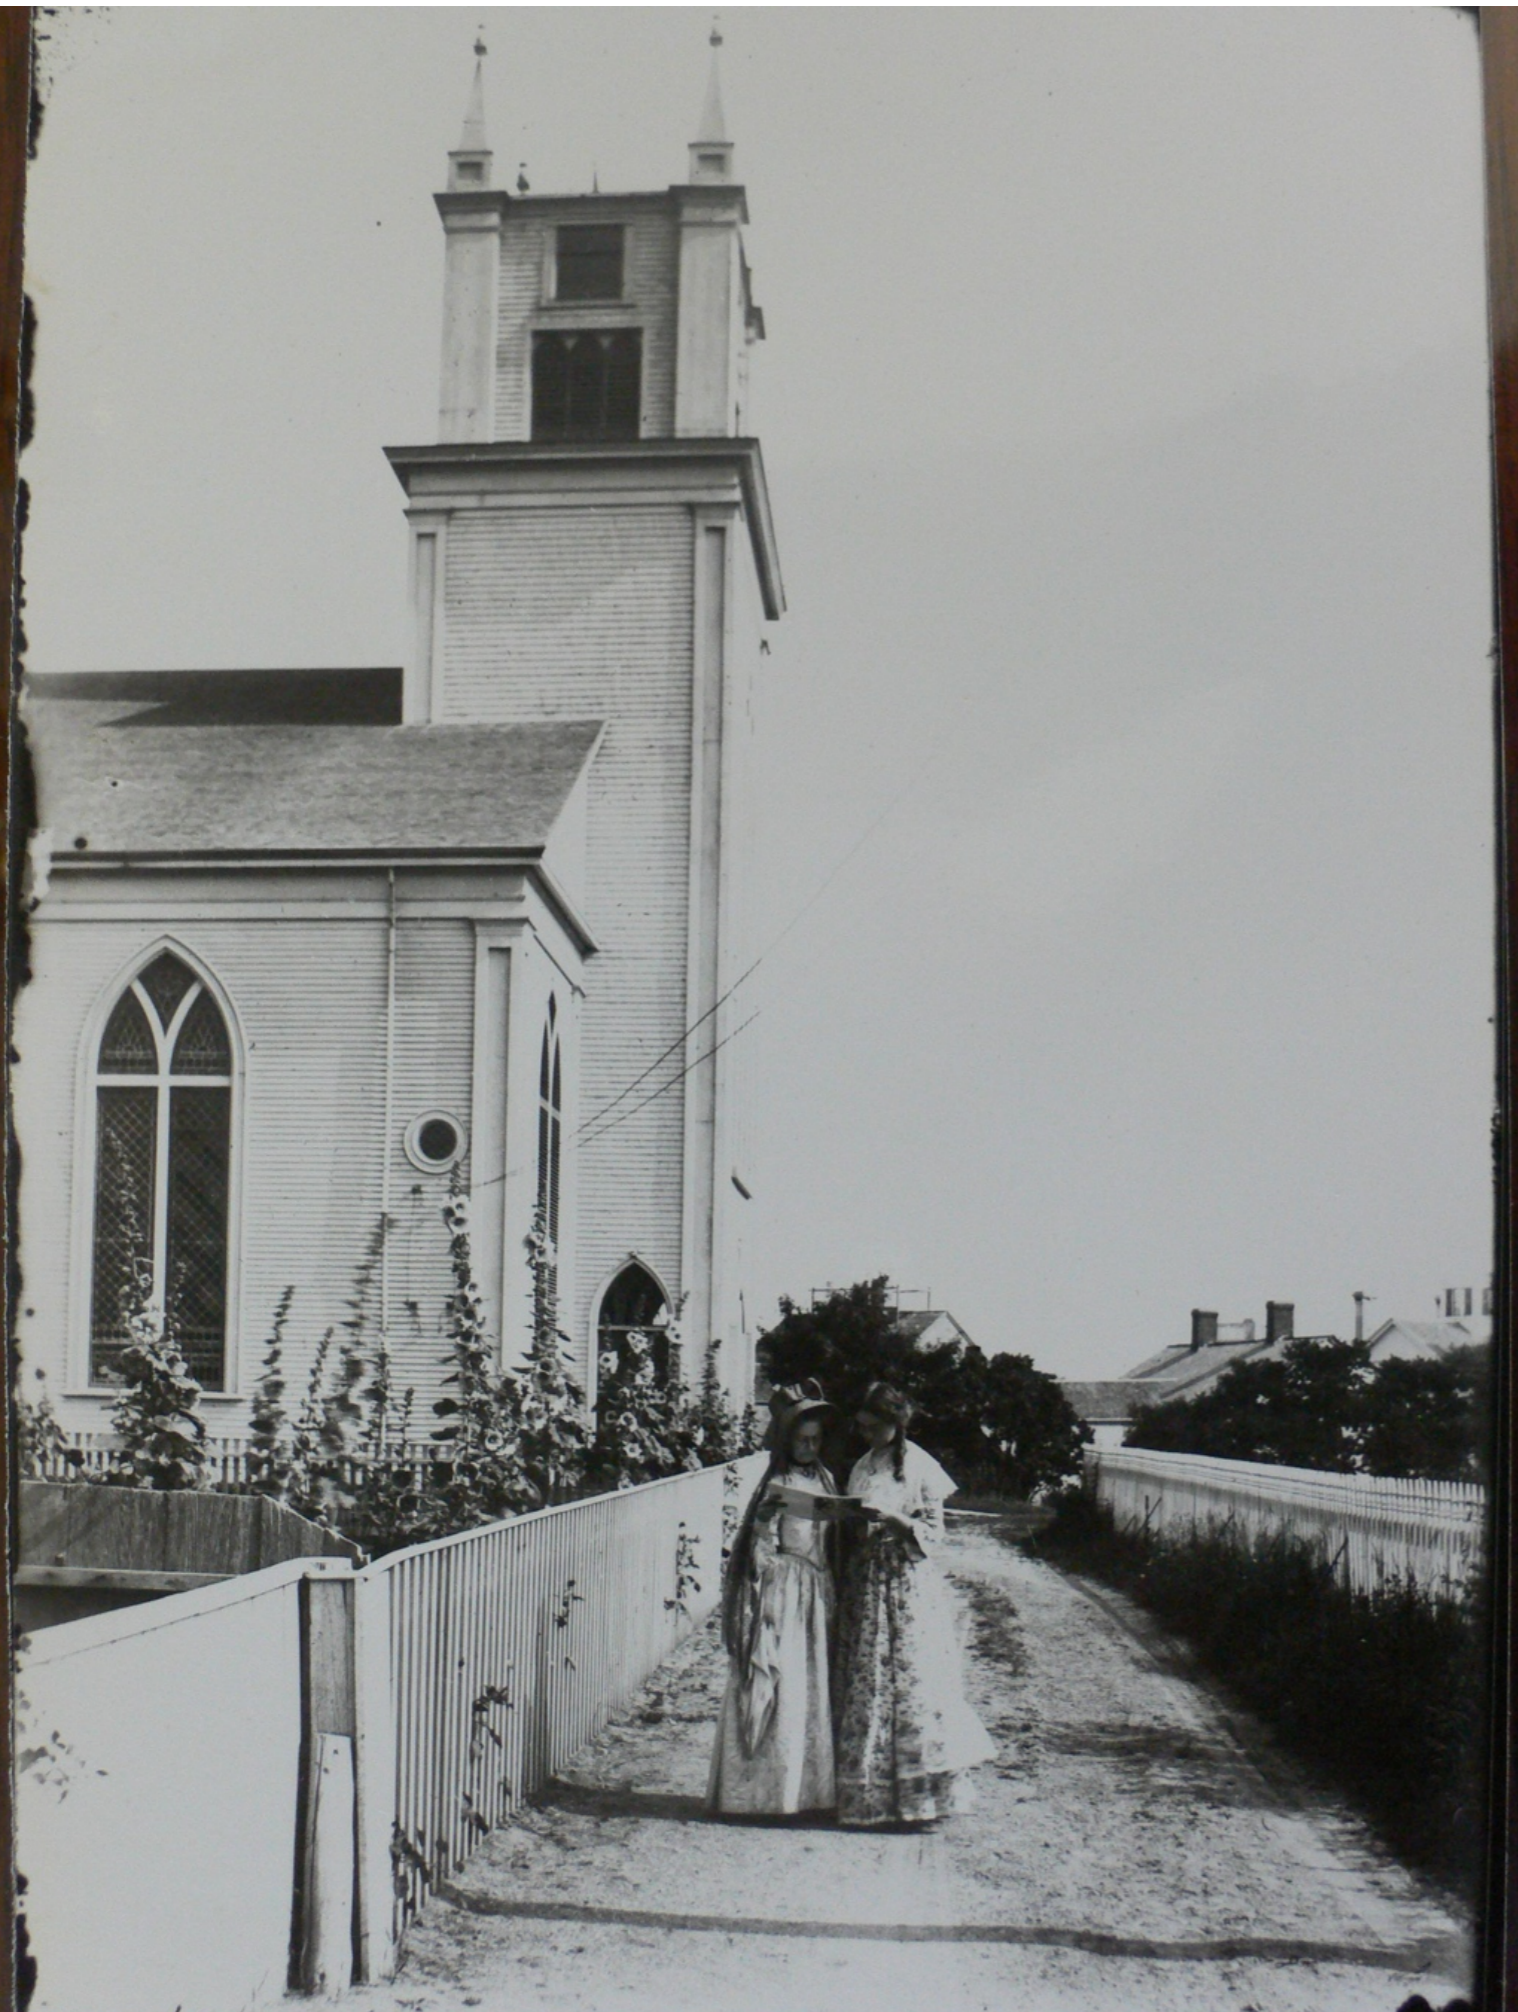
Note Balustrade of c1860's missing

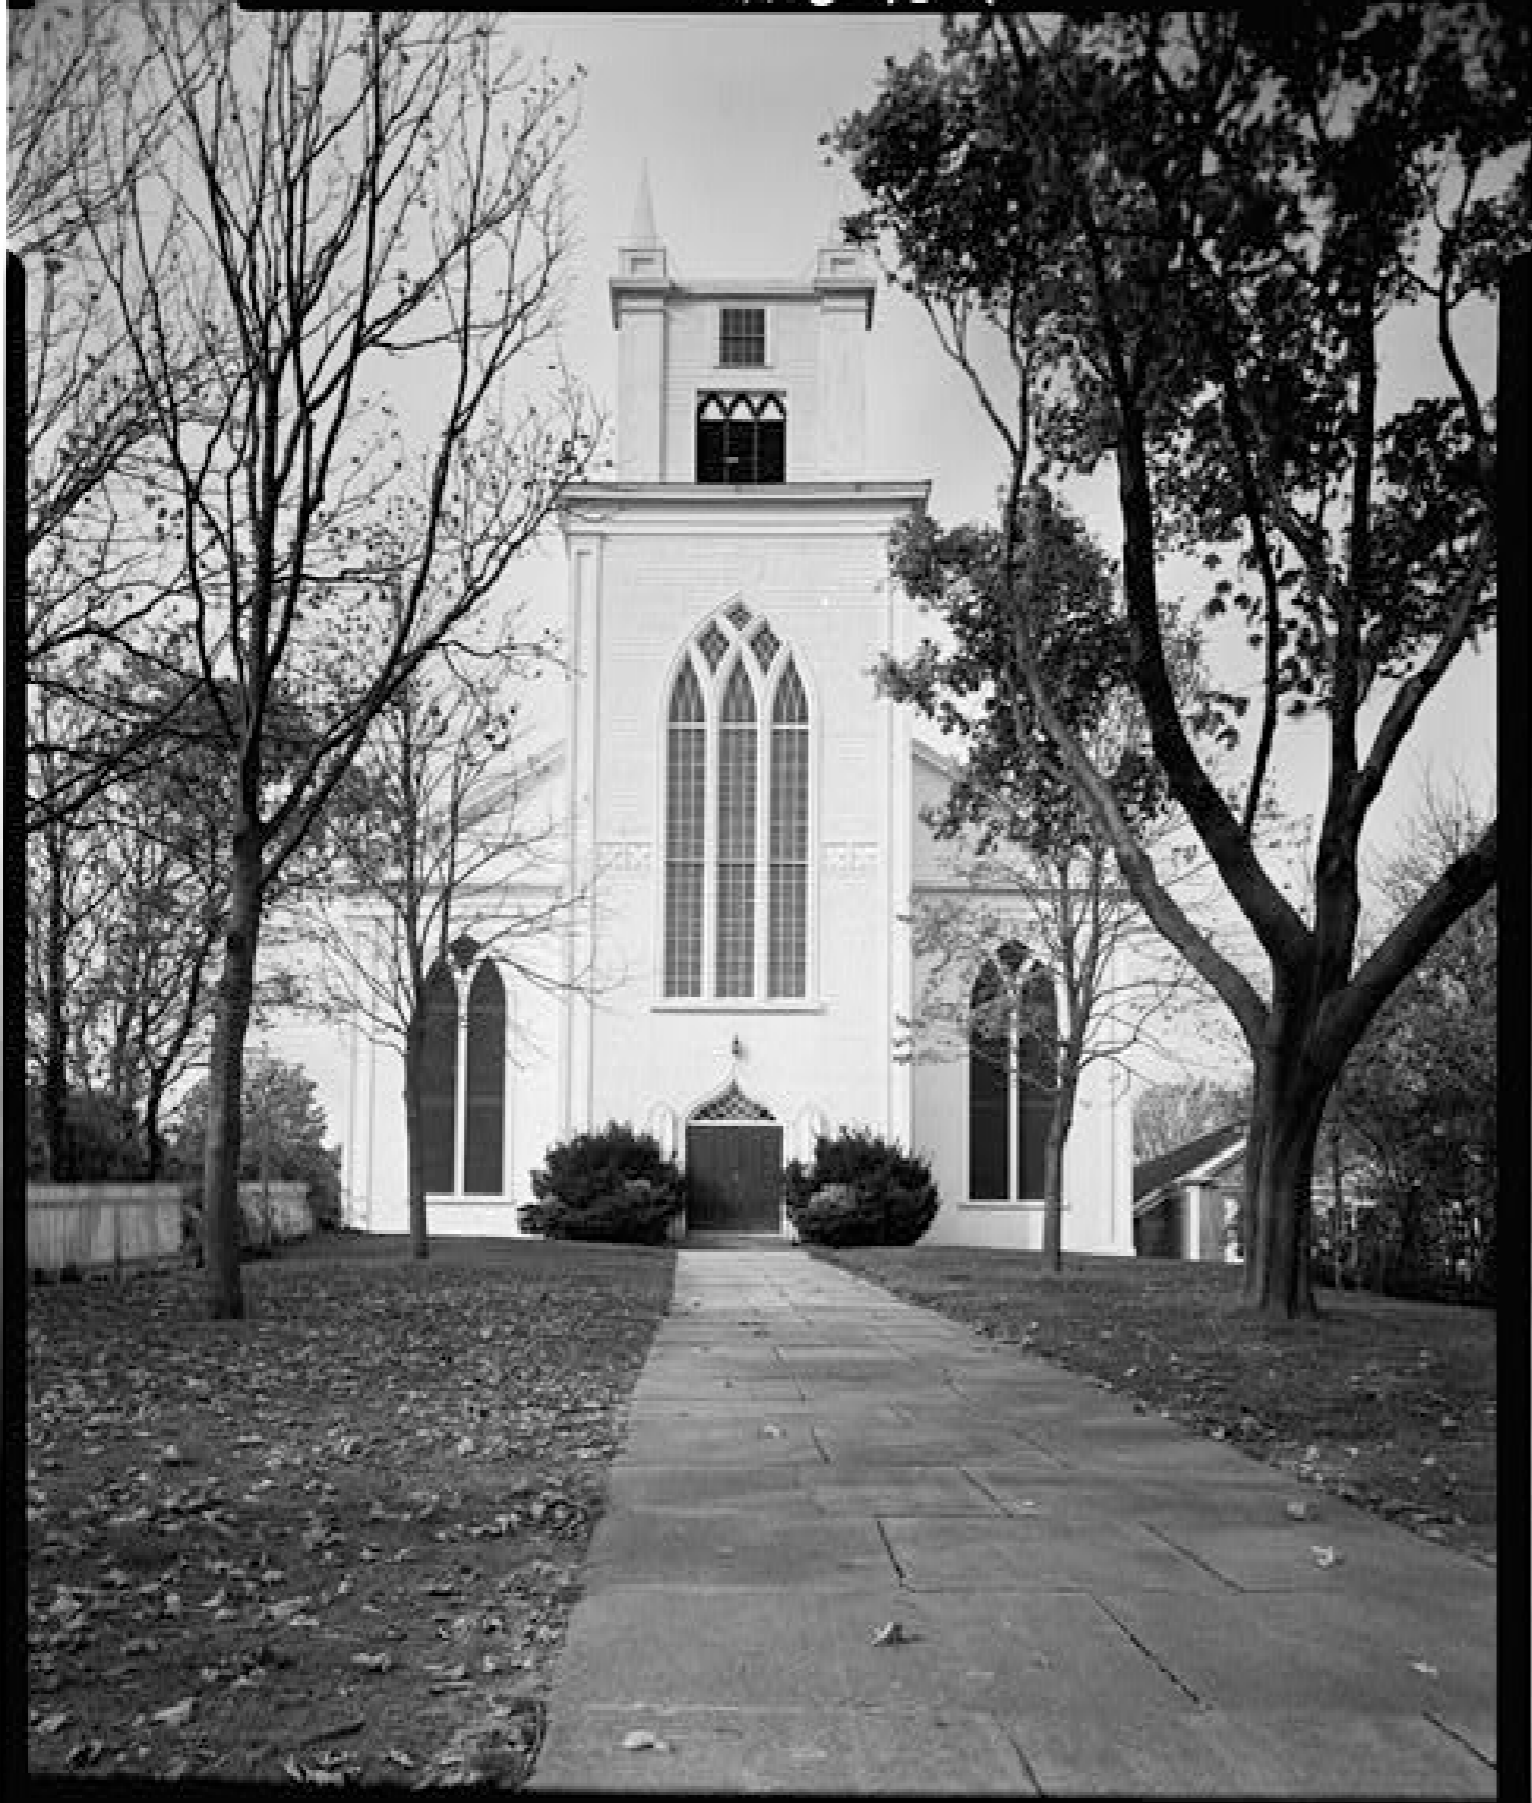
MASS-4024

Note Balustrade of 1866 removed

**Note Door surround
compared to 1860's**

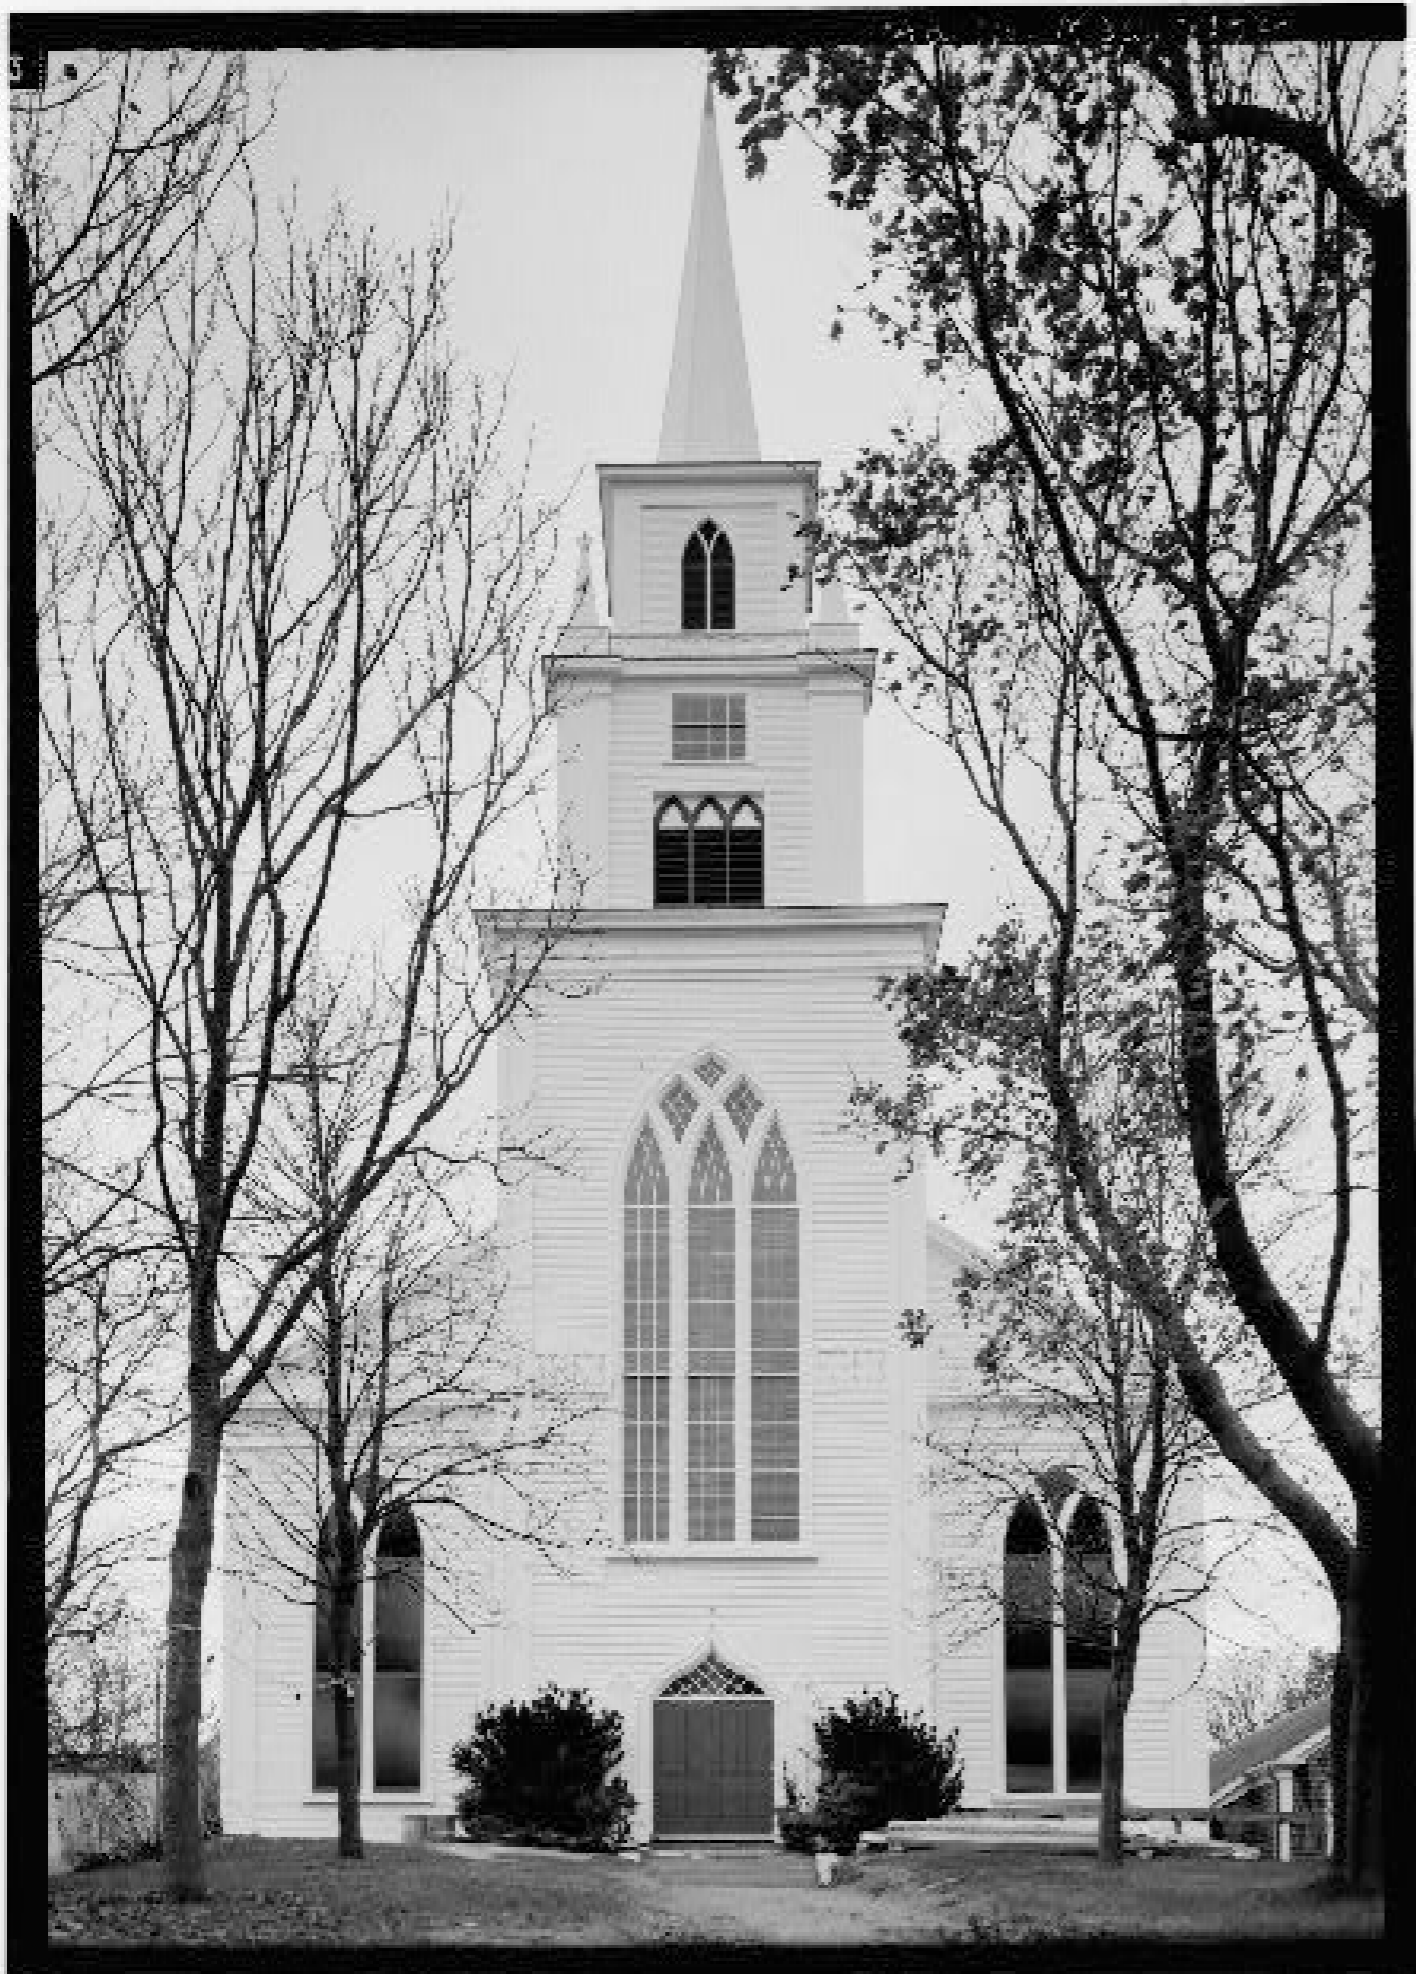
**Library of Congress, HABS
1970, Jack Boucher**

**Church just after 1968
restoration**

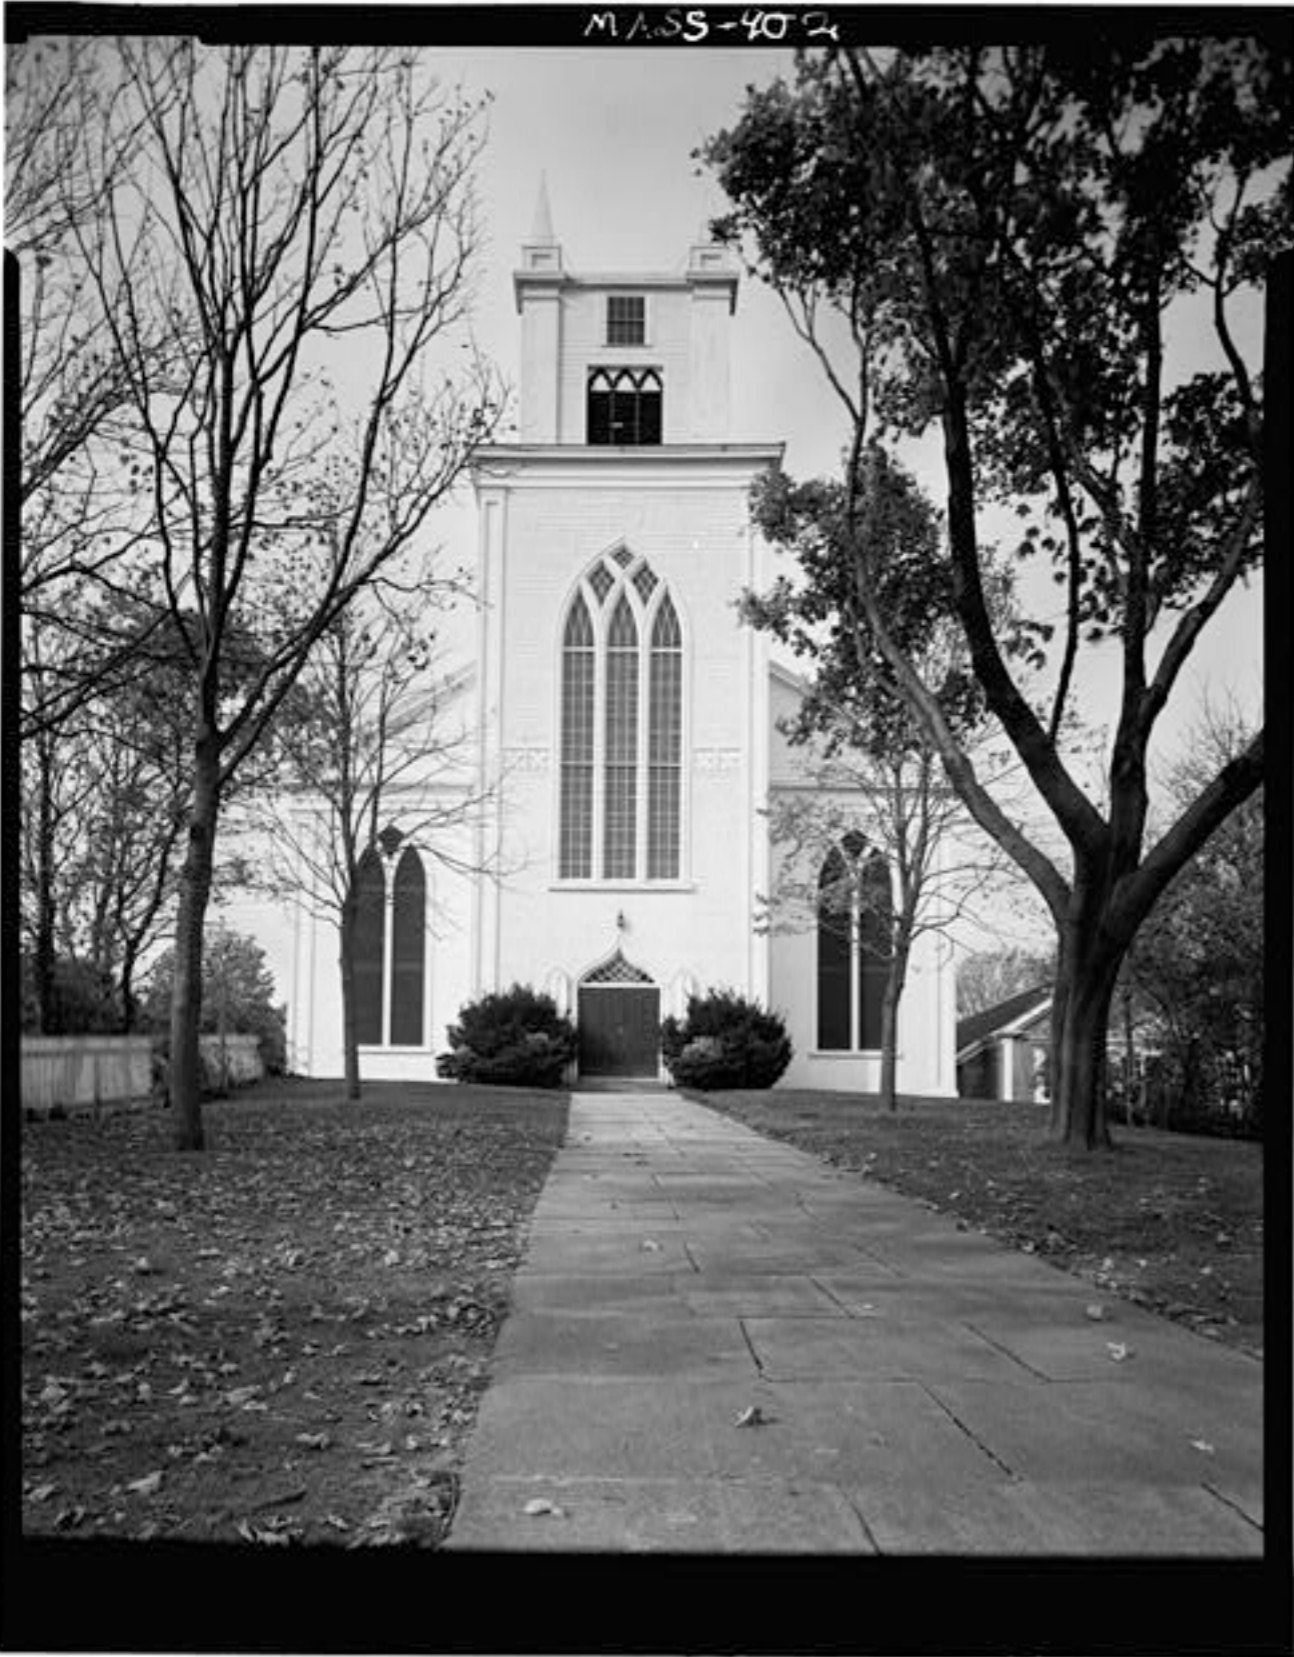
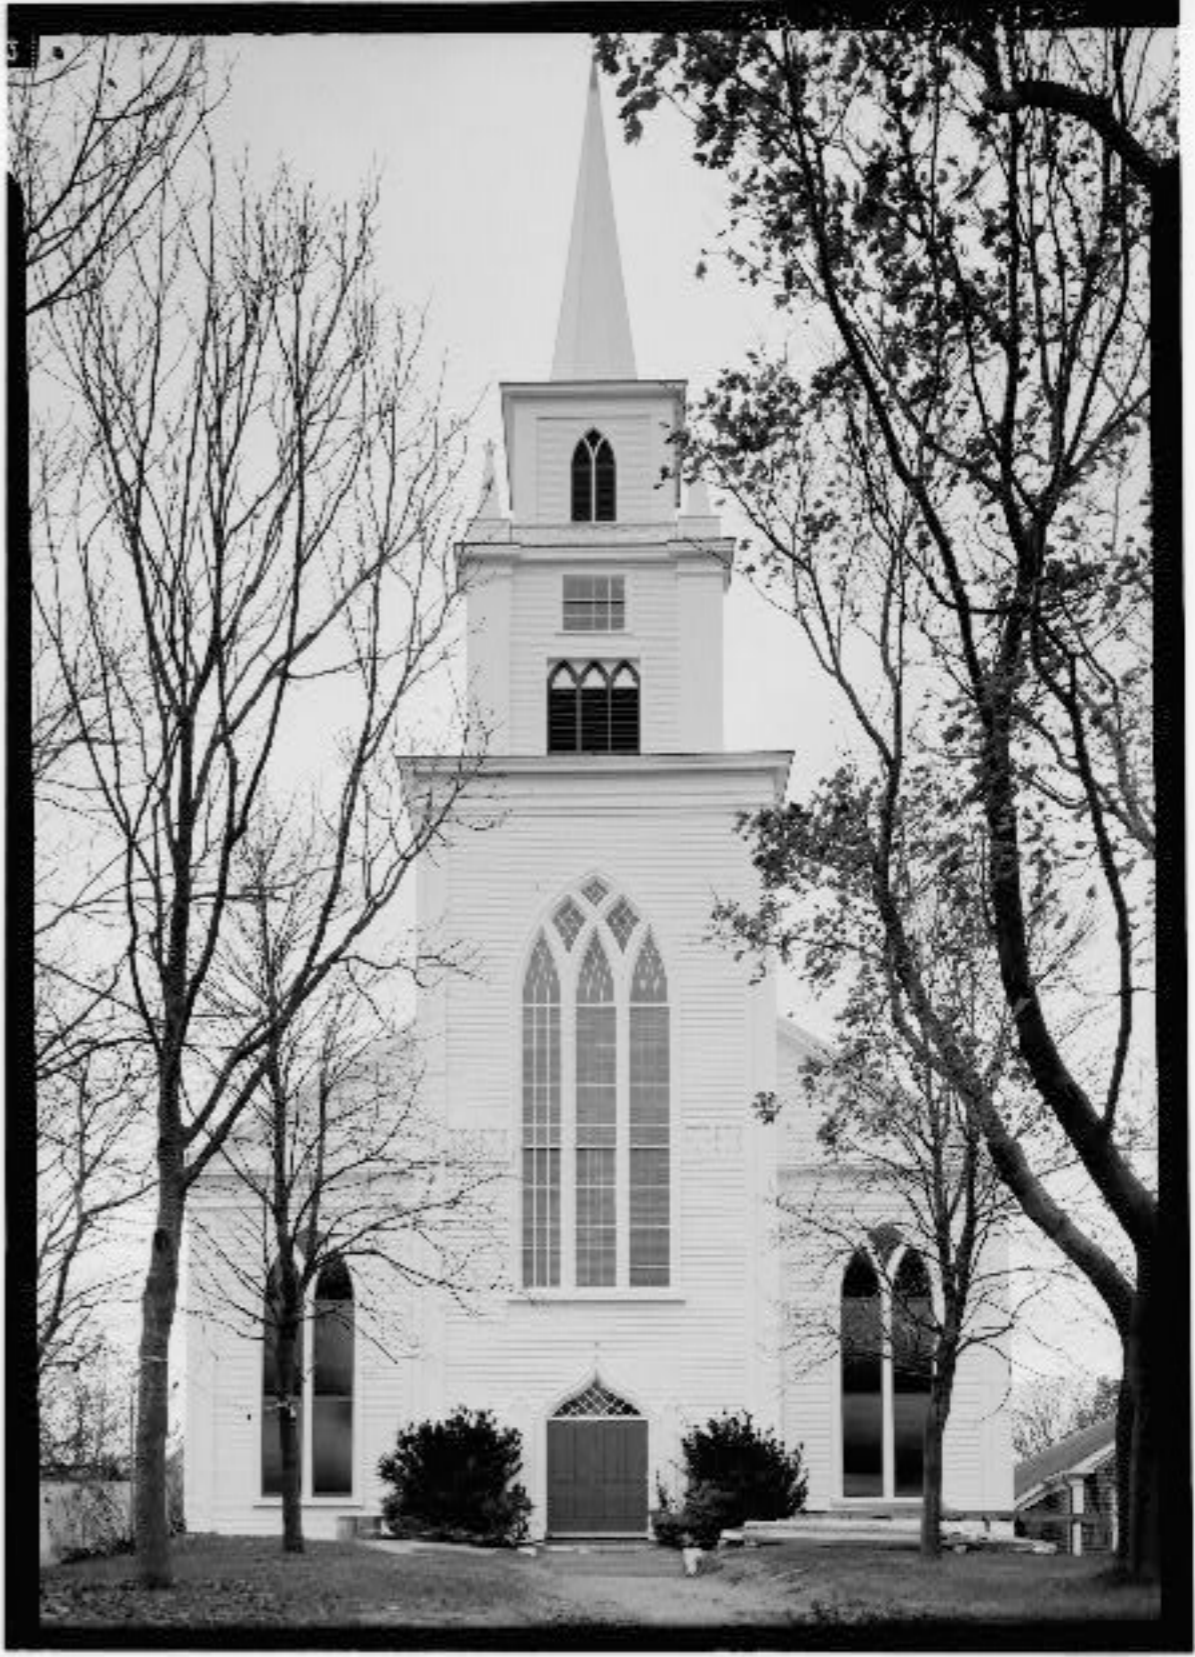
Comparison of 1966 and 1970 (after restoration), HABS photographs

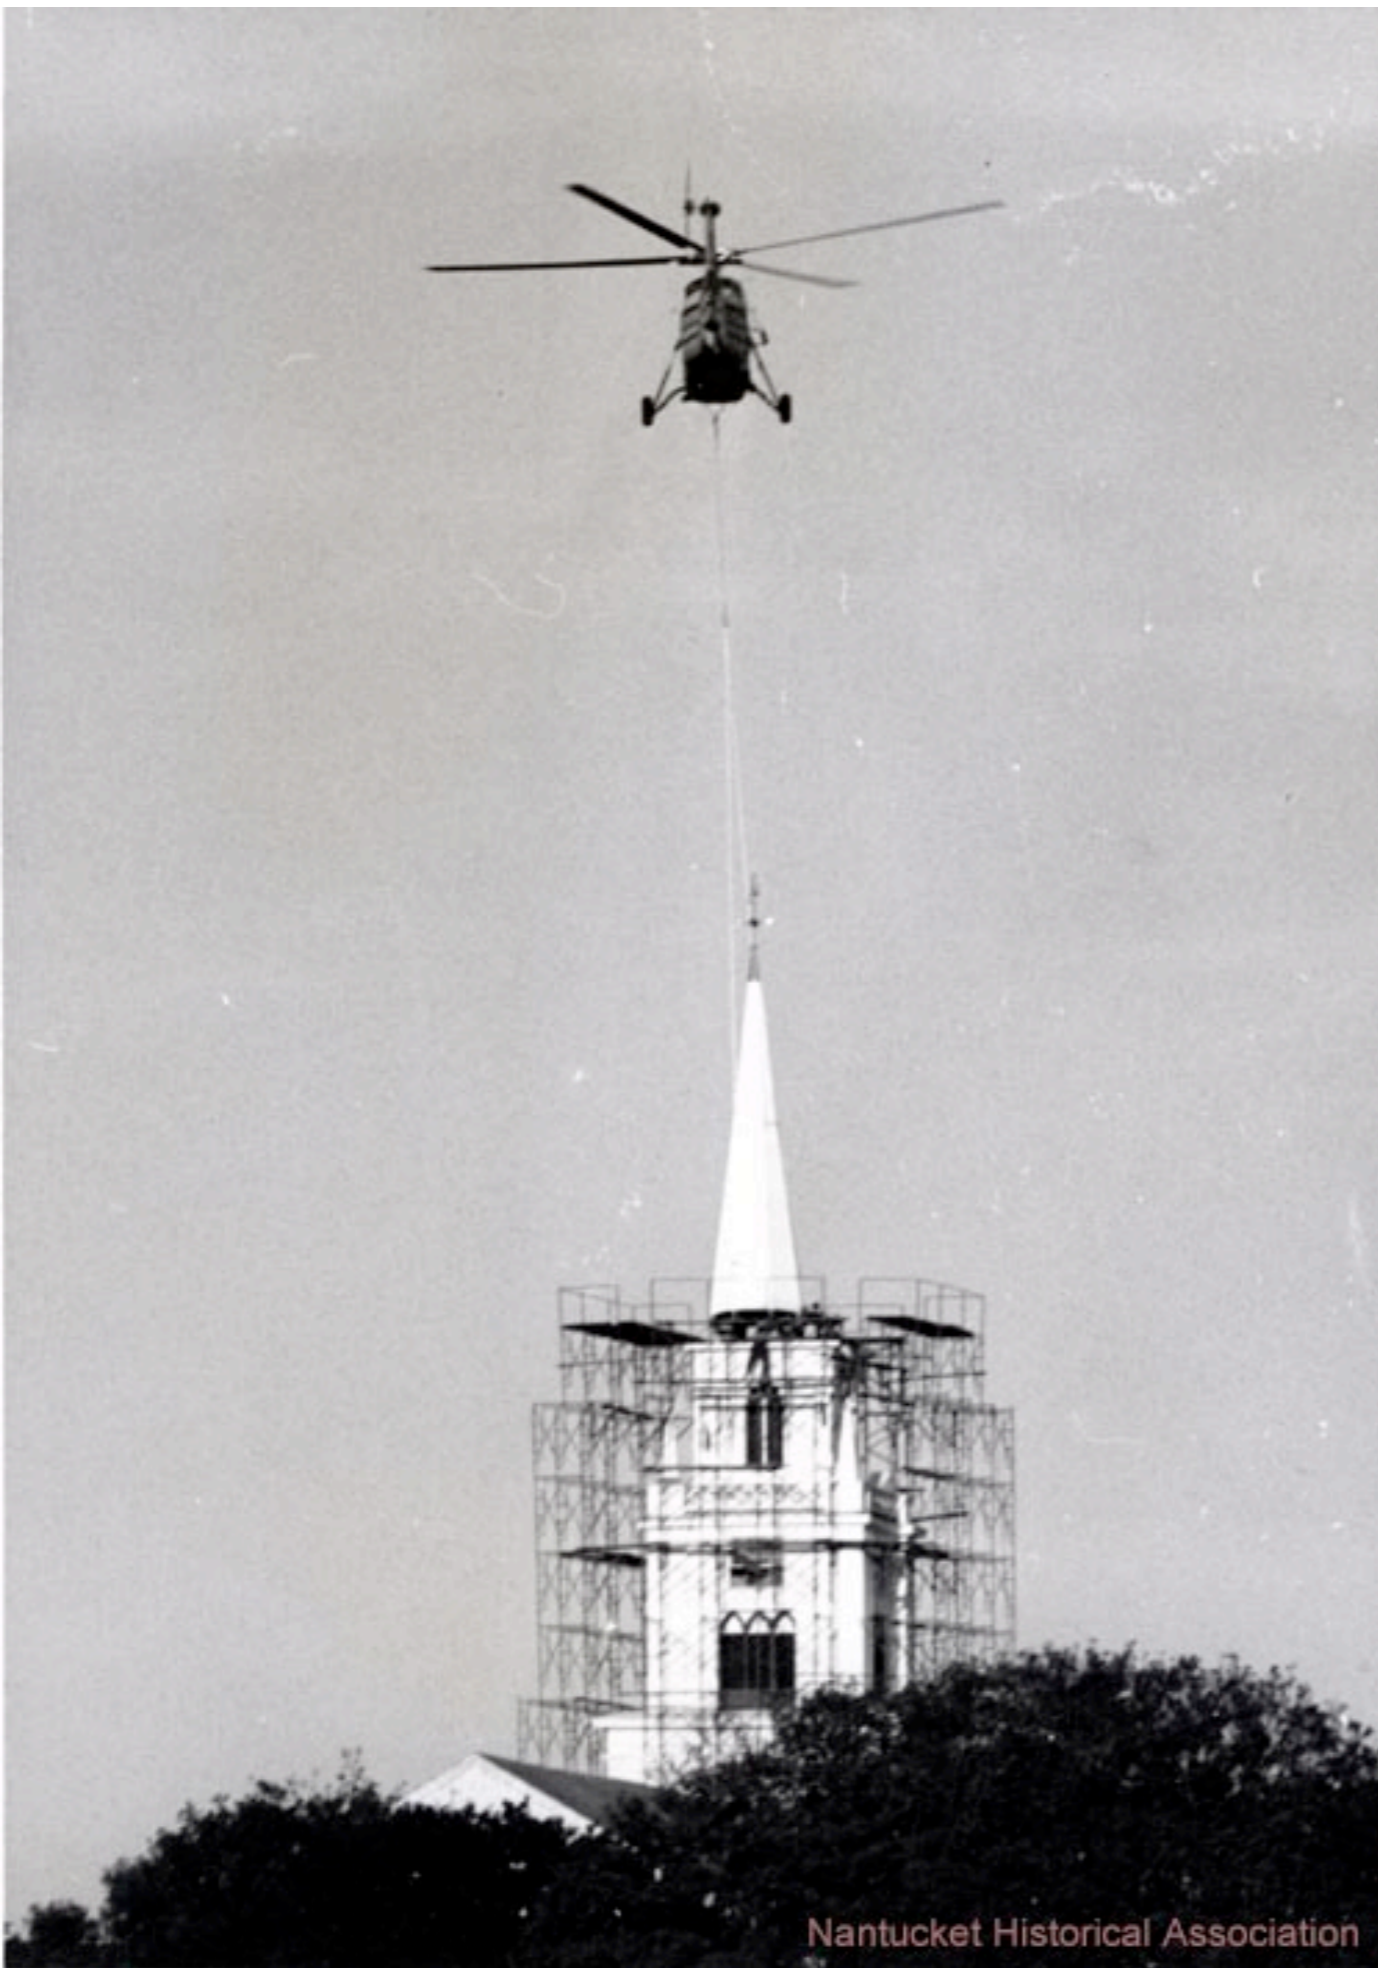
Nantucket Historical Association, 9/5/68, photographer unknown.

Spire being placed on restored second stage

The finials and balustrade depicted in Ames & Graves 1968 design appear to have been installed when this photo was taken.

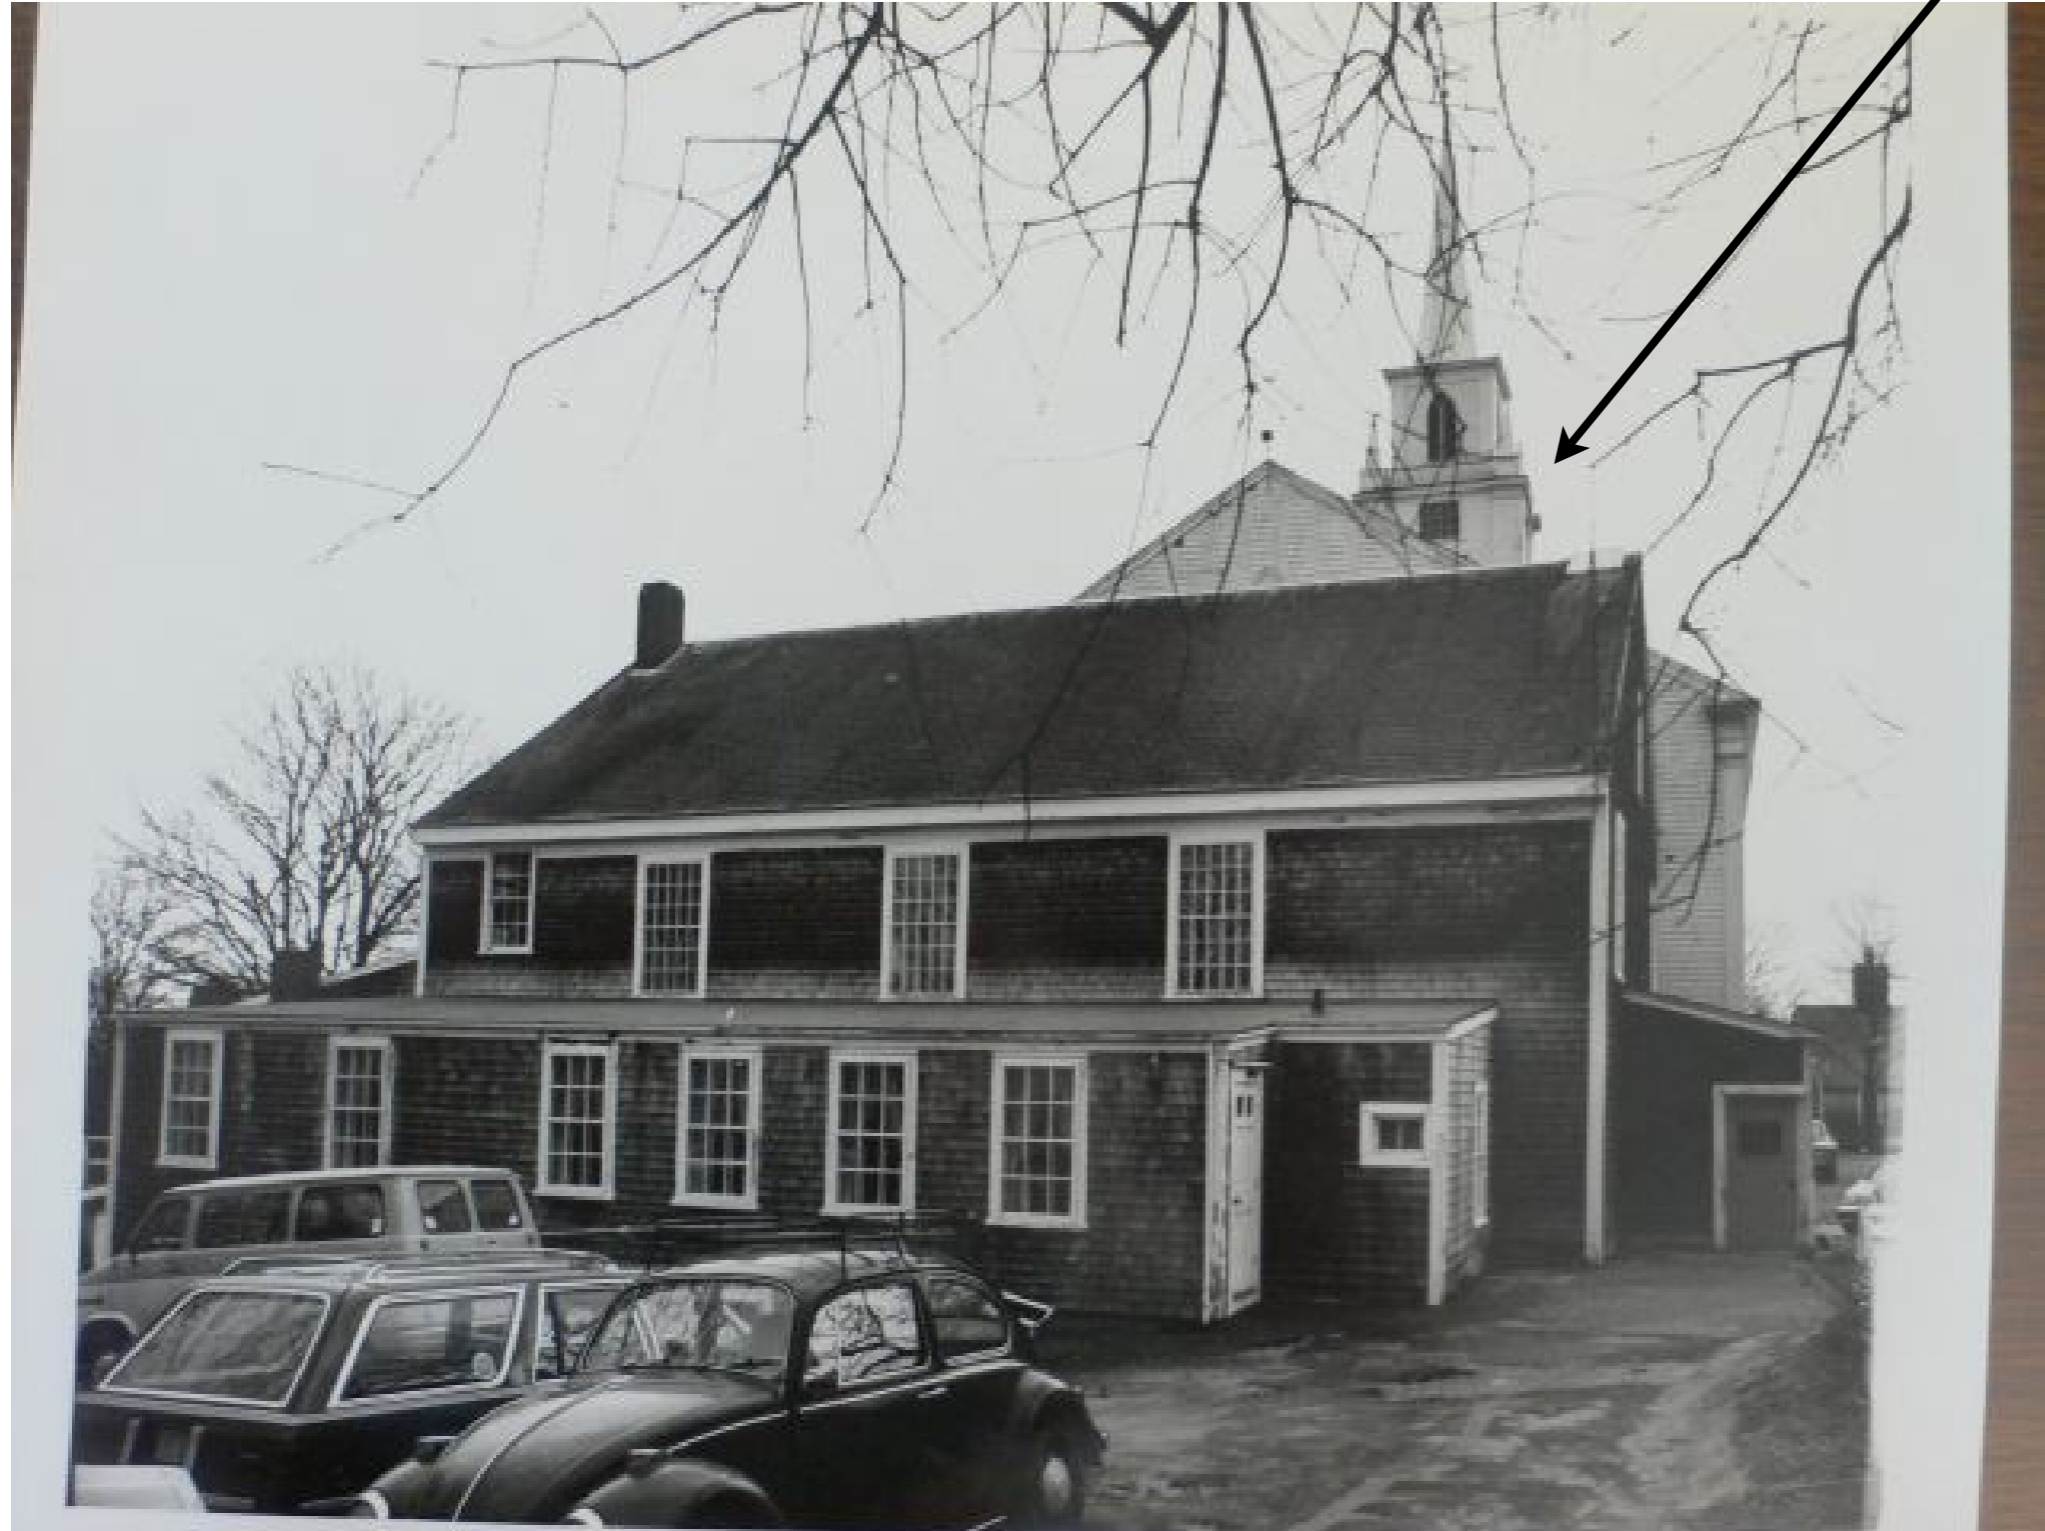
Note Balustrade

**Balustrade apparently
“restored” in the 1968 work.
Removed sometime after 1970
and prior to 2007.**

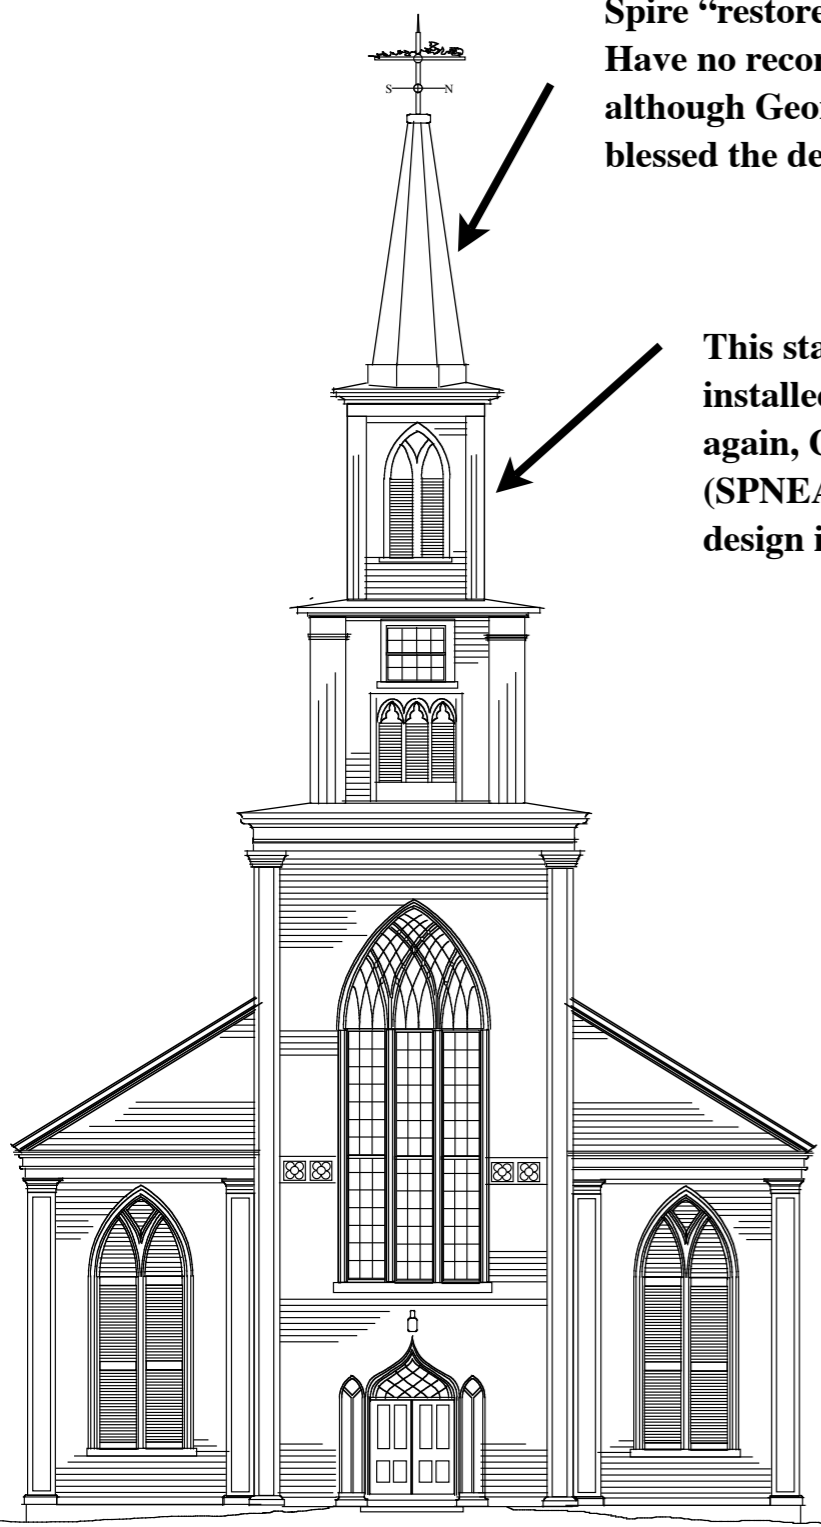
East Existing

**Spire "restored" in 1968
Have no record of justification,
although George Wrenn (SPNEA)
blessed the design in 1968**

**This stage was
installed in 1968;
again, George Wrenn
(SPNEA) blessed the
design in 1968**
