**First Congregational Church
Nantucket, MA
Exterior Tower Repairs, Restoration and Conservation**

Study photos

August 22, 2007

**DMH Enterprises, Architects
104 Federal Street
Salem, MA 01970
617-745-2172**

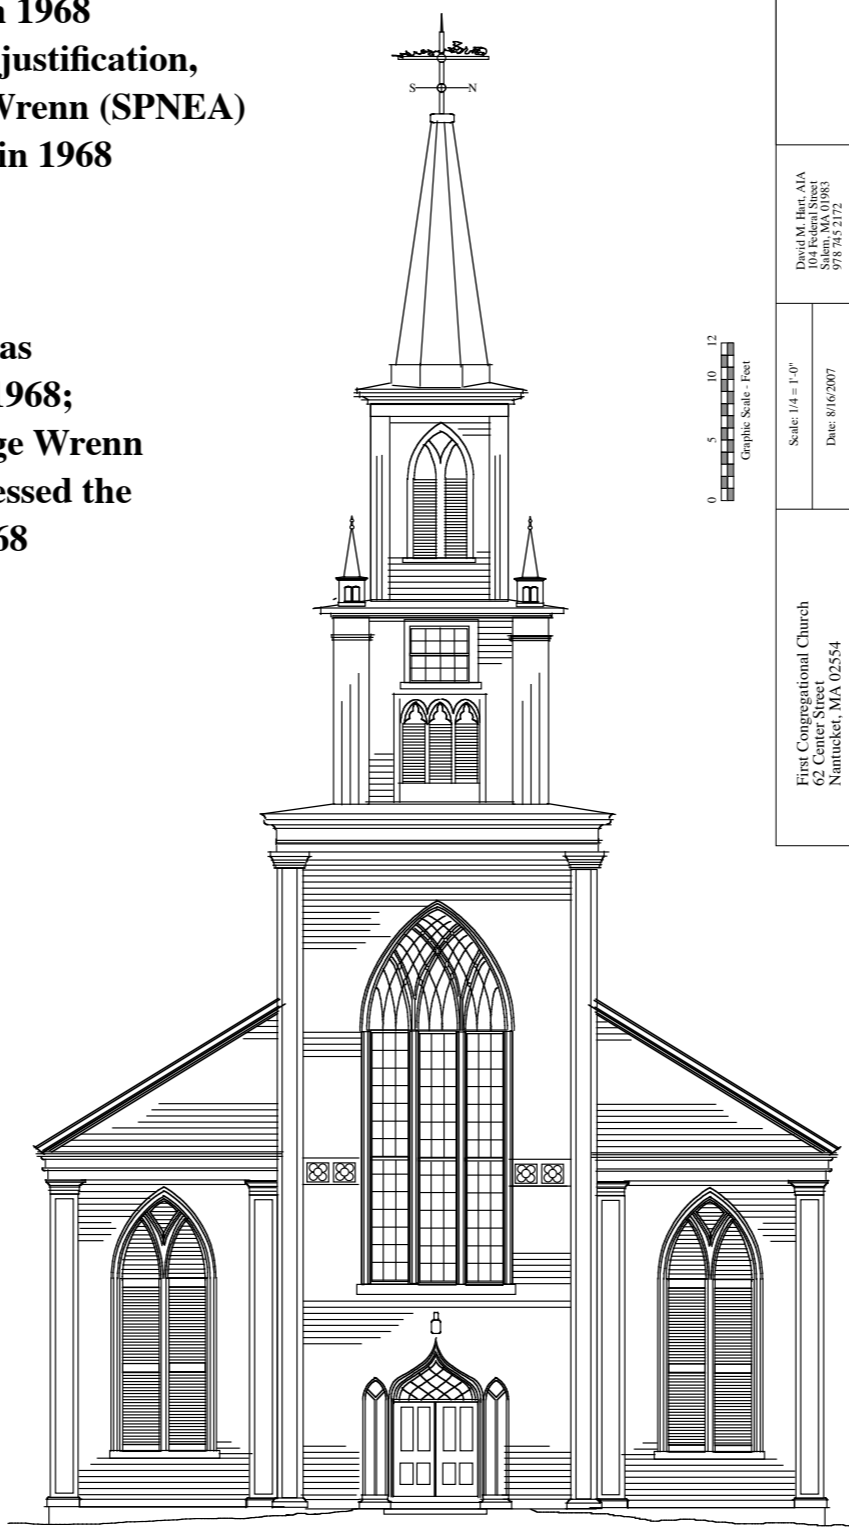
East - can justify this set

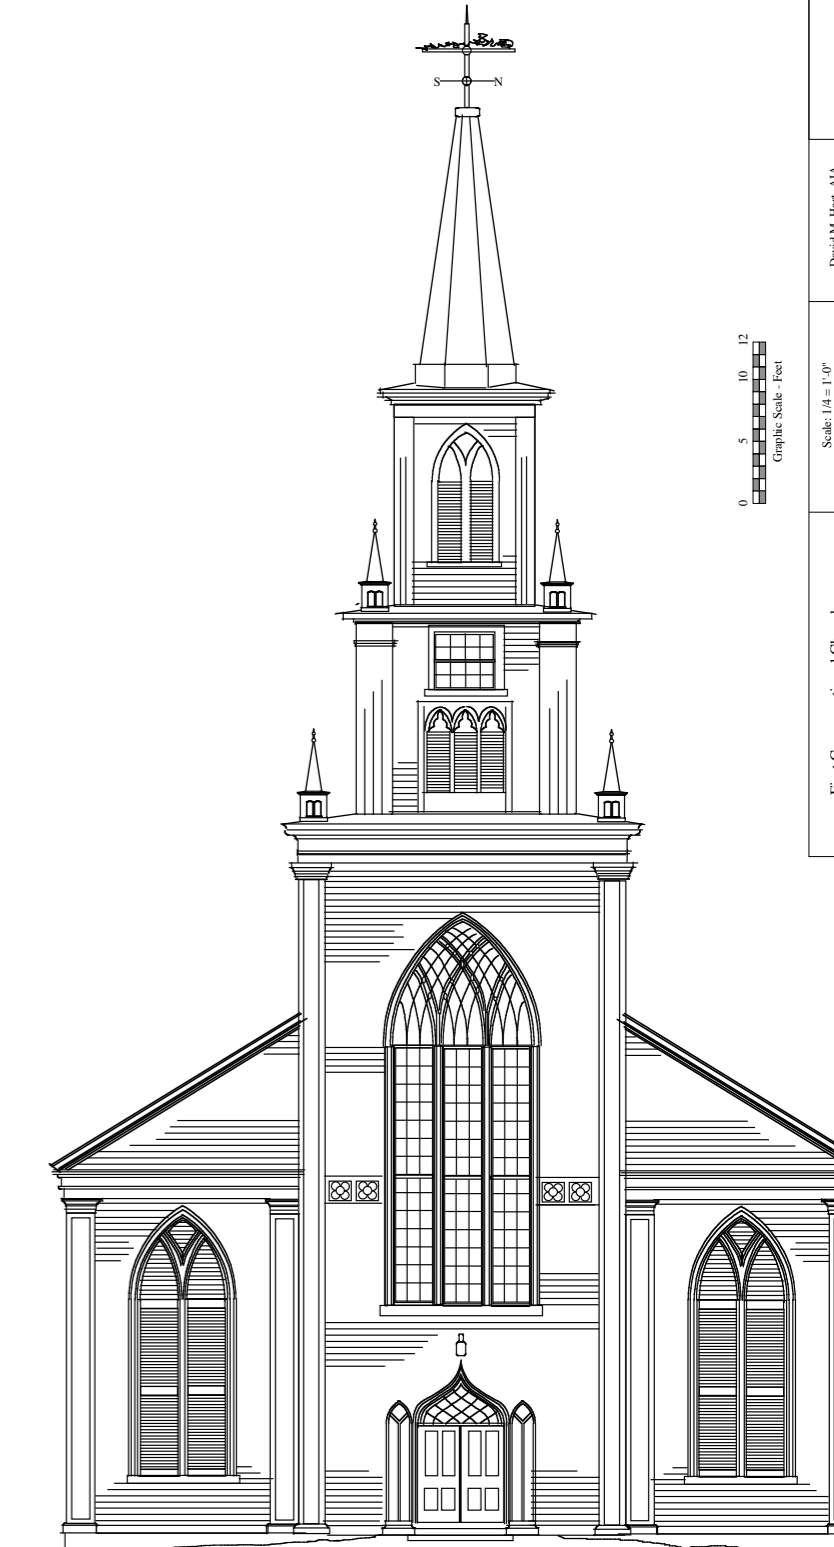
**East - have no
documentation for the
second set**
