**First Congregational Church
Nantucket, MA
Interior Repairs, Restoration and Conservation**

September 12, 2007 Revised June 13, 2008

**DMH Enterprises, Architects
104 Federal Street
Salem, MA 01970
617-745-2172**

The following pages depict existing conditions as of 2007 and recommendations for conservation/restoration.

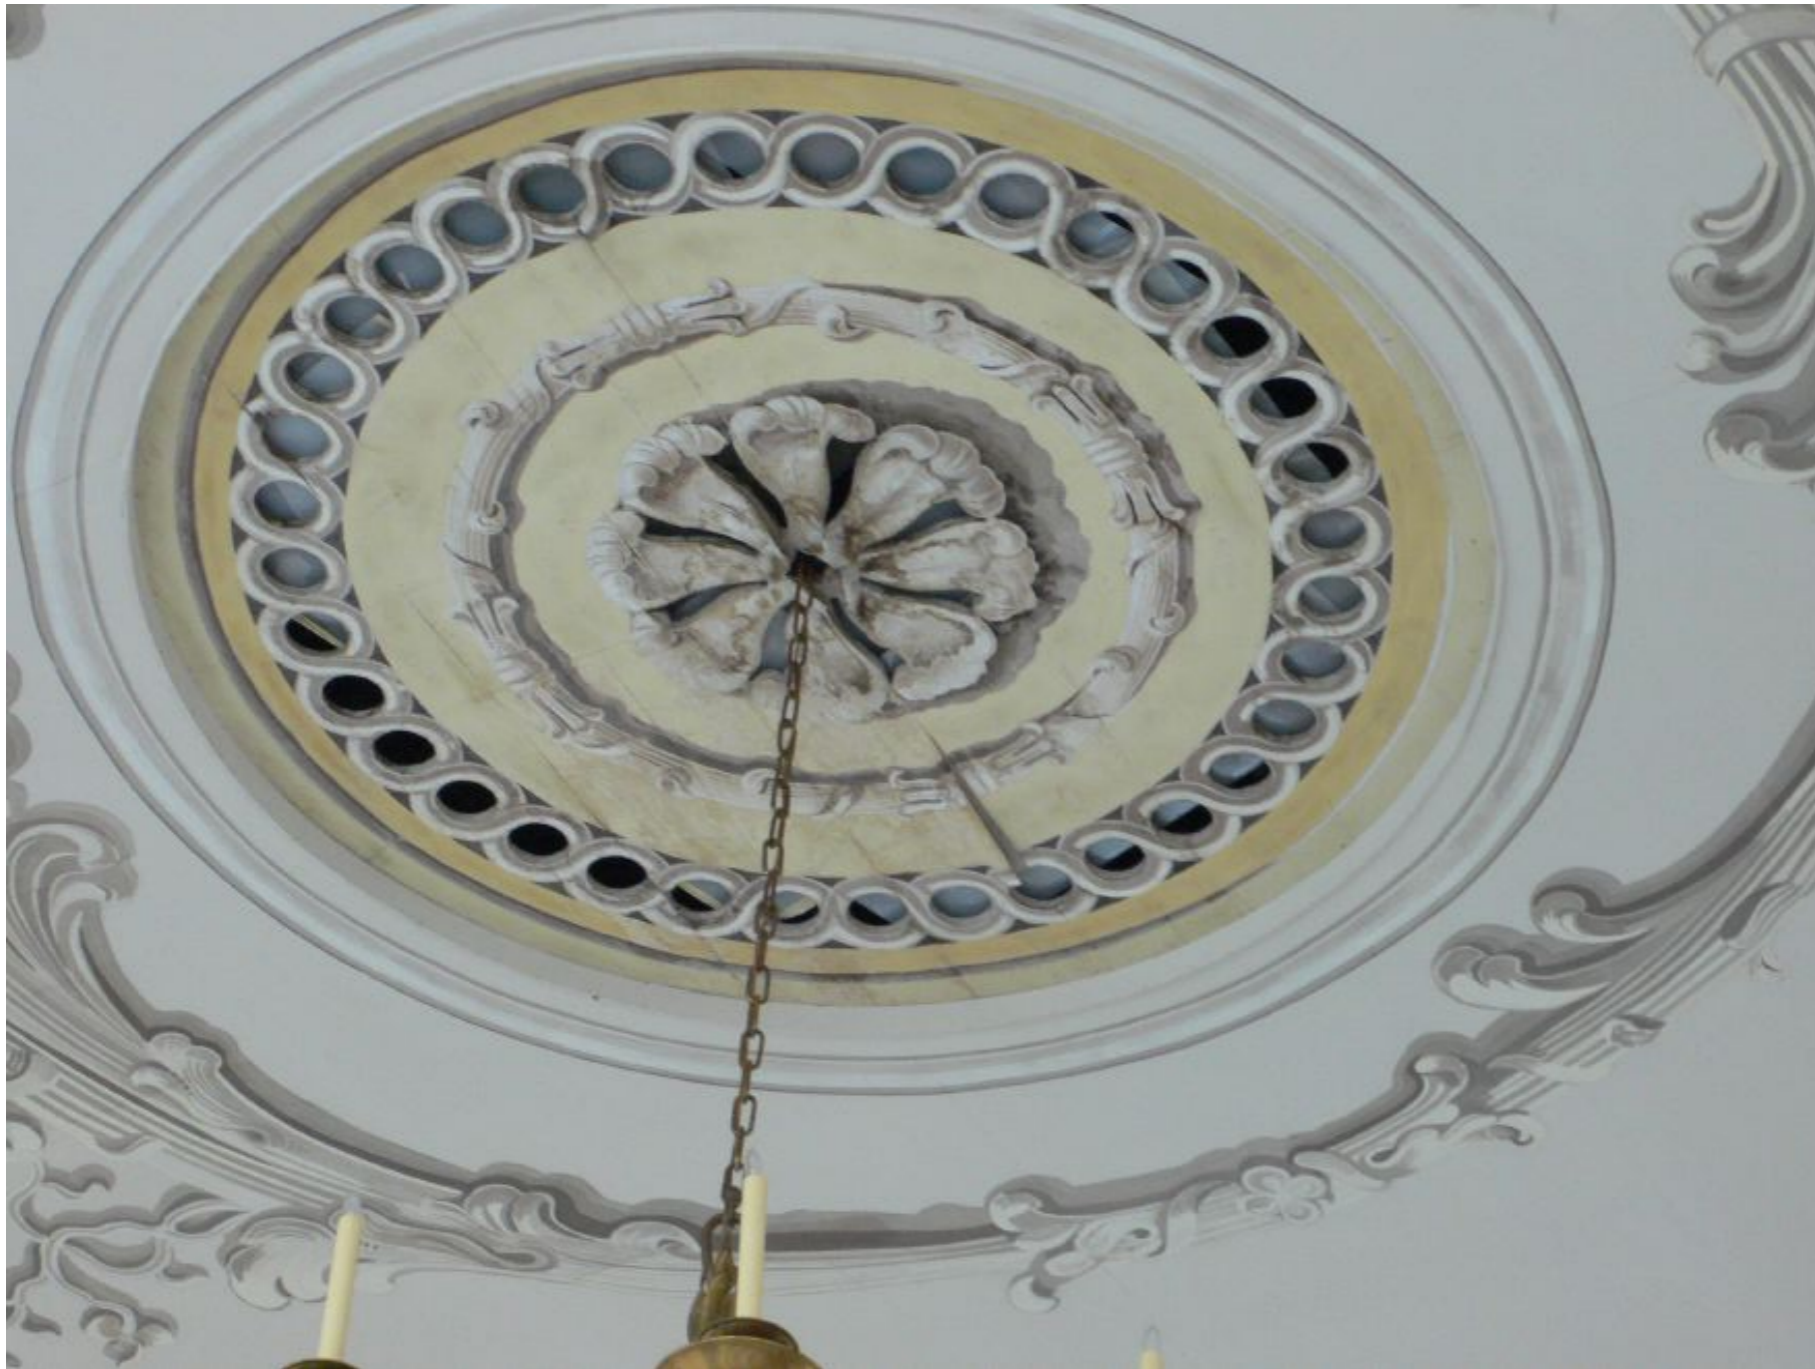
L1030690

The central portion of the decoration may be rather early, as it appears to have been painted directly on wooden ceiling boards

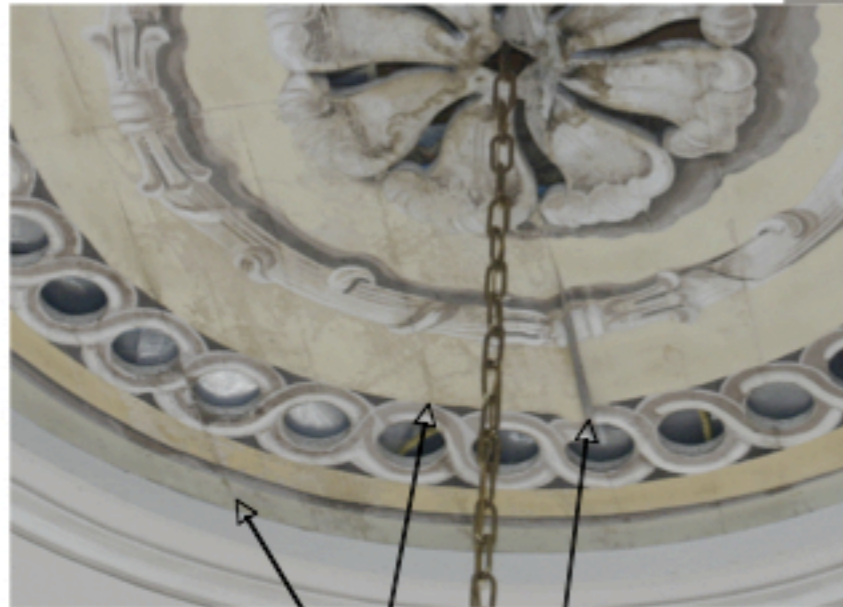
Ceiling cracked and peeling

**Detail of sanctuary
plaster rosette and ceiling
plaster behind organ to
be repaired.**
