CHRISTINE THOMSON
DECORATIVE ARTS CONSERVATION & HISTORIC PAINT ANALYSIS

ASSESSMENT OF PAINT CONDITIONS

For: David Hart, Architect
Project: First Congregational Church, Nantucket, MA
Date: July 1, 2008

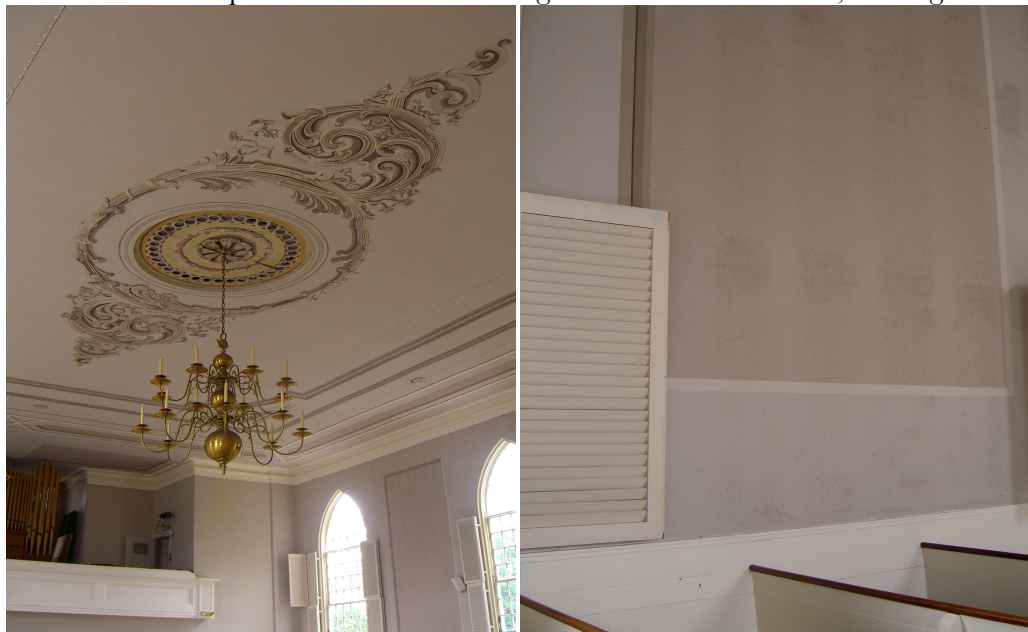
2. The painted walls appear dirty in many areas. This is the result of a number of factors. For one, periods of high humidity have caused a mold bloom consisting of dark, round splotches to appear in many areas. In addition, images of the under structure have telescoped through the paint and have left a pattern on the surface. This is often thought to be the result of a disparity in temperature between structural members that are in direct contact with the back of the wallboard and the gaps between the members. The difference in temperature can affect the surface and can cause dirt to adhere more tightly in some places than in others. This phenomenon is visible in the photograph of the wall on the first page.

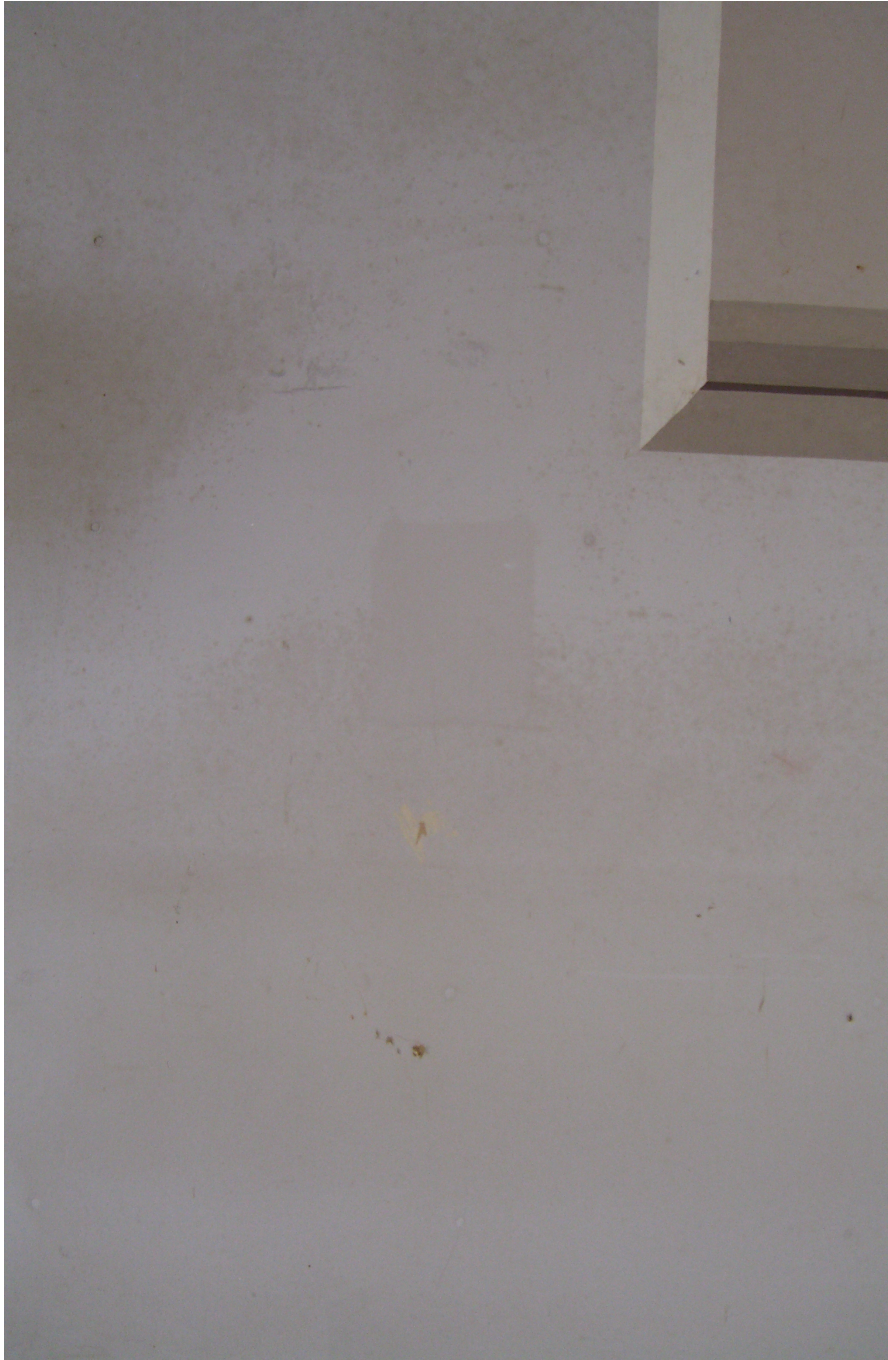
solution. It was rubbed lightly onto the surface with a clean cloth and rinsed off with water. This soap solution easily removed mildew spots and surface grime. (See photo at the end of this report). A 6 x 9" rectangle was cleaned in several areas, and in all test areas the results were successful.

In the center of this photograph is a 6" x 9" rectangle showing the cleaned area. The cleaning solution easily removed mildew and grime, and revealed an acceptably clean painted surface consistent in color and appearance.
