**First Congregational Church  
Nantucket, MA  
Interior Repairs, Restoration and Conservation**

**September 12, 2007 Revised May 27, 2008**

**DMH Enterprises, Architects  
104 Federal Street  
Salem, MA 01970  
617-745-2172**

**Donald Mroz, Ph.D.  
Waves of Change Partnership  
268 Madaket Rd,  
Nantucket, MA 02554  
508-228-5398**

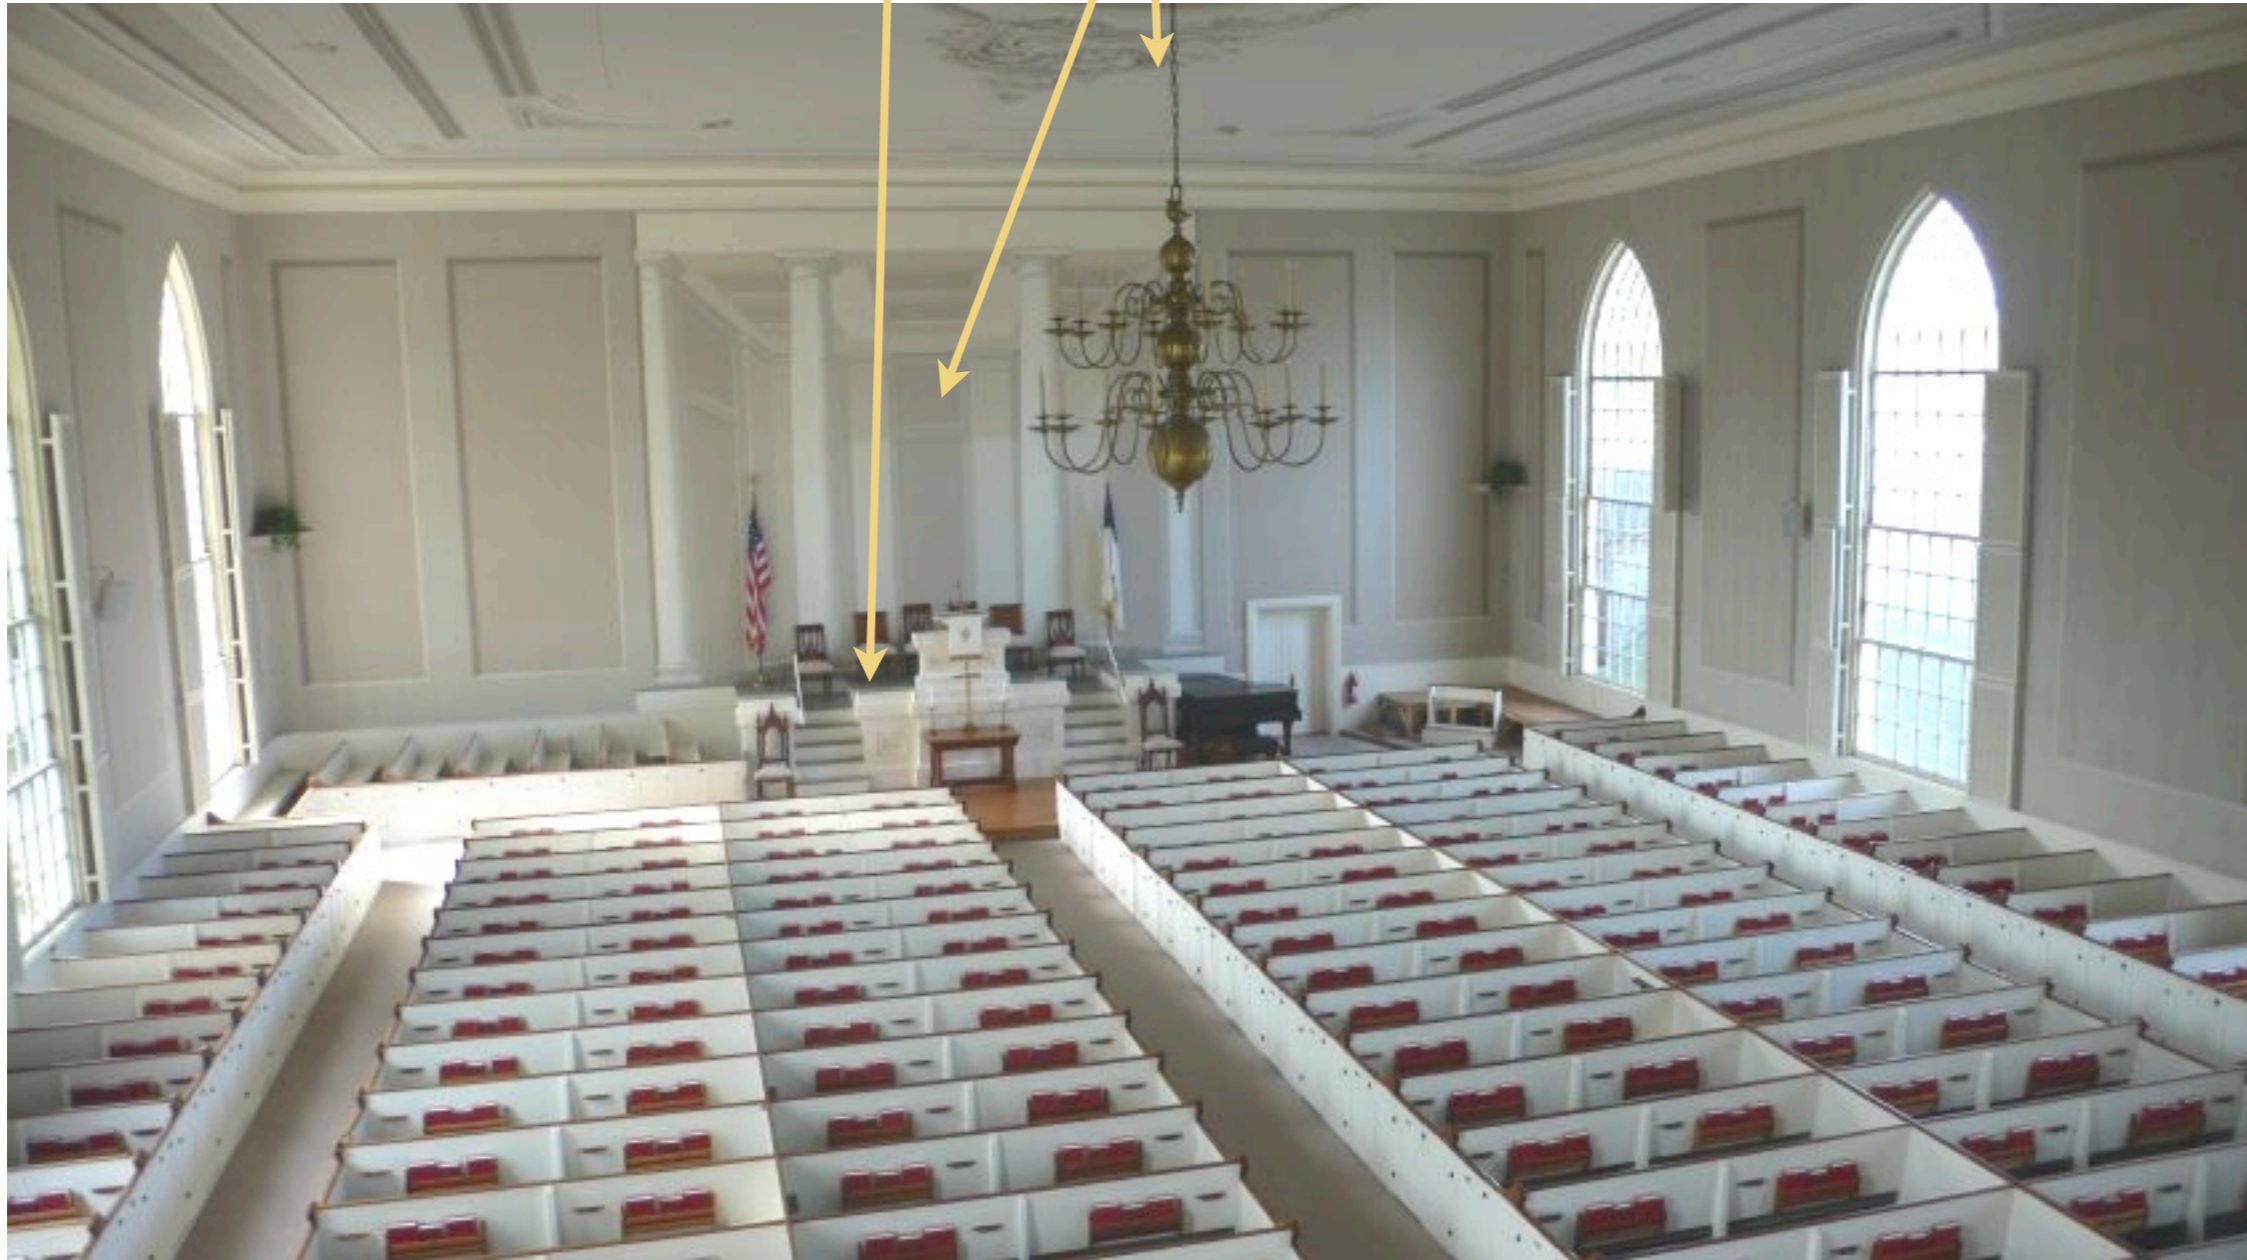
L1030232

**Trompe l'oeil to be repainted or conserved, ceiling and walls**

**Sanctuary, looking west**

**Appropriate handrails to be added to pulpit area**

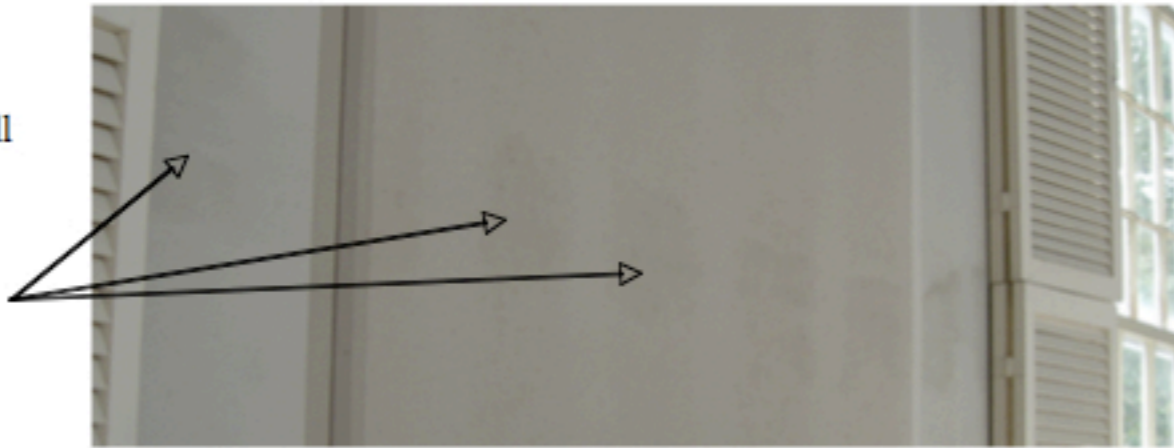
Interior Wall  
Mold and  
discolored

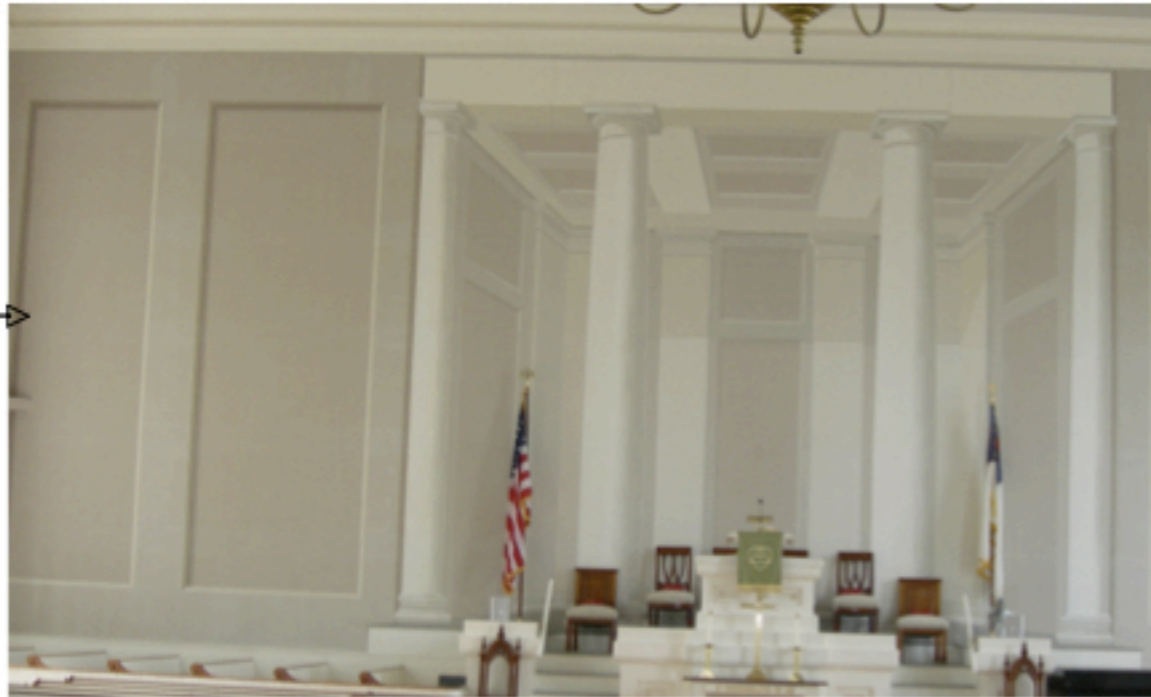
Front  
Inside  
Church

**Detail of walls and decorative trompe l'oeil to be repainted or conserved.**

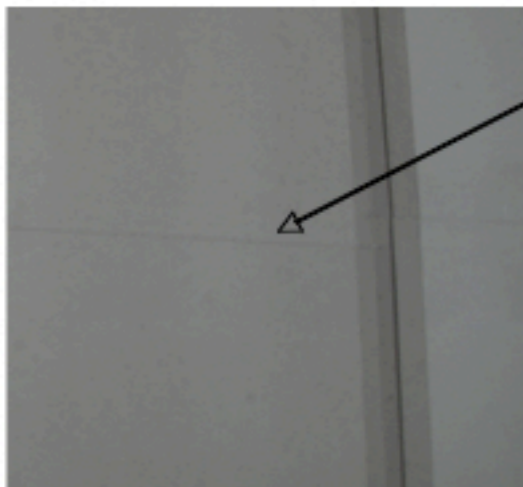
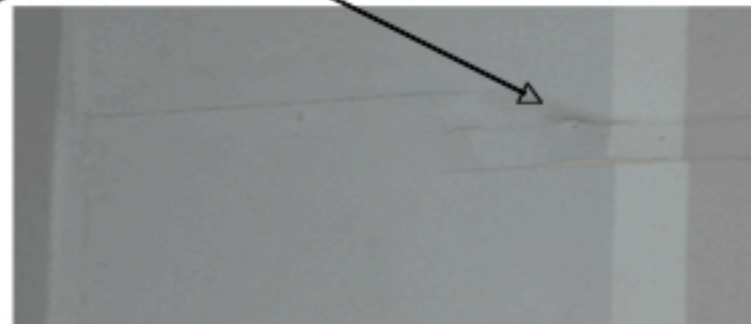
Morz091107.003

Interior Cracks and Peeling

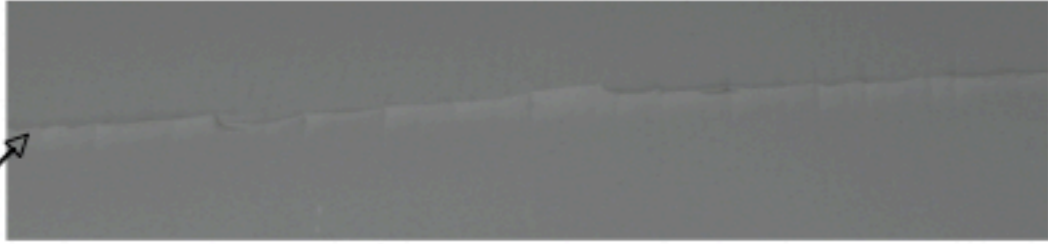
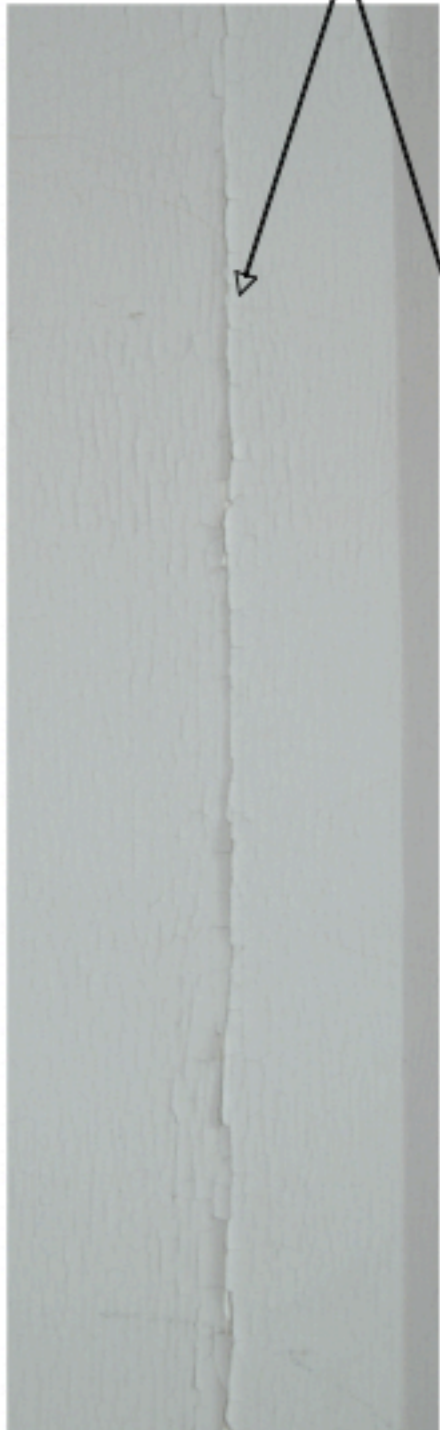
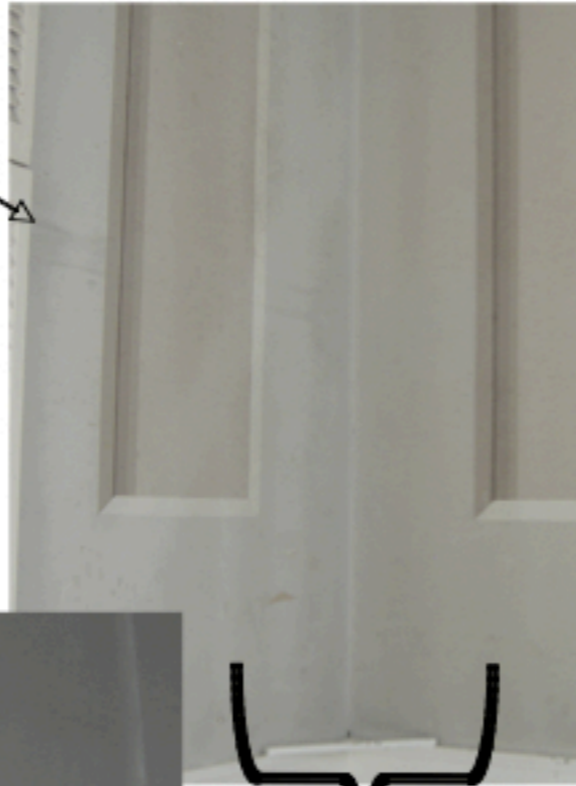
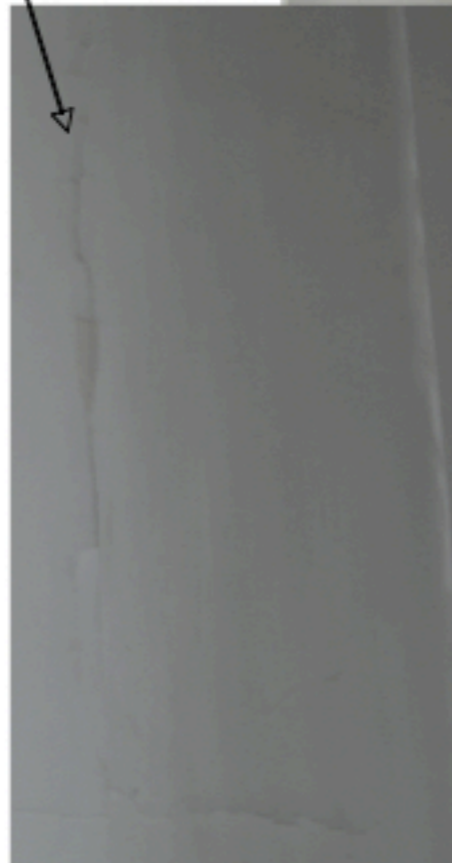
Morz091107.002

Interior Cracks and Peeling

Mold

**Detail of walls and  
wooden paneling to be  
repainted or conserved.**

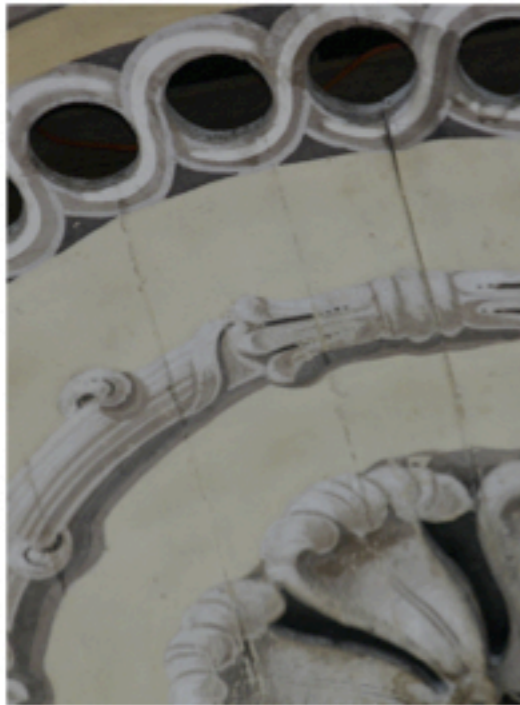
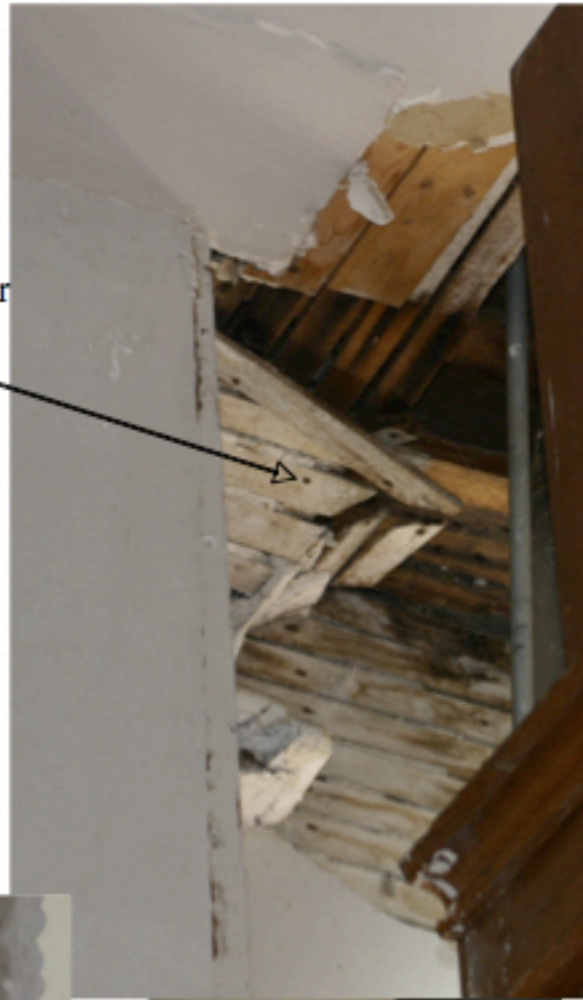
Ceiling behind  
Organ in Summer  
Church

Ceiling cracked and peeling

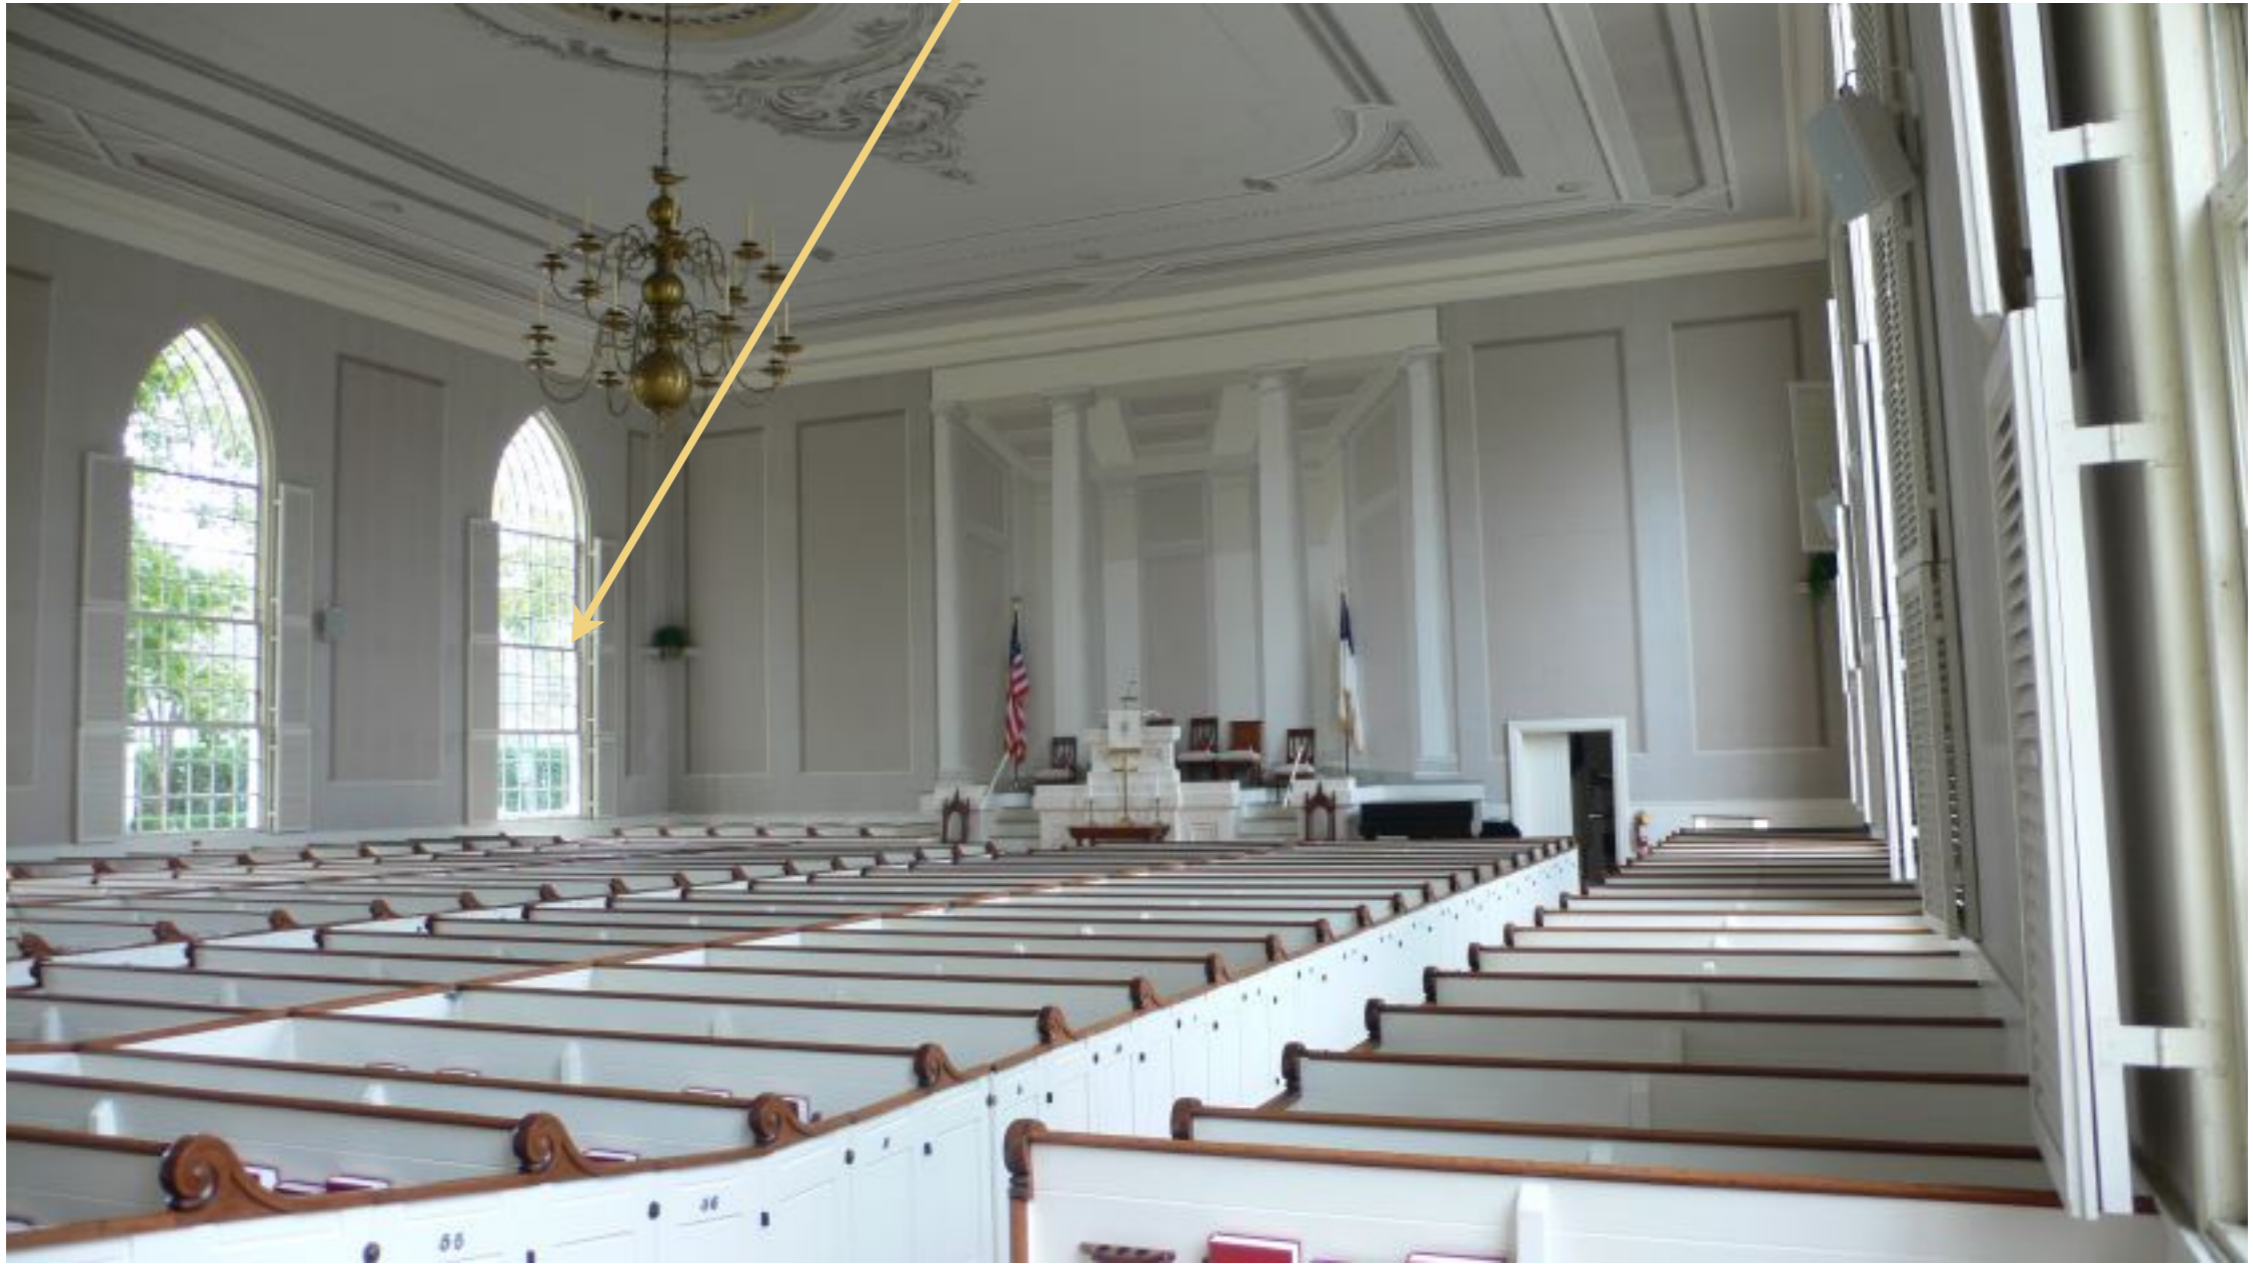
L1030184

**Interior of windows to be repaired and repainted**

**Sanctuary, looking west**

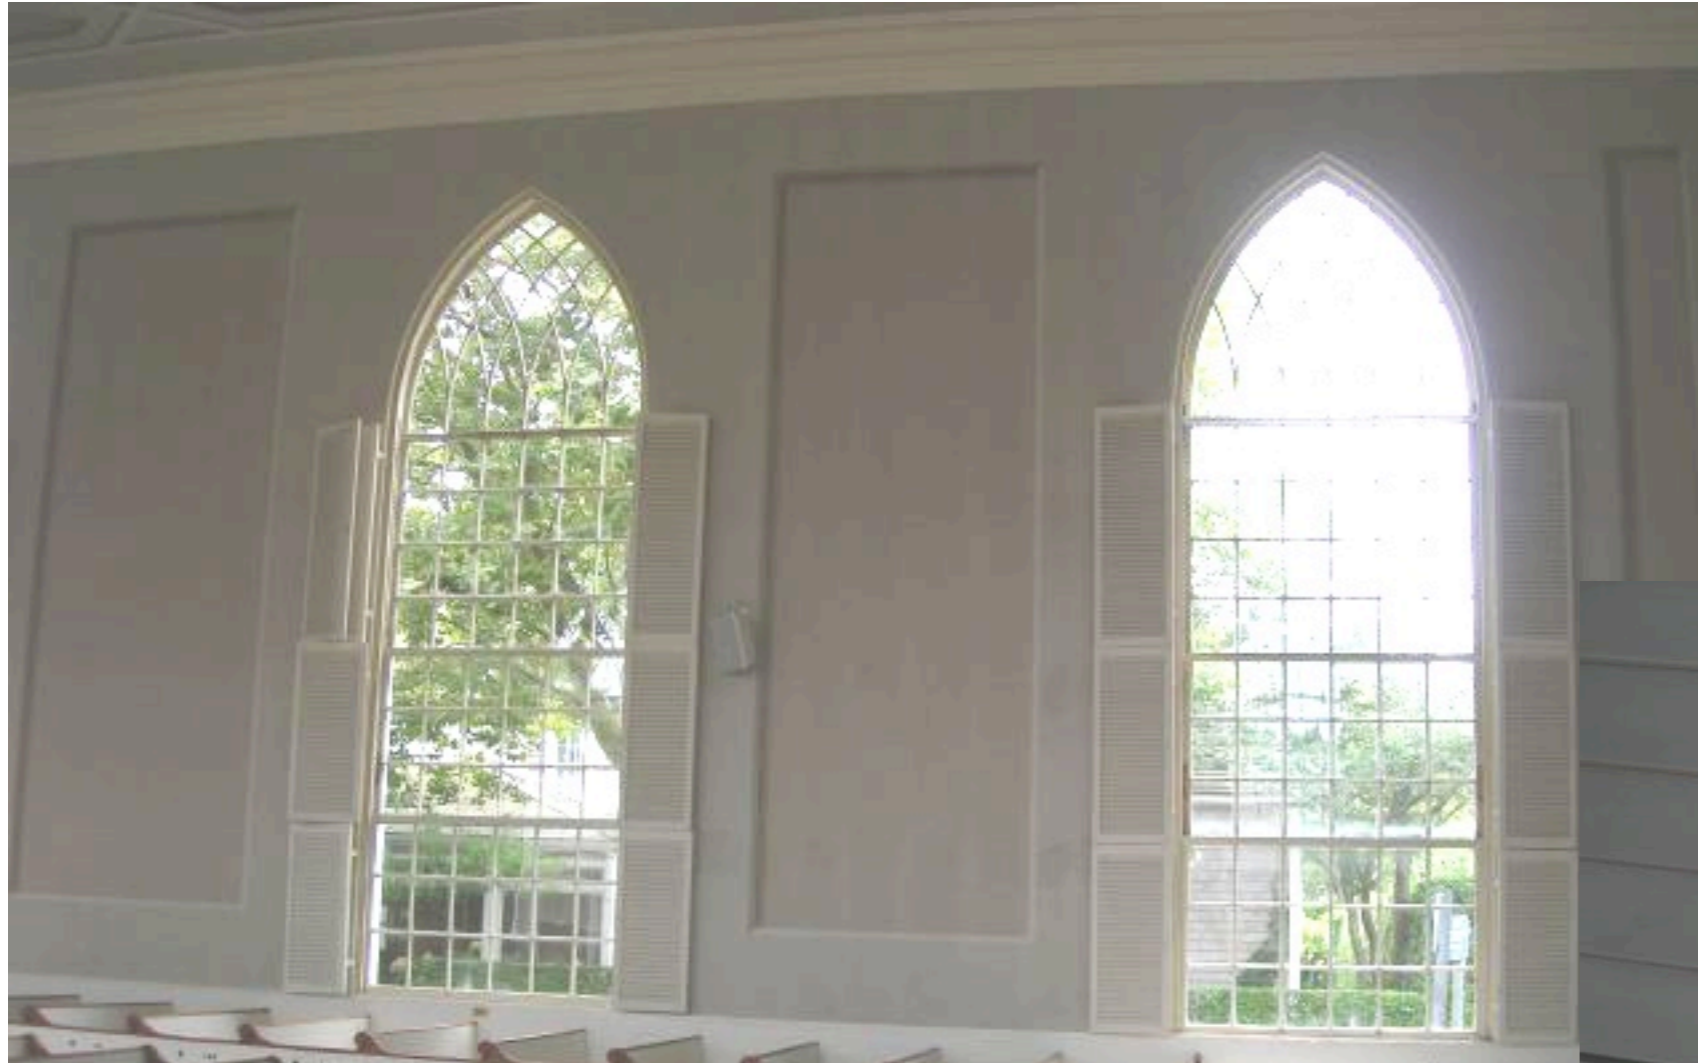
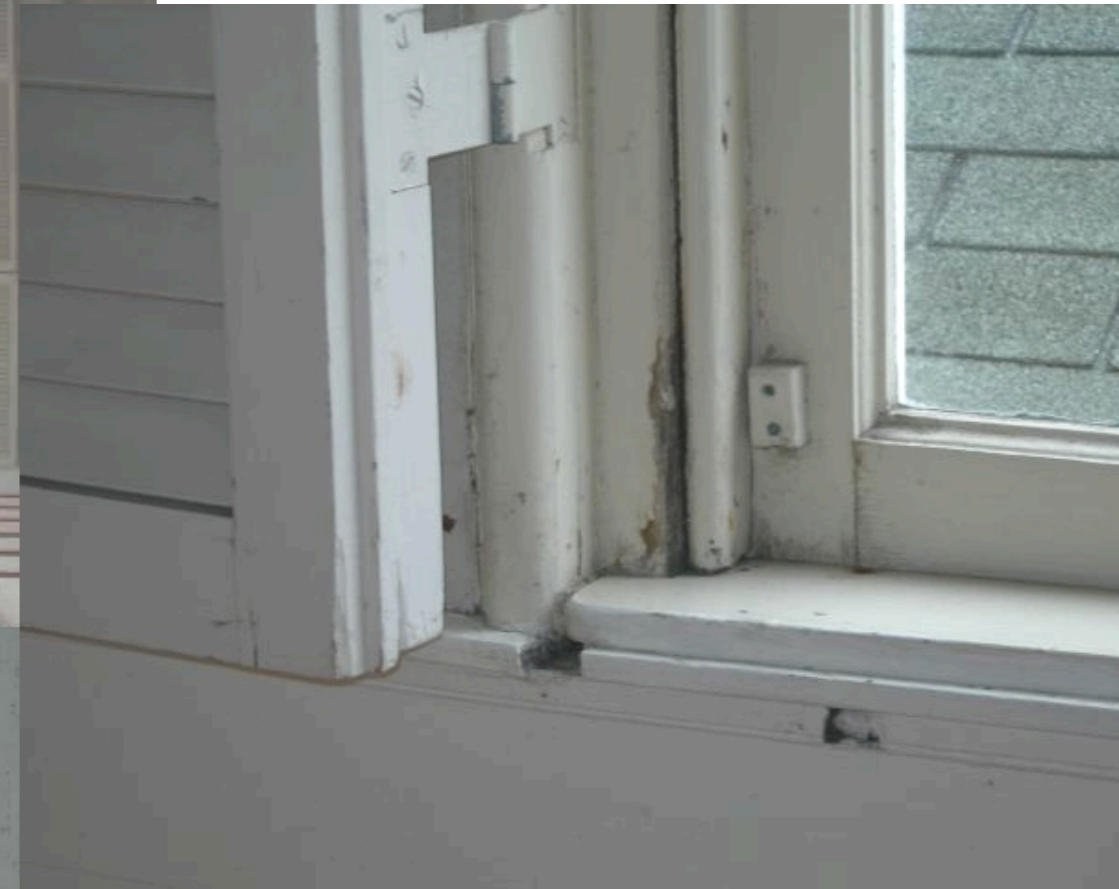
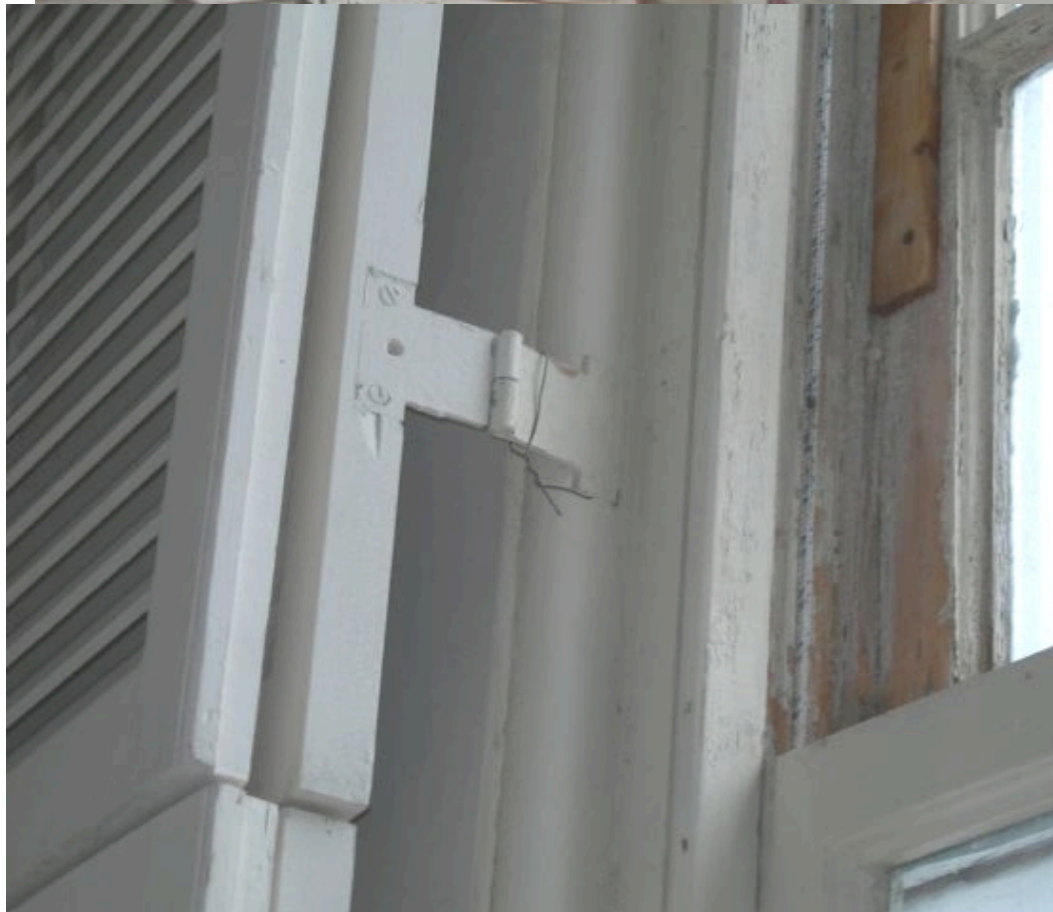
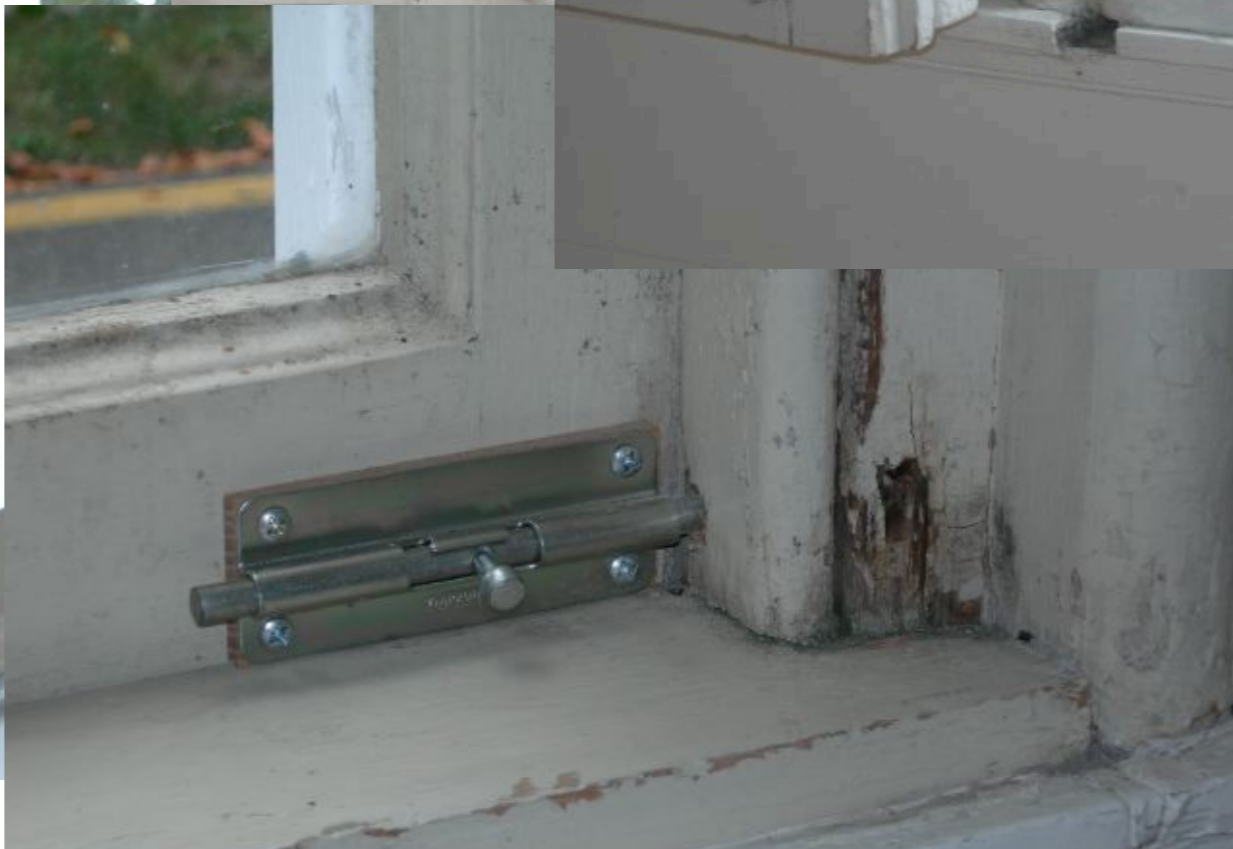
DSCN0570

**Detail of window sash and frame deterioration at interior of sanctuary to be repaired and repainted.**

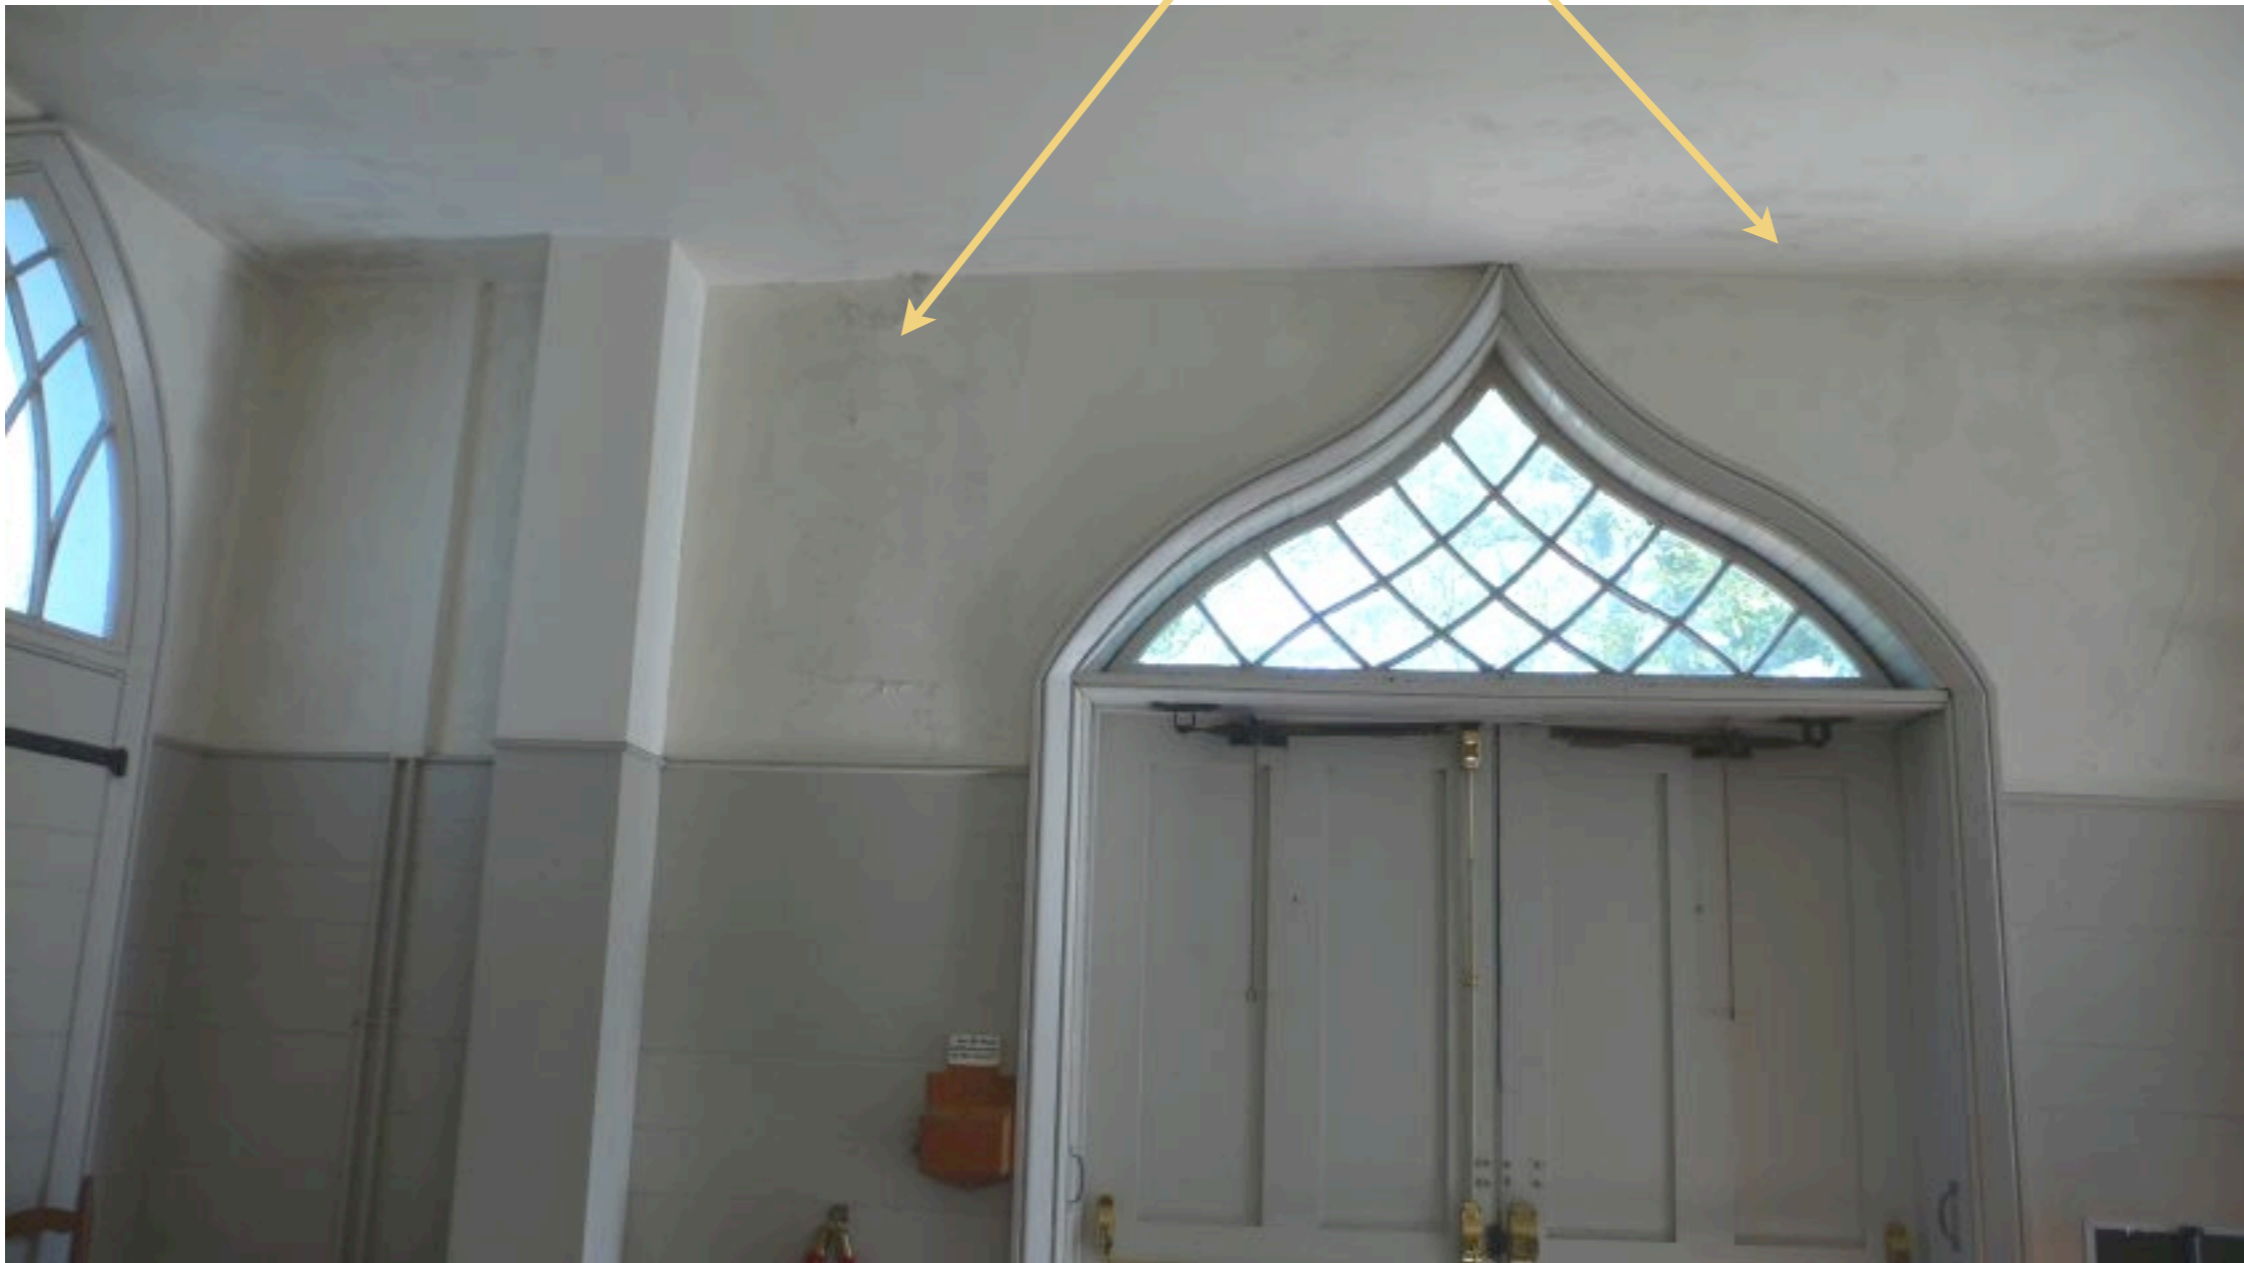
L1030211

**Narthex plaster wall and ceilings to be repaired and repainted**

**Narthex, looking east**

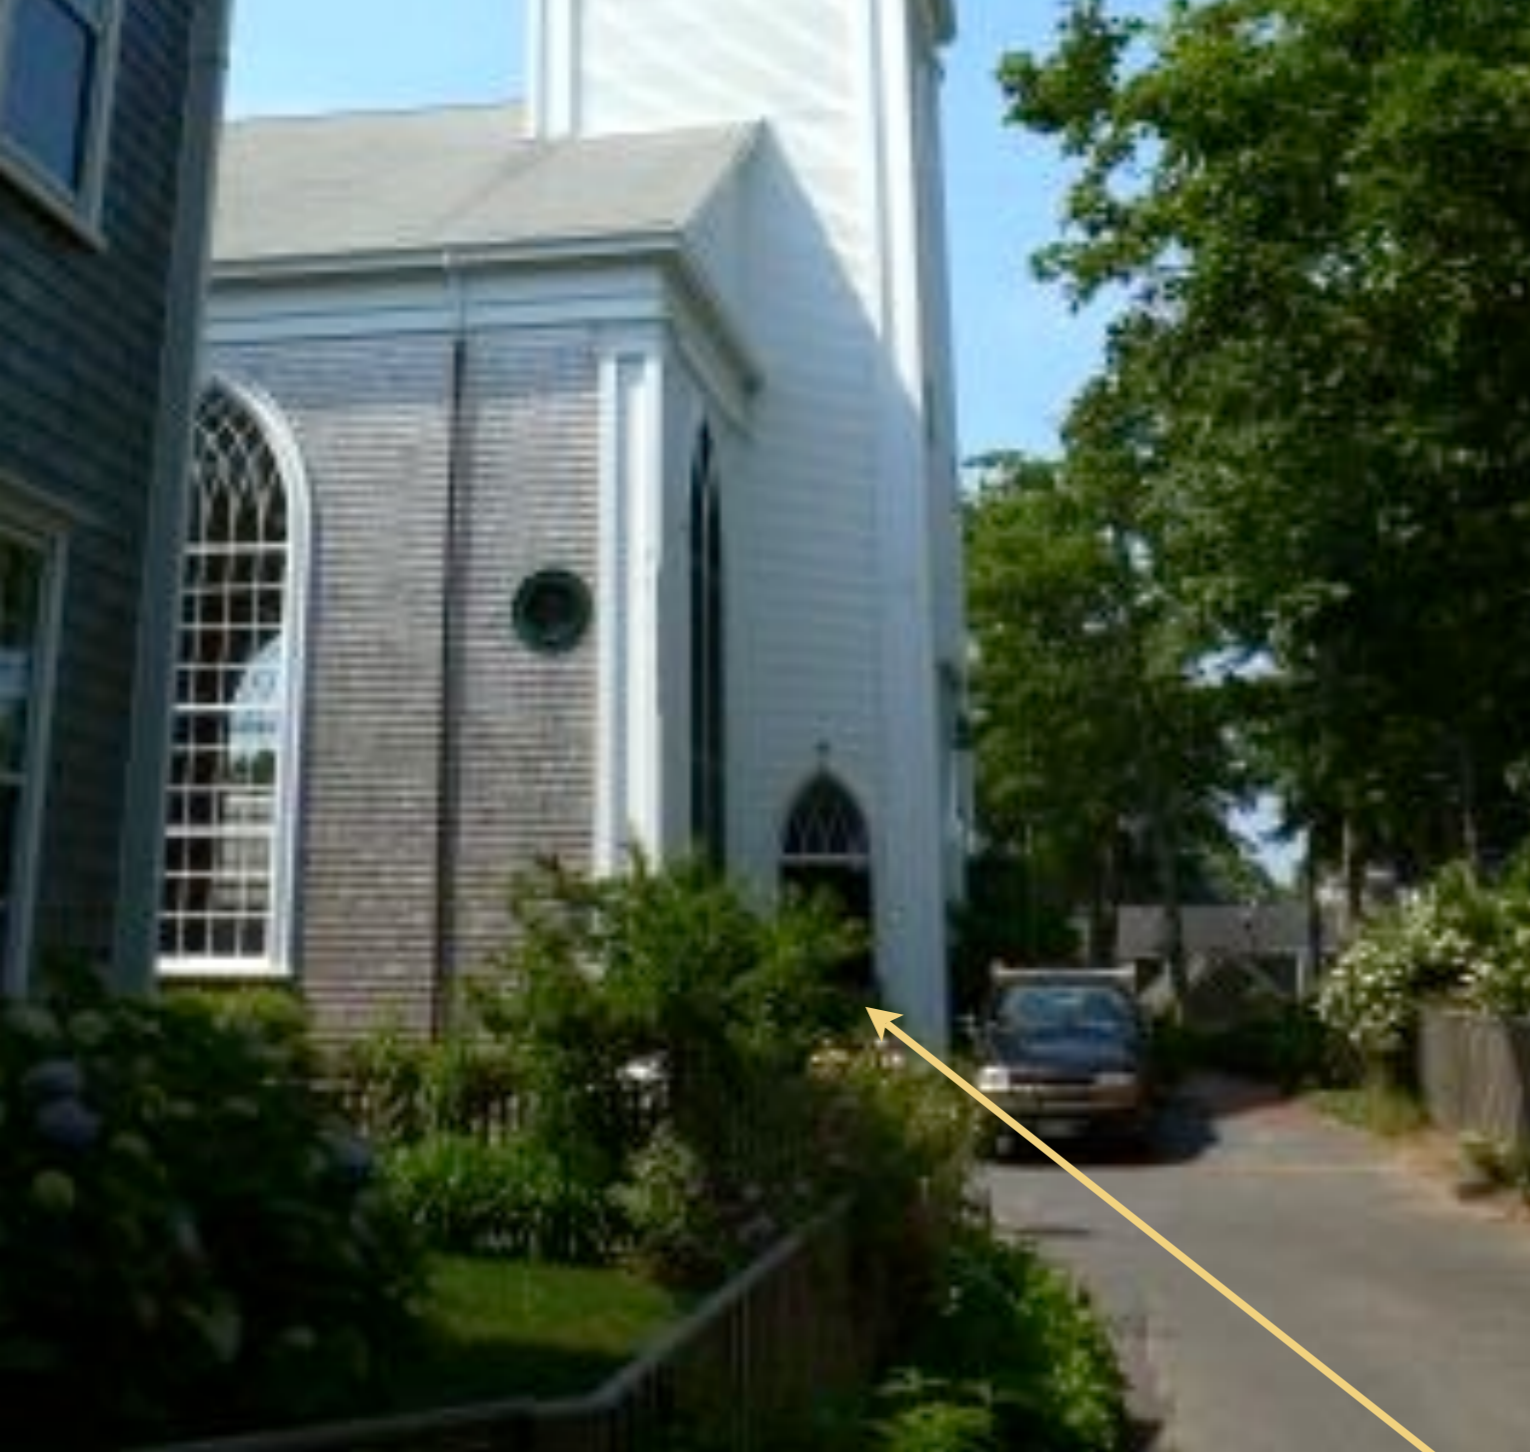
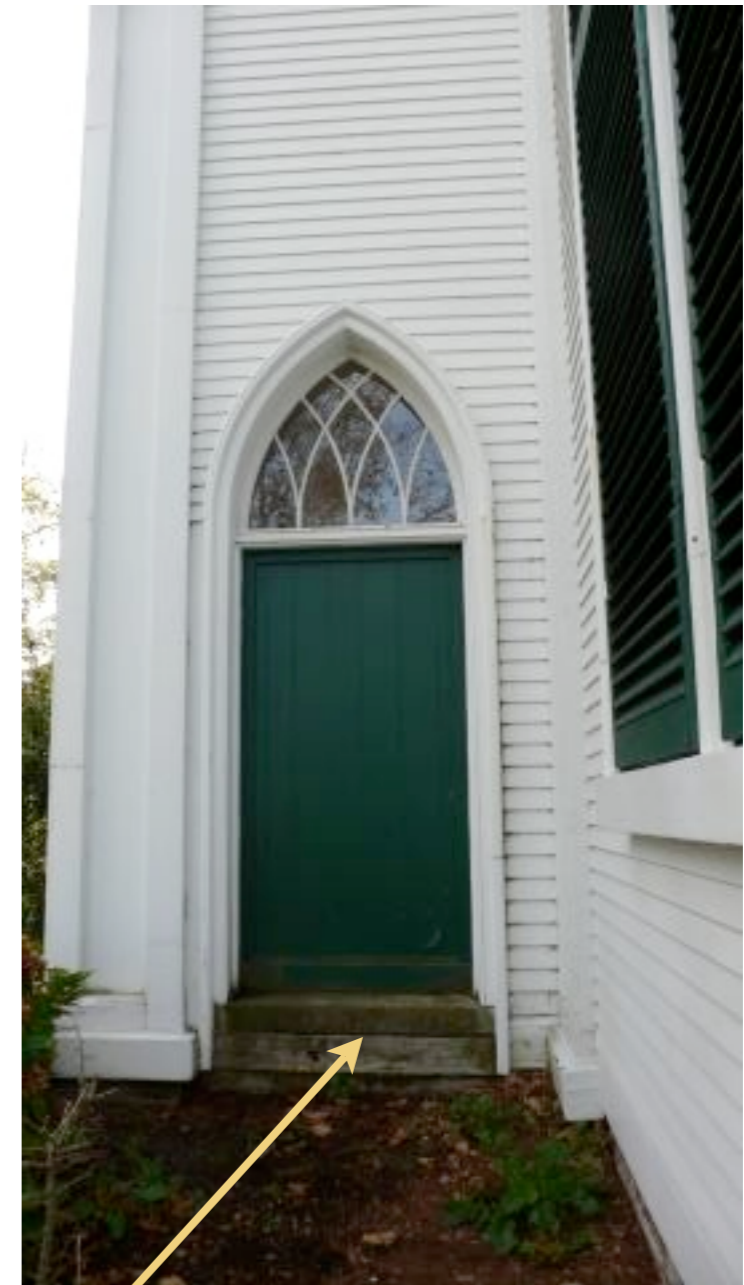
**Two exterior side doors to be repaired and panic hardware installed**

**Exterior, south and north facades**
