**First Congregational Church  
Nantucket, MA  
Interior Repairs, Restoration and Conservation**

**September 12, 2007 Revised May 27, 2008**

**DMH Enterprises, Architects  
104 Federal Street  
Salem, MA 01970  
617-745-2172**

**Donald Mroz, Ph.D.  
Waves of Change Partnership  
268 Madaket Rd,  
Nantucket, MA 02554  
508-228-5398**

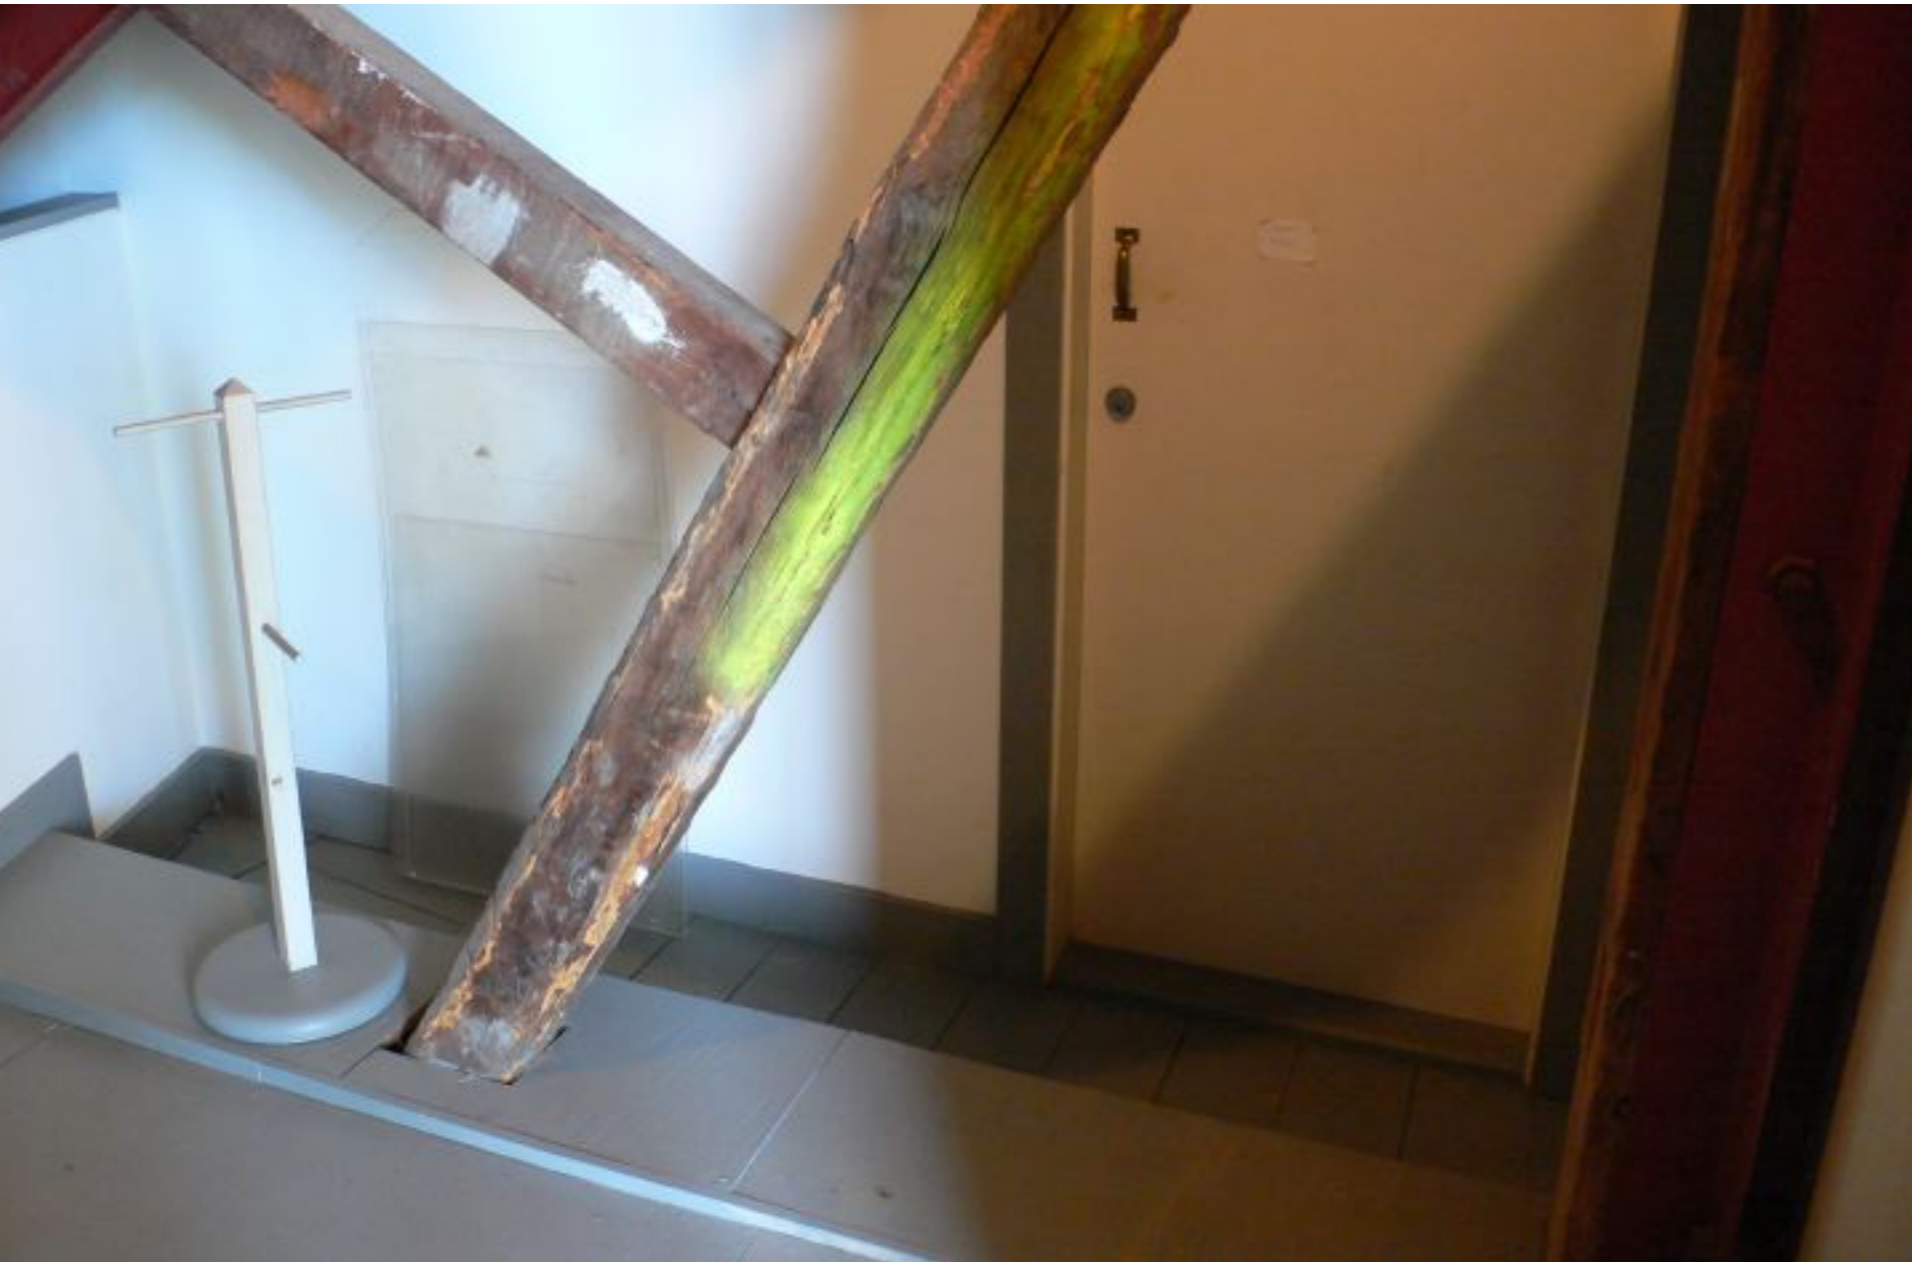
L1030233

**Proper lighting to be installed in stair  
areas of tower where public has access**

**Tower interior, typical**
