**First Congregational Church
Nantucket, MA
Exterior Analysis and Recommendations for Repairs,
Restoration and Conservation**

October 23, 2006

**DMH Enterprises, Architects
104 Federal Street
Salem, MA 01970
617-744-8202**

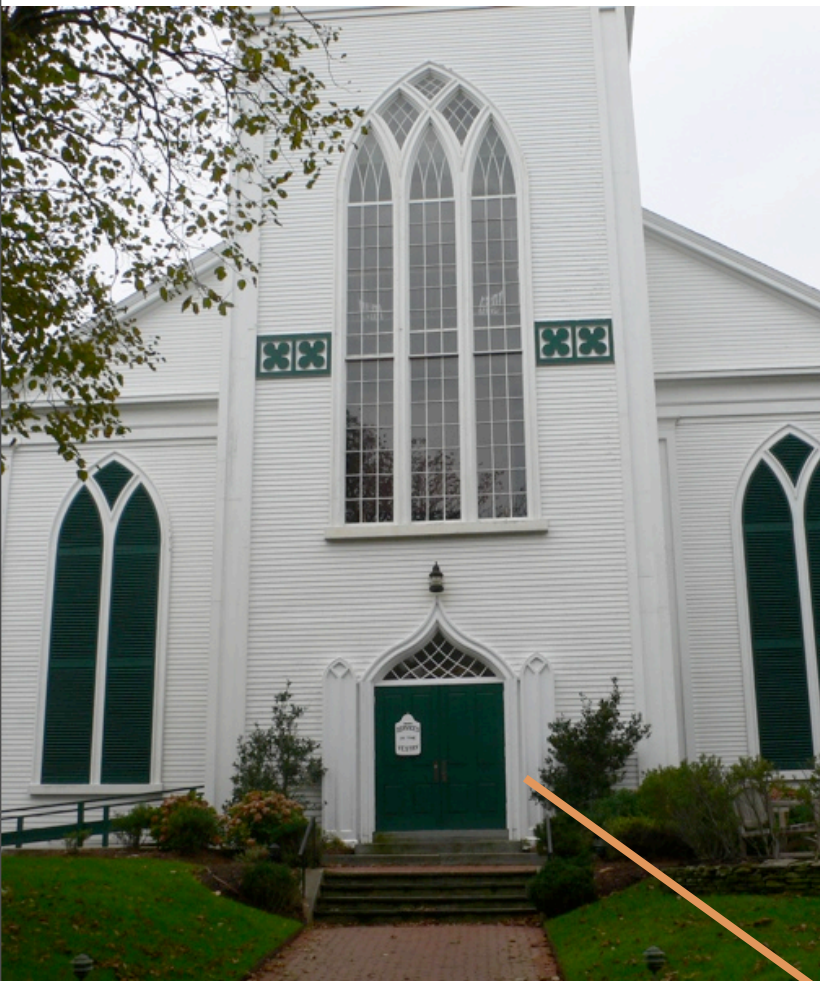
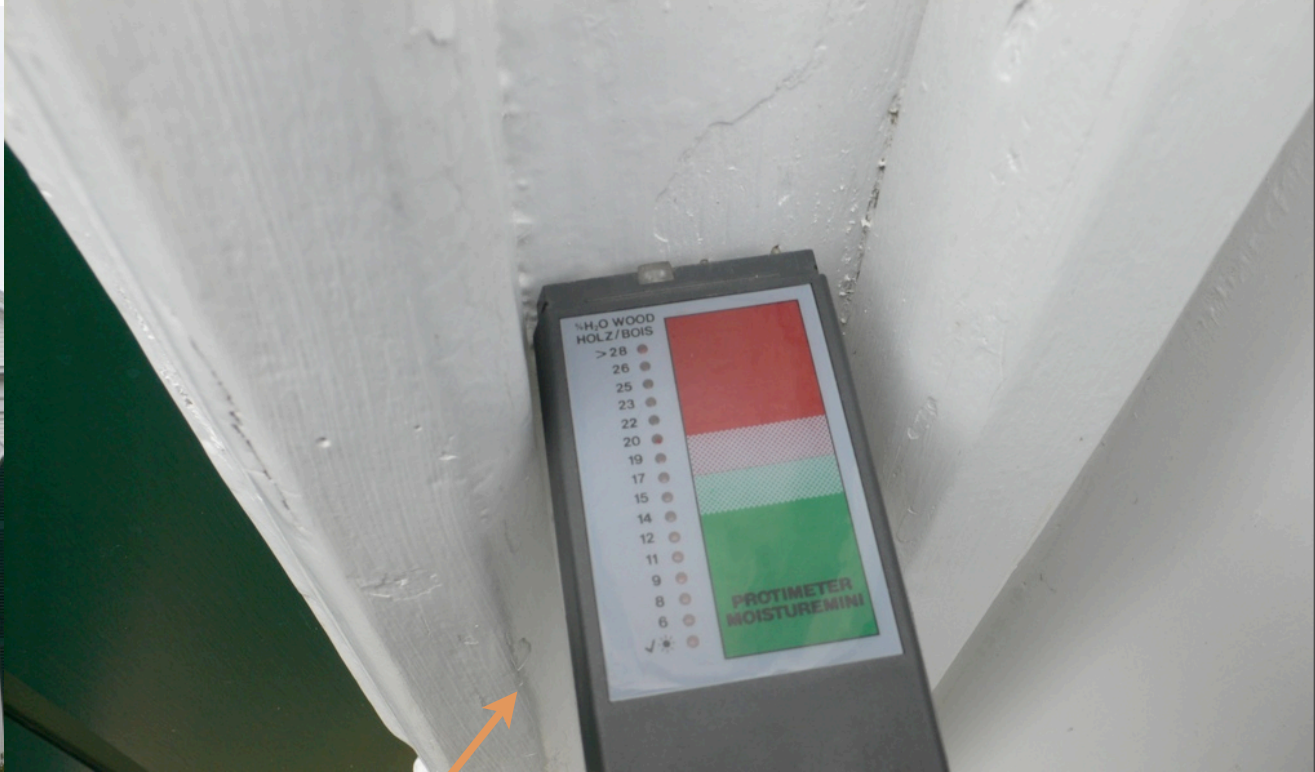
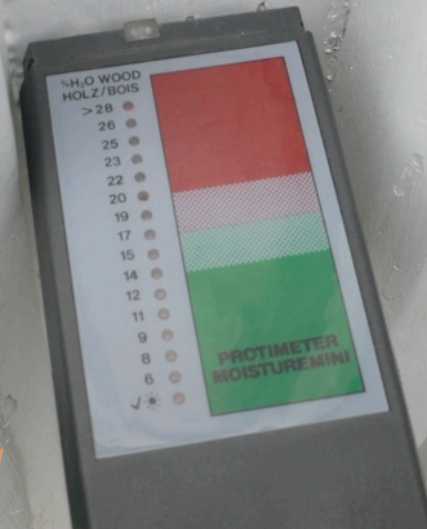
L1030203

Illustrates measurement of moisture in wooden elements. Here the level is 28%+ - "off the chart". Also, meter probes are buried in rotted wood.

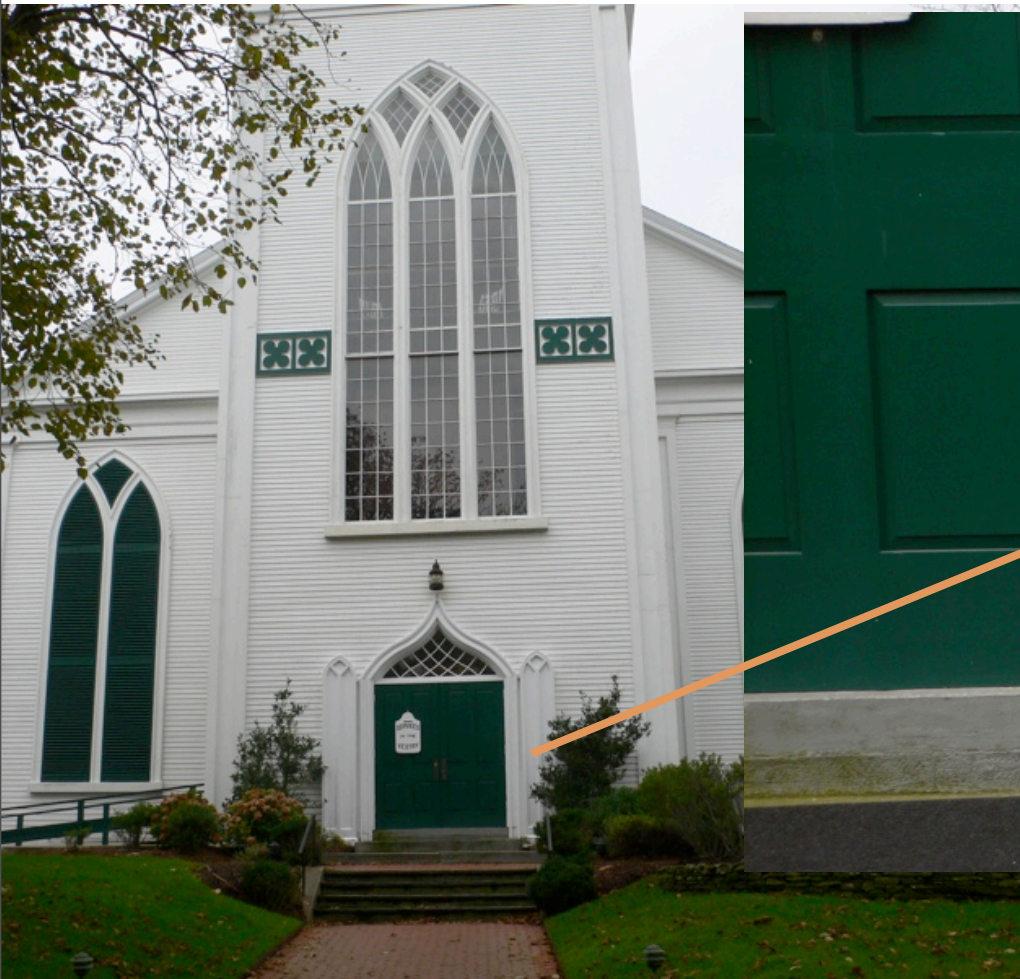
L10301204

Wood element is saturated with moisture and rotted. Here the screwdriver is partially buried in the wood.

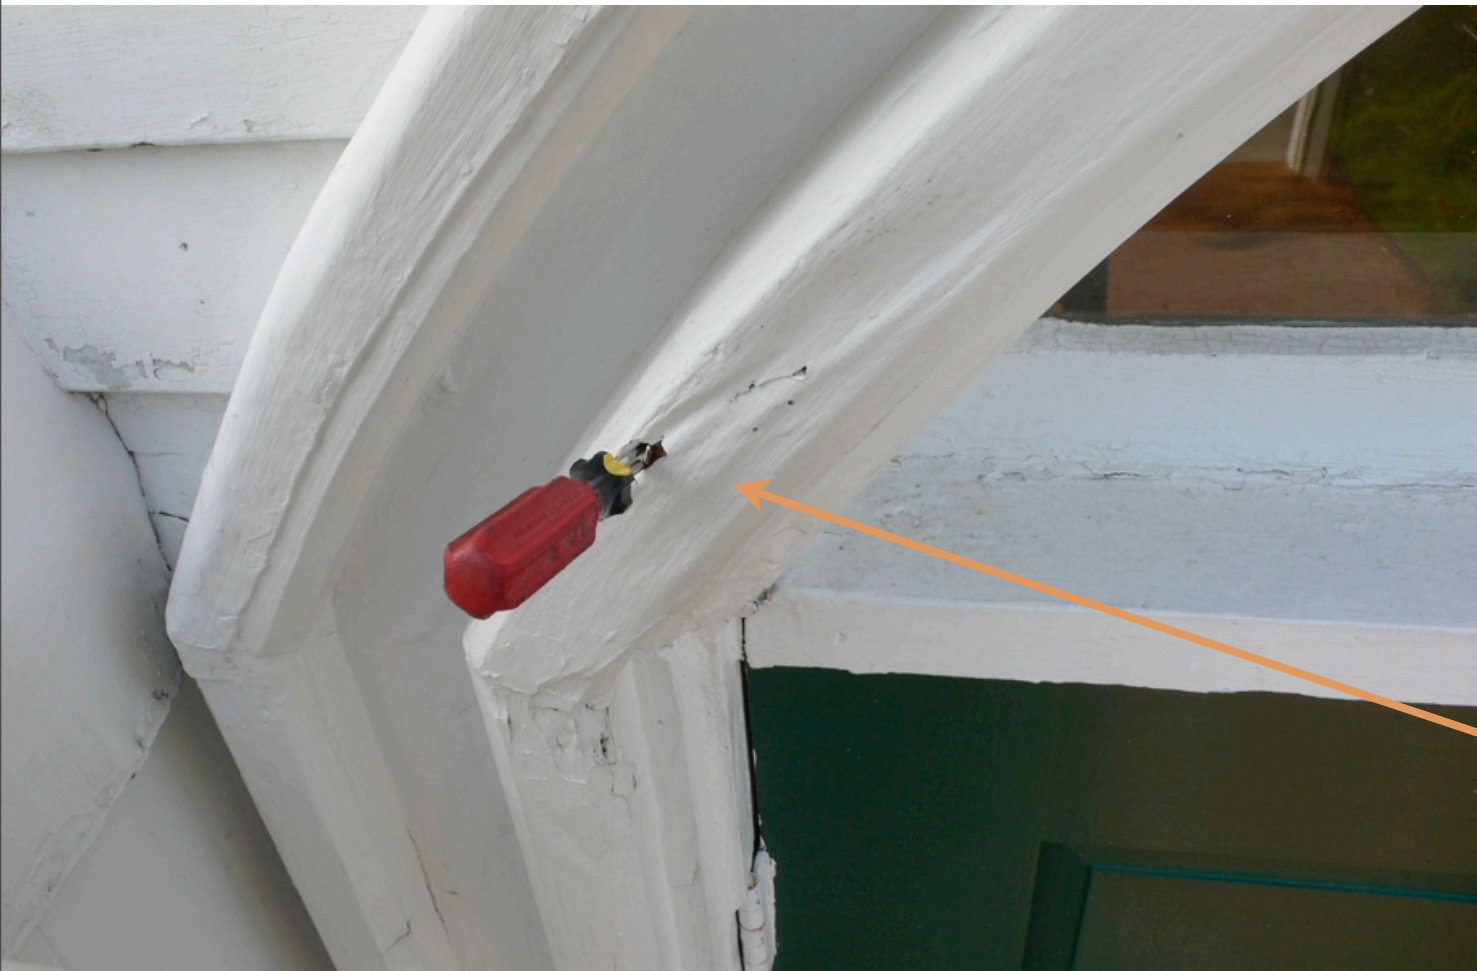
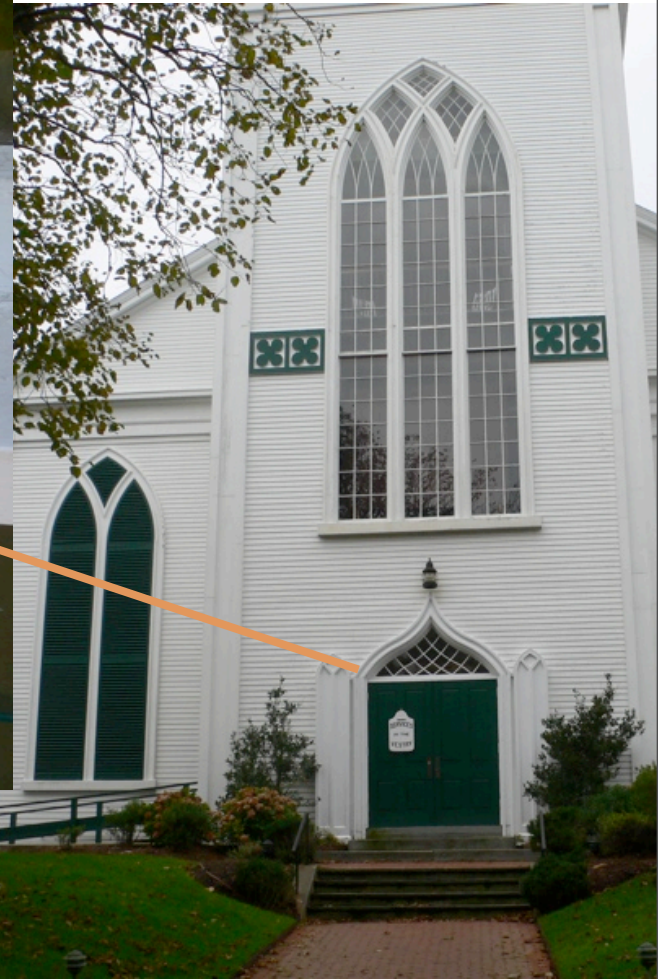
L1030213

Wood element is saturated with moisture and rotted. Here the screwdriver shaft is buried in the wood.

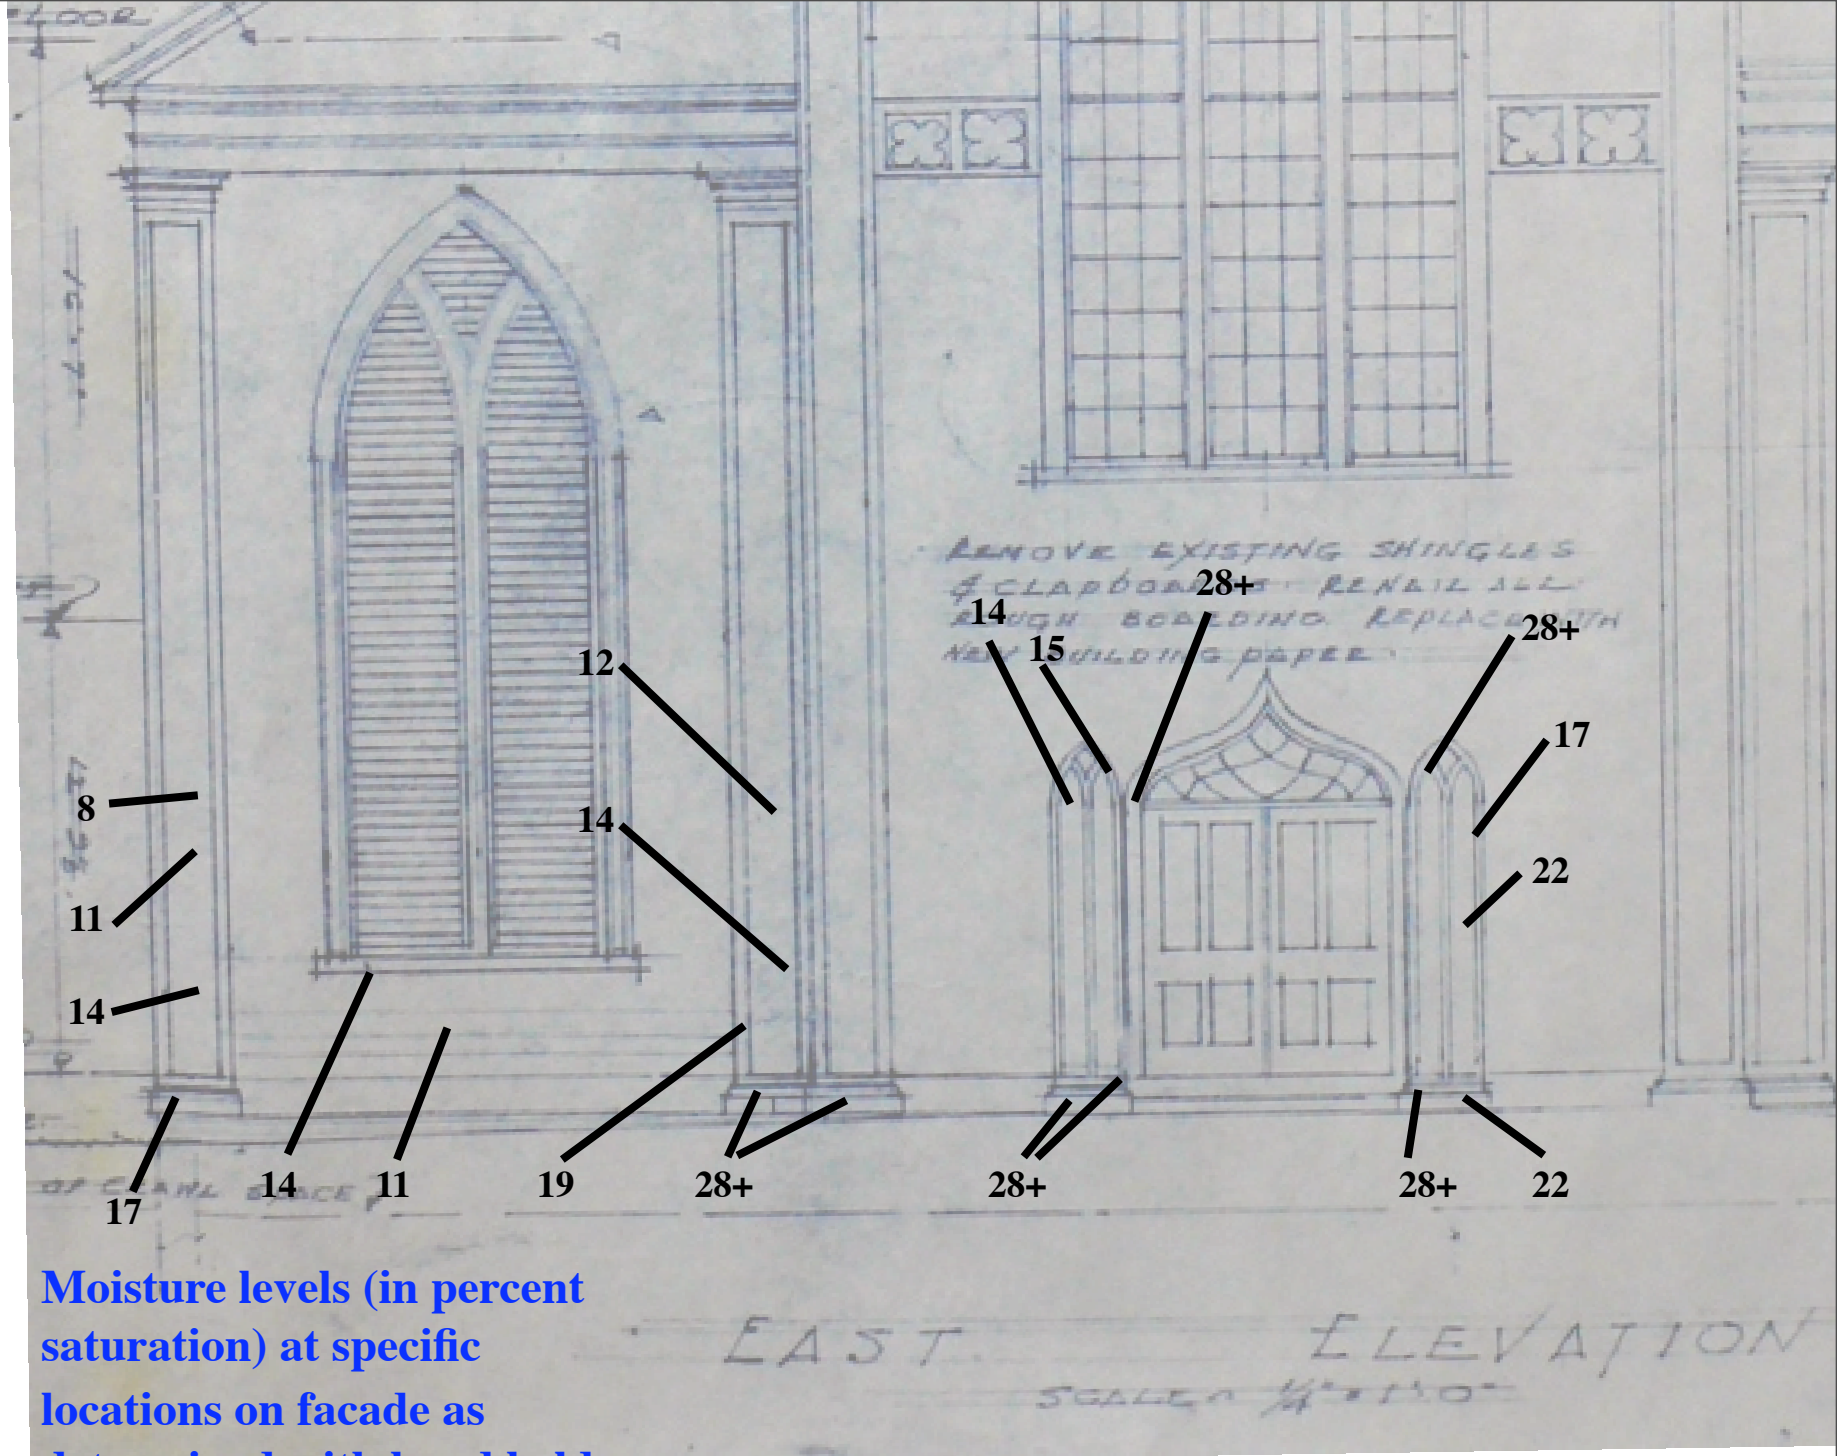
Moisture levels (in percent saturation) at specific locations on facade as determined with hand held moisture meter

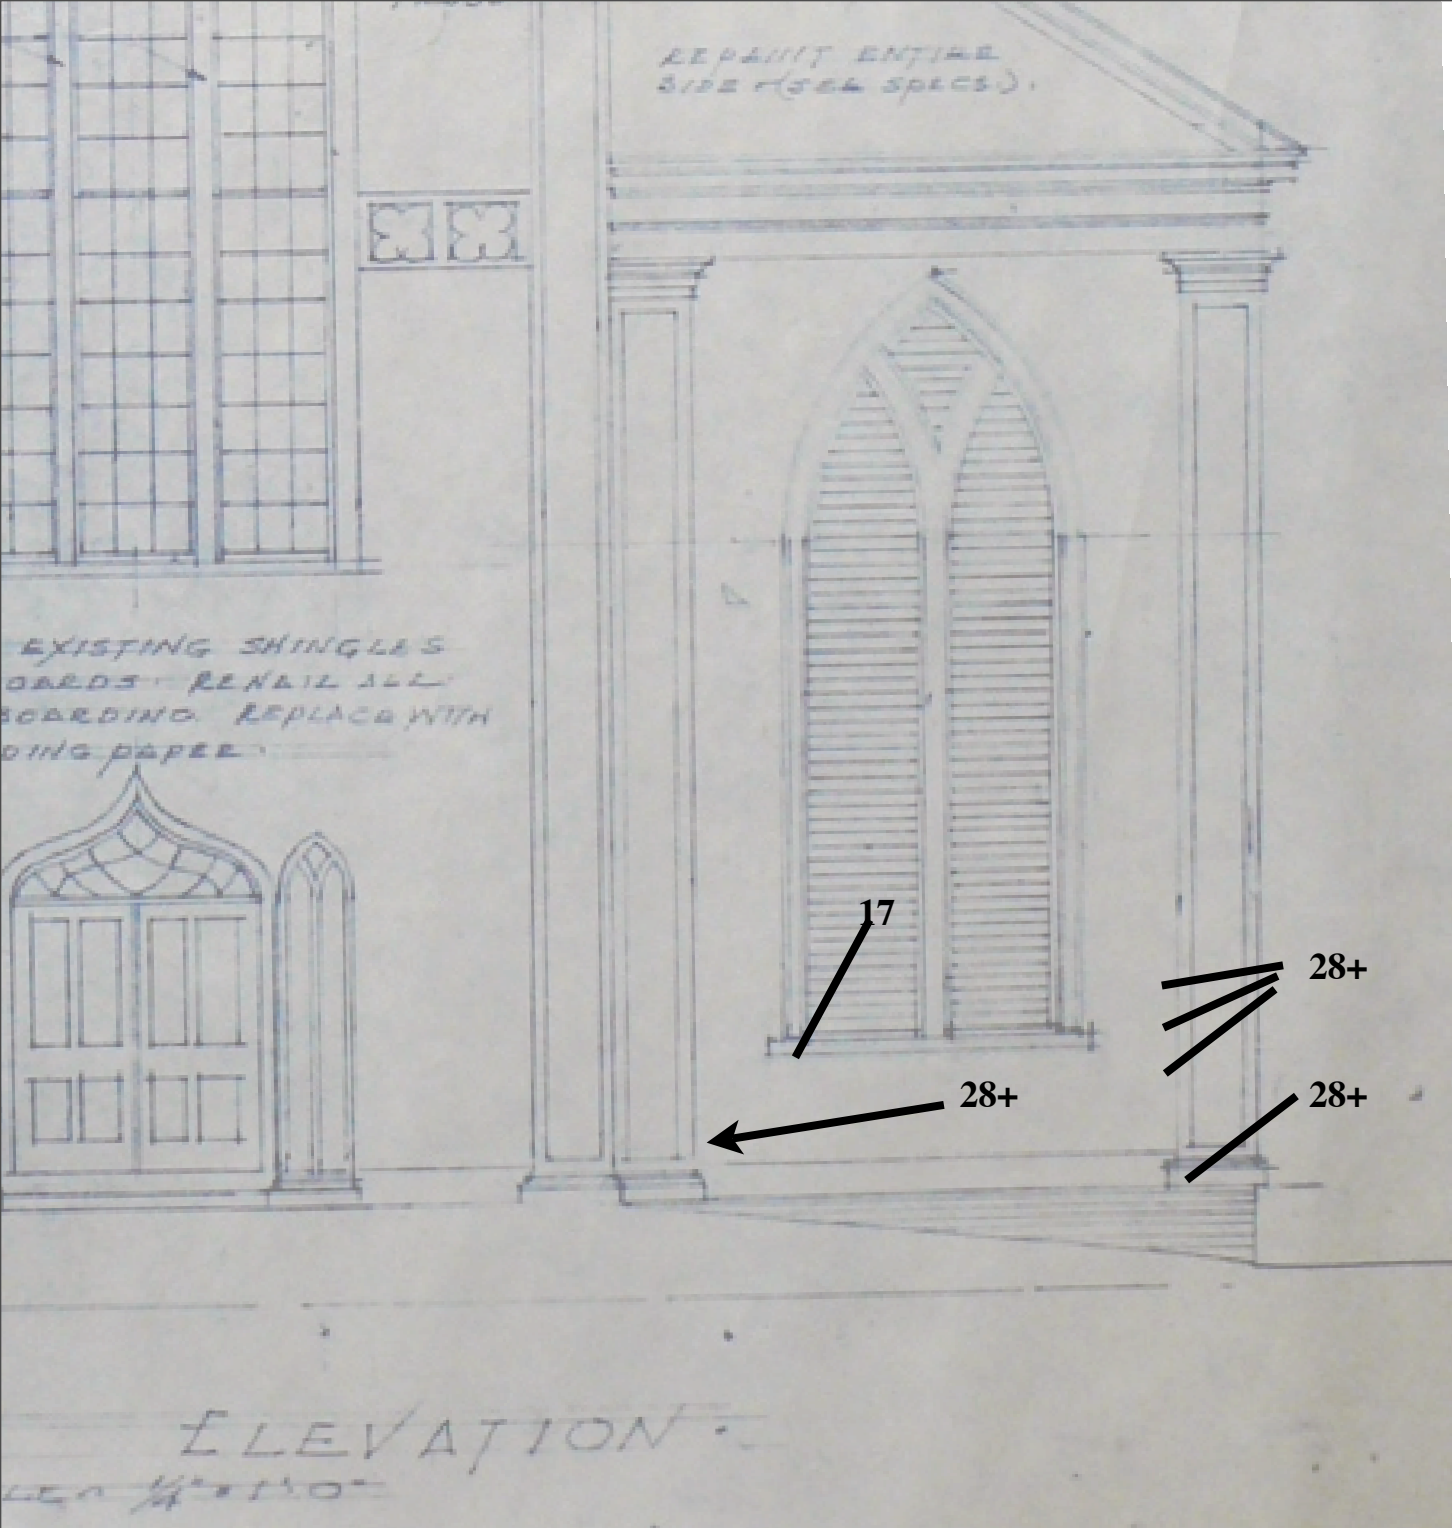
Moisture levels (in percent saturation) at specific locations on facade as determined with hand held moisture meter

Temperature and Humidity levels were also recorded at various levels and are reported here

Temperature	Humidity
65	68%
68	63%
66	62%
66	64%
63	64%

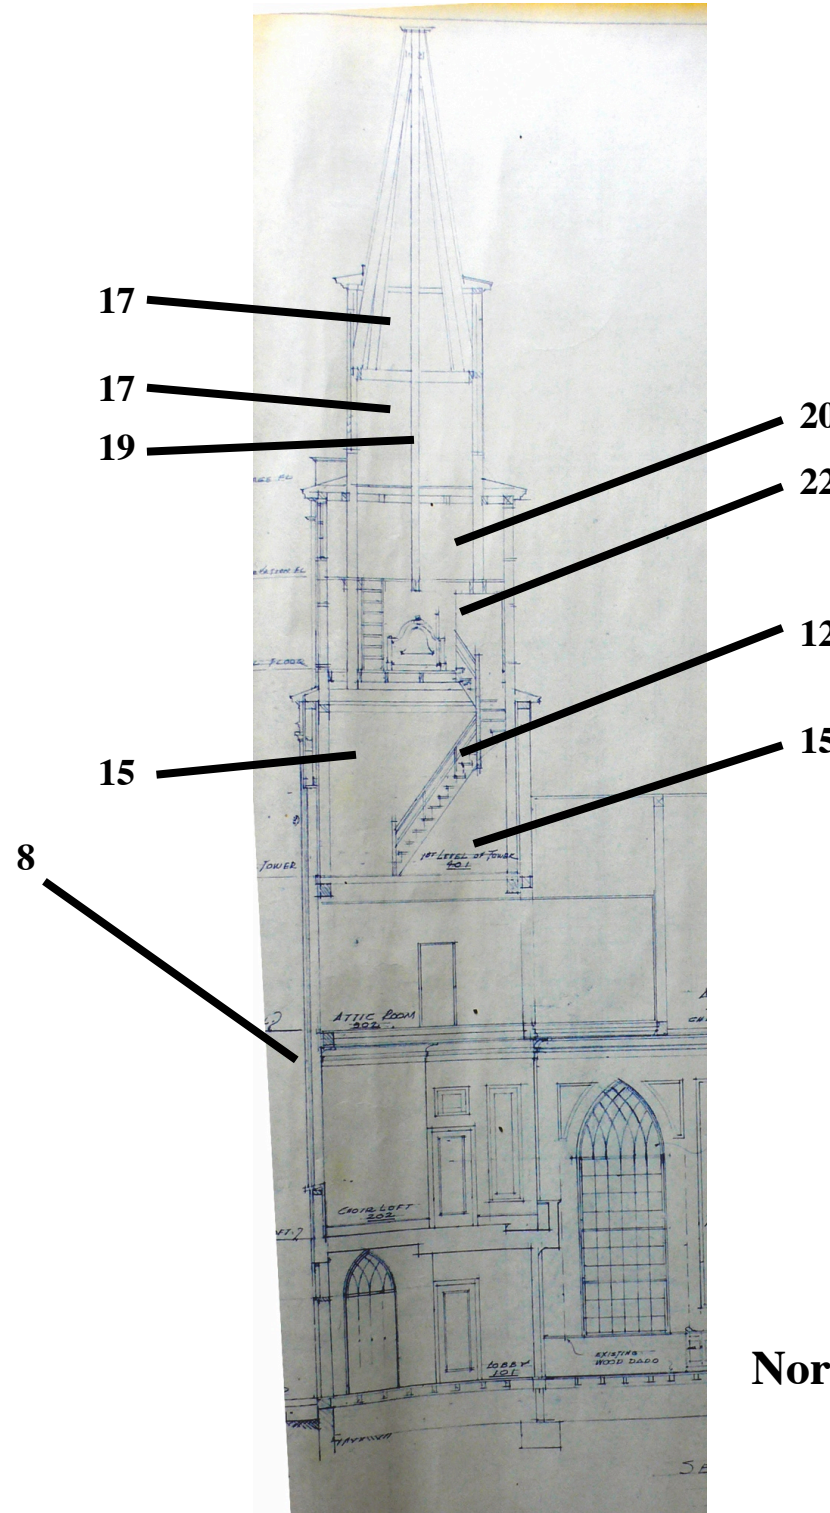
North facade/section of church

Moisture levels (in percent saturation) at specific locations at interior framing elements and interior surface of wooden sheathing as determined with hand held moisture meter

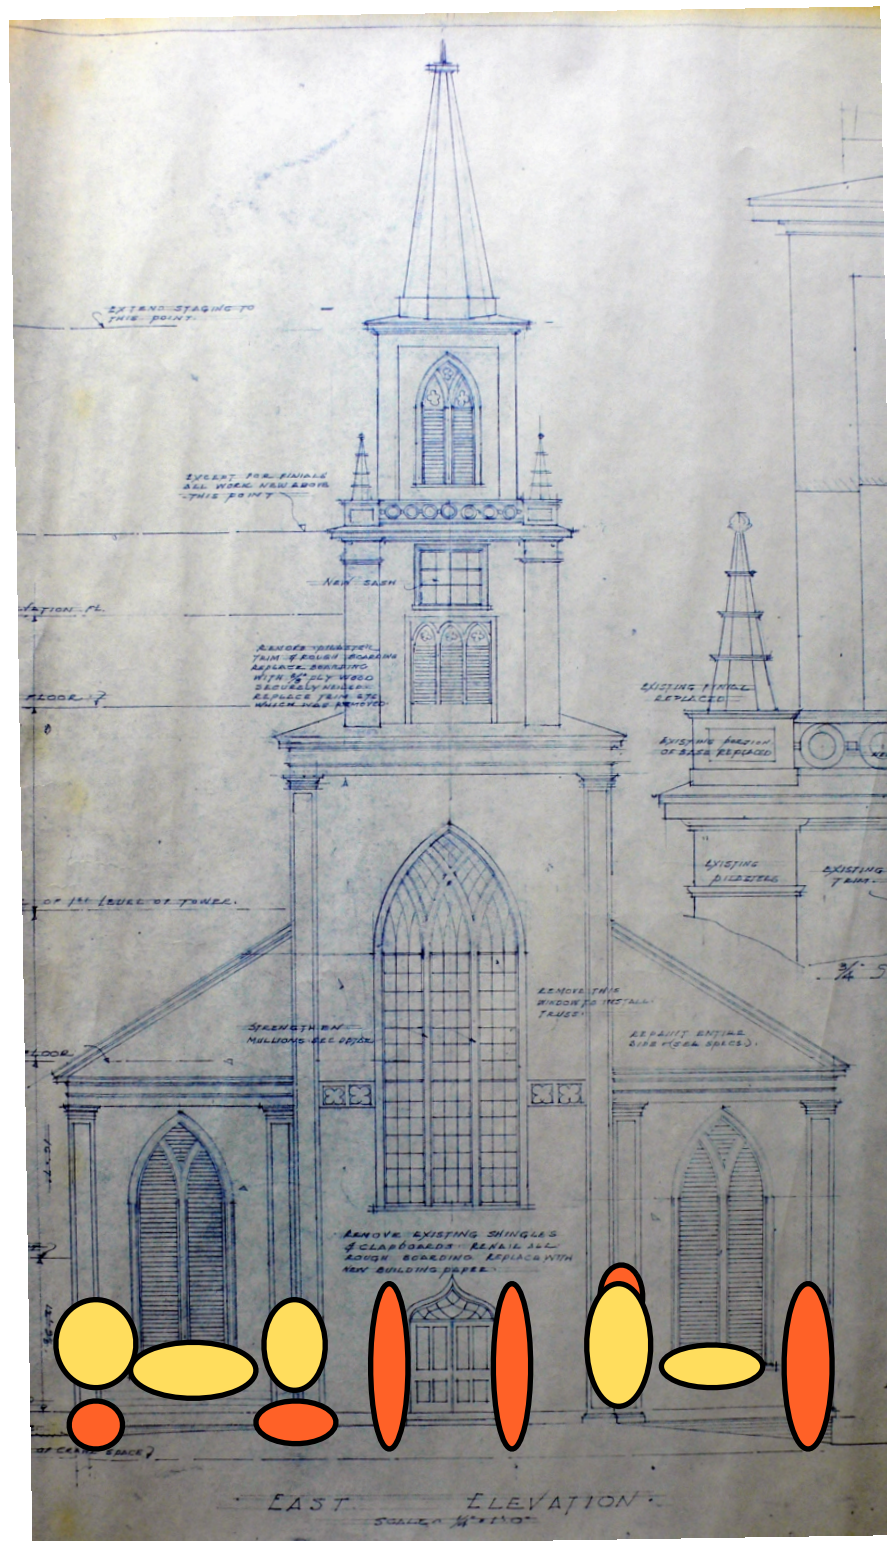
East facade of church

Moisture levels as illustrated by color (red is saturation of 28%+, yellow is approaching saturation and is in the range of 15 -22%) at specific locations on facade as determined with hand held moisture meter
