**First Congregational Church  
Nantucket, MA  
Interior Repairs, Restoration and Conservation**

**September 12, 2007 Revised October 29, 2008**

**DMH Enterprises, Architects  
104 Federal Street  
Salem, MA 01970  
617-745-2172**

**The following pages depict existing conditions as of 2007 and 2008 and recommendations for conservation/restoration.**

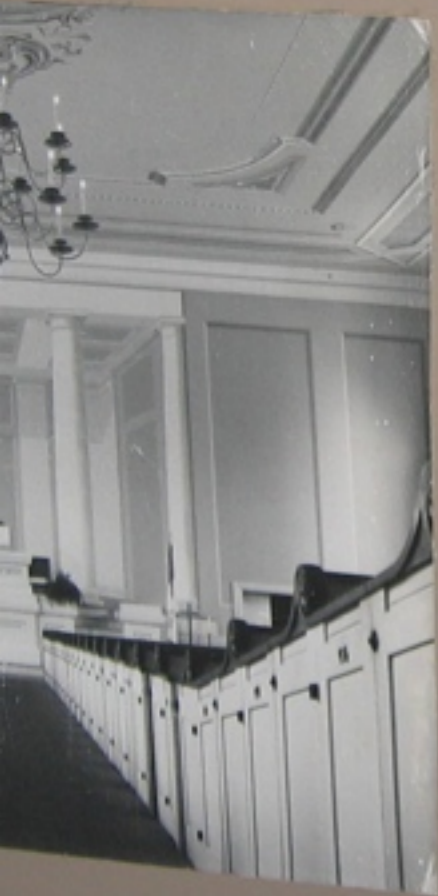
**TROMPEL'OEIL** is French for deceive the eye. During the redecoration of the church the metal ceiling was removed and this form of three-dimensional painting was revealed. Using early photos and the colors from the ceiling, the church has been restored to its original state. It is the finest example of this style of decoration in southern New England.

**Photo in Plaque (undated) detailing presumably the sanctuary redecoration as well as the tower exhibit. Ceiling photo is unidentified but does show both trompe l'oeil as well as rectangular ceiling panels.**

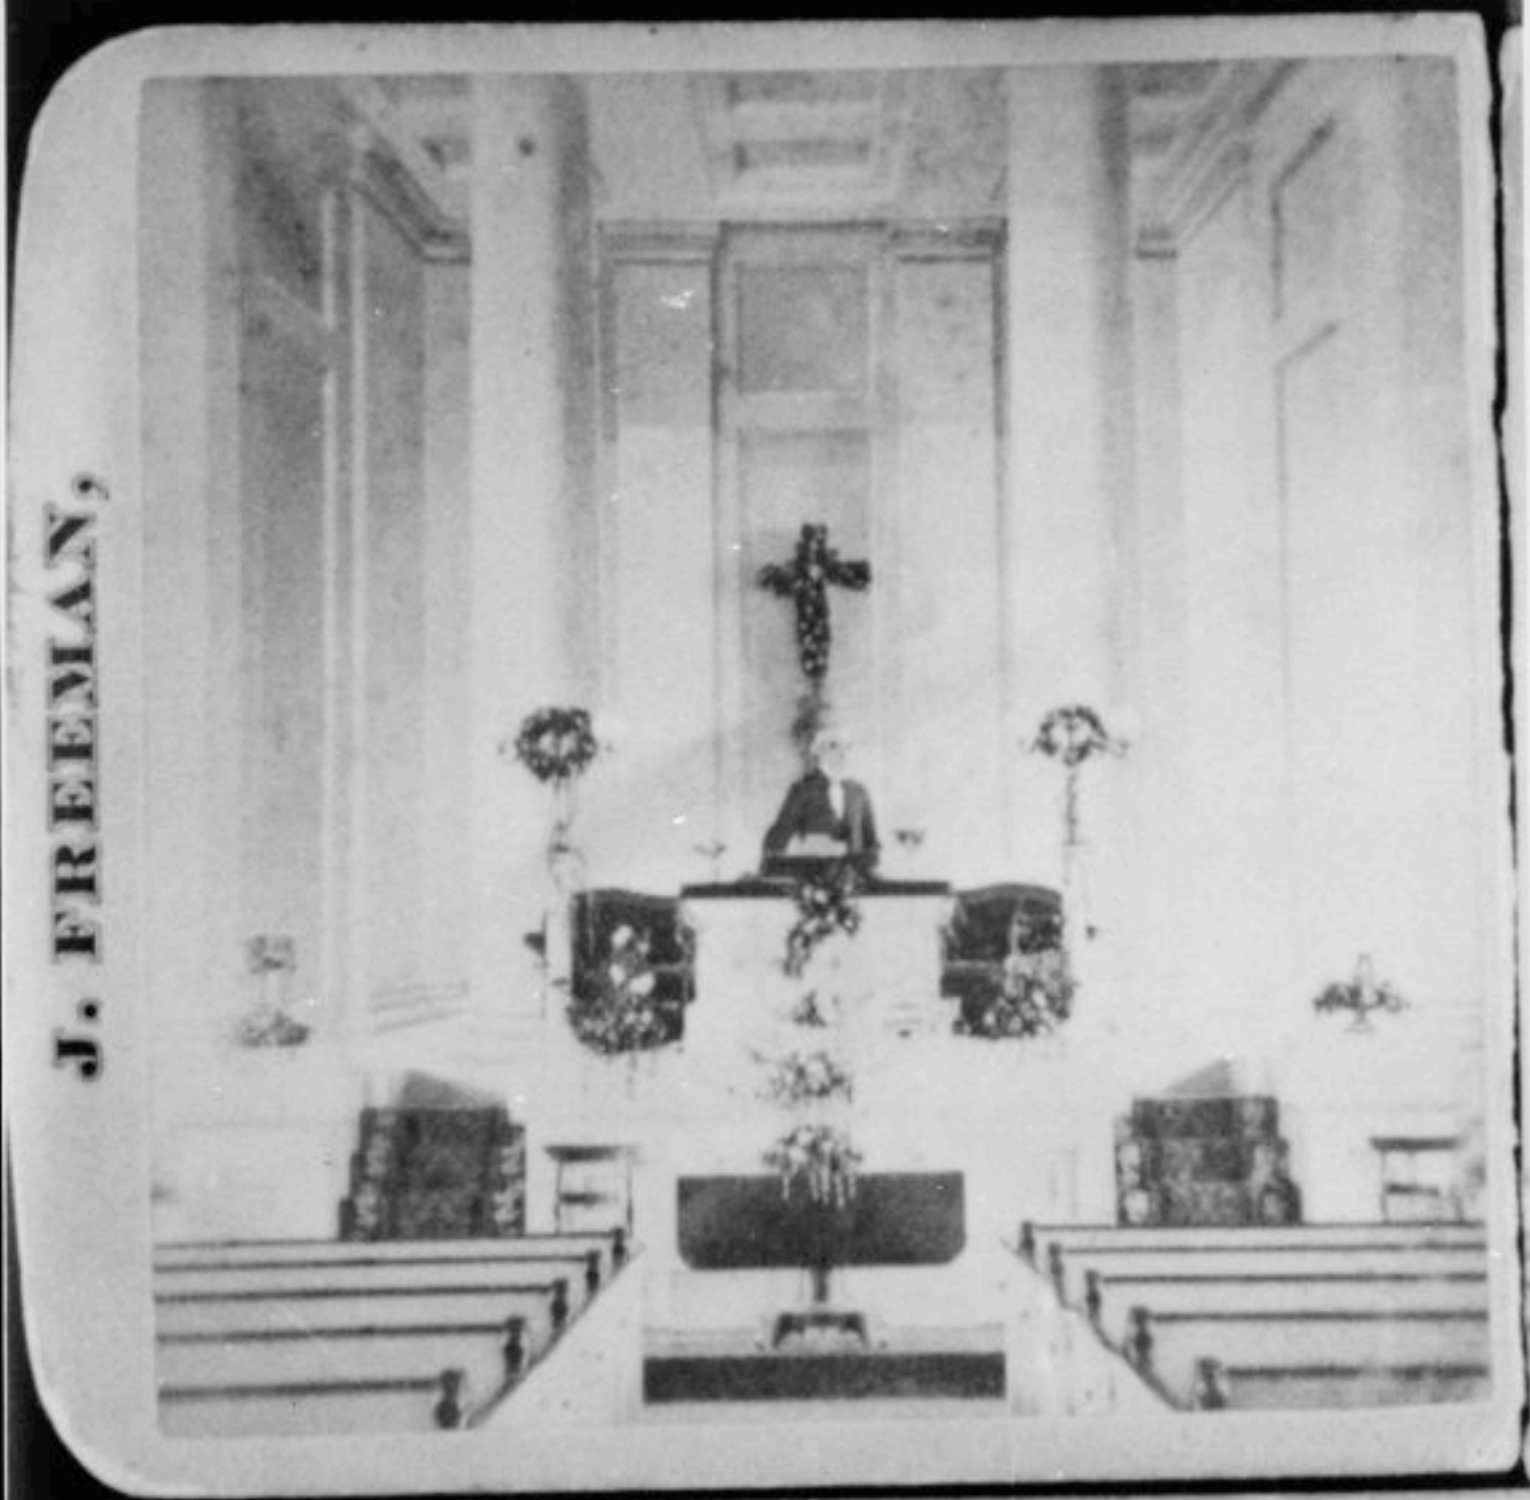
1885, Sanctuary, looking west

16. Historic American  
Buildings Survey COPY OF  
STEREOPTICON BY J.  
FREEMAN, C. 1885, OF  
WEST WALL WITH  
ORIGINAL TROMPE  
L'OEIL PAINTING  
HABS MASS,10-NANT,26-16

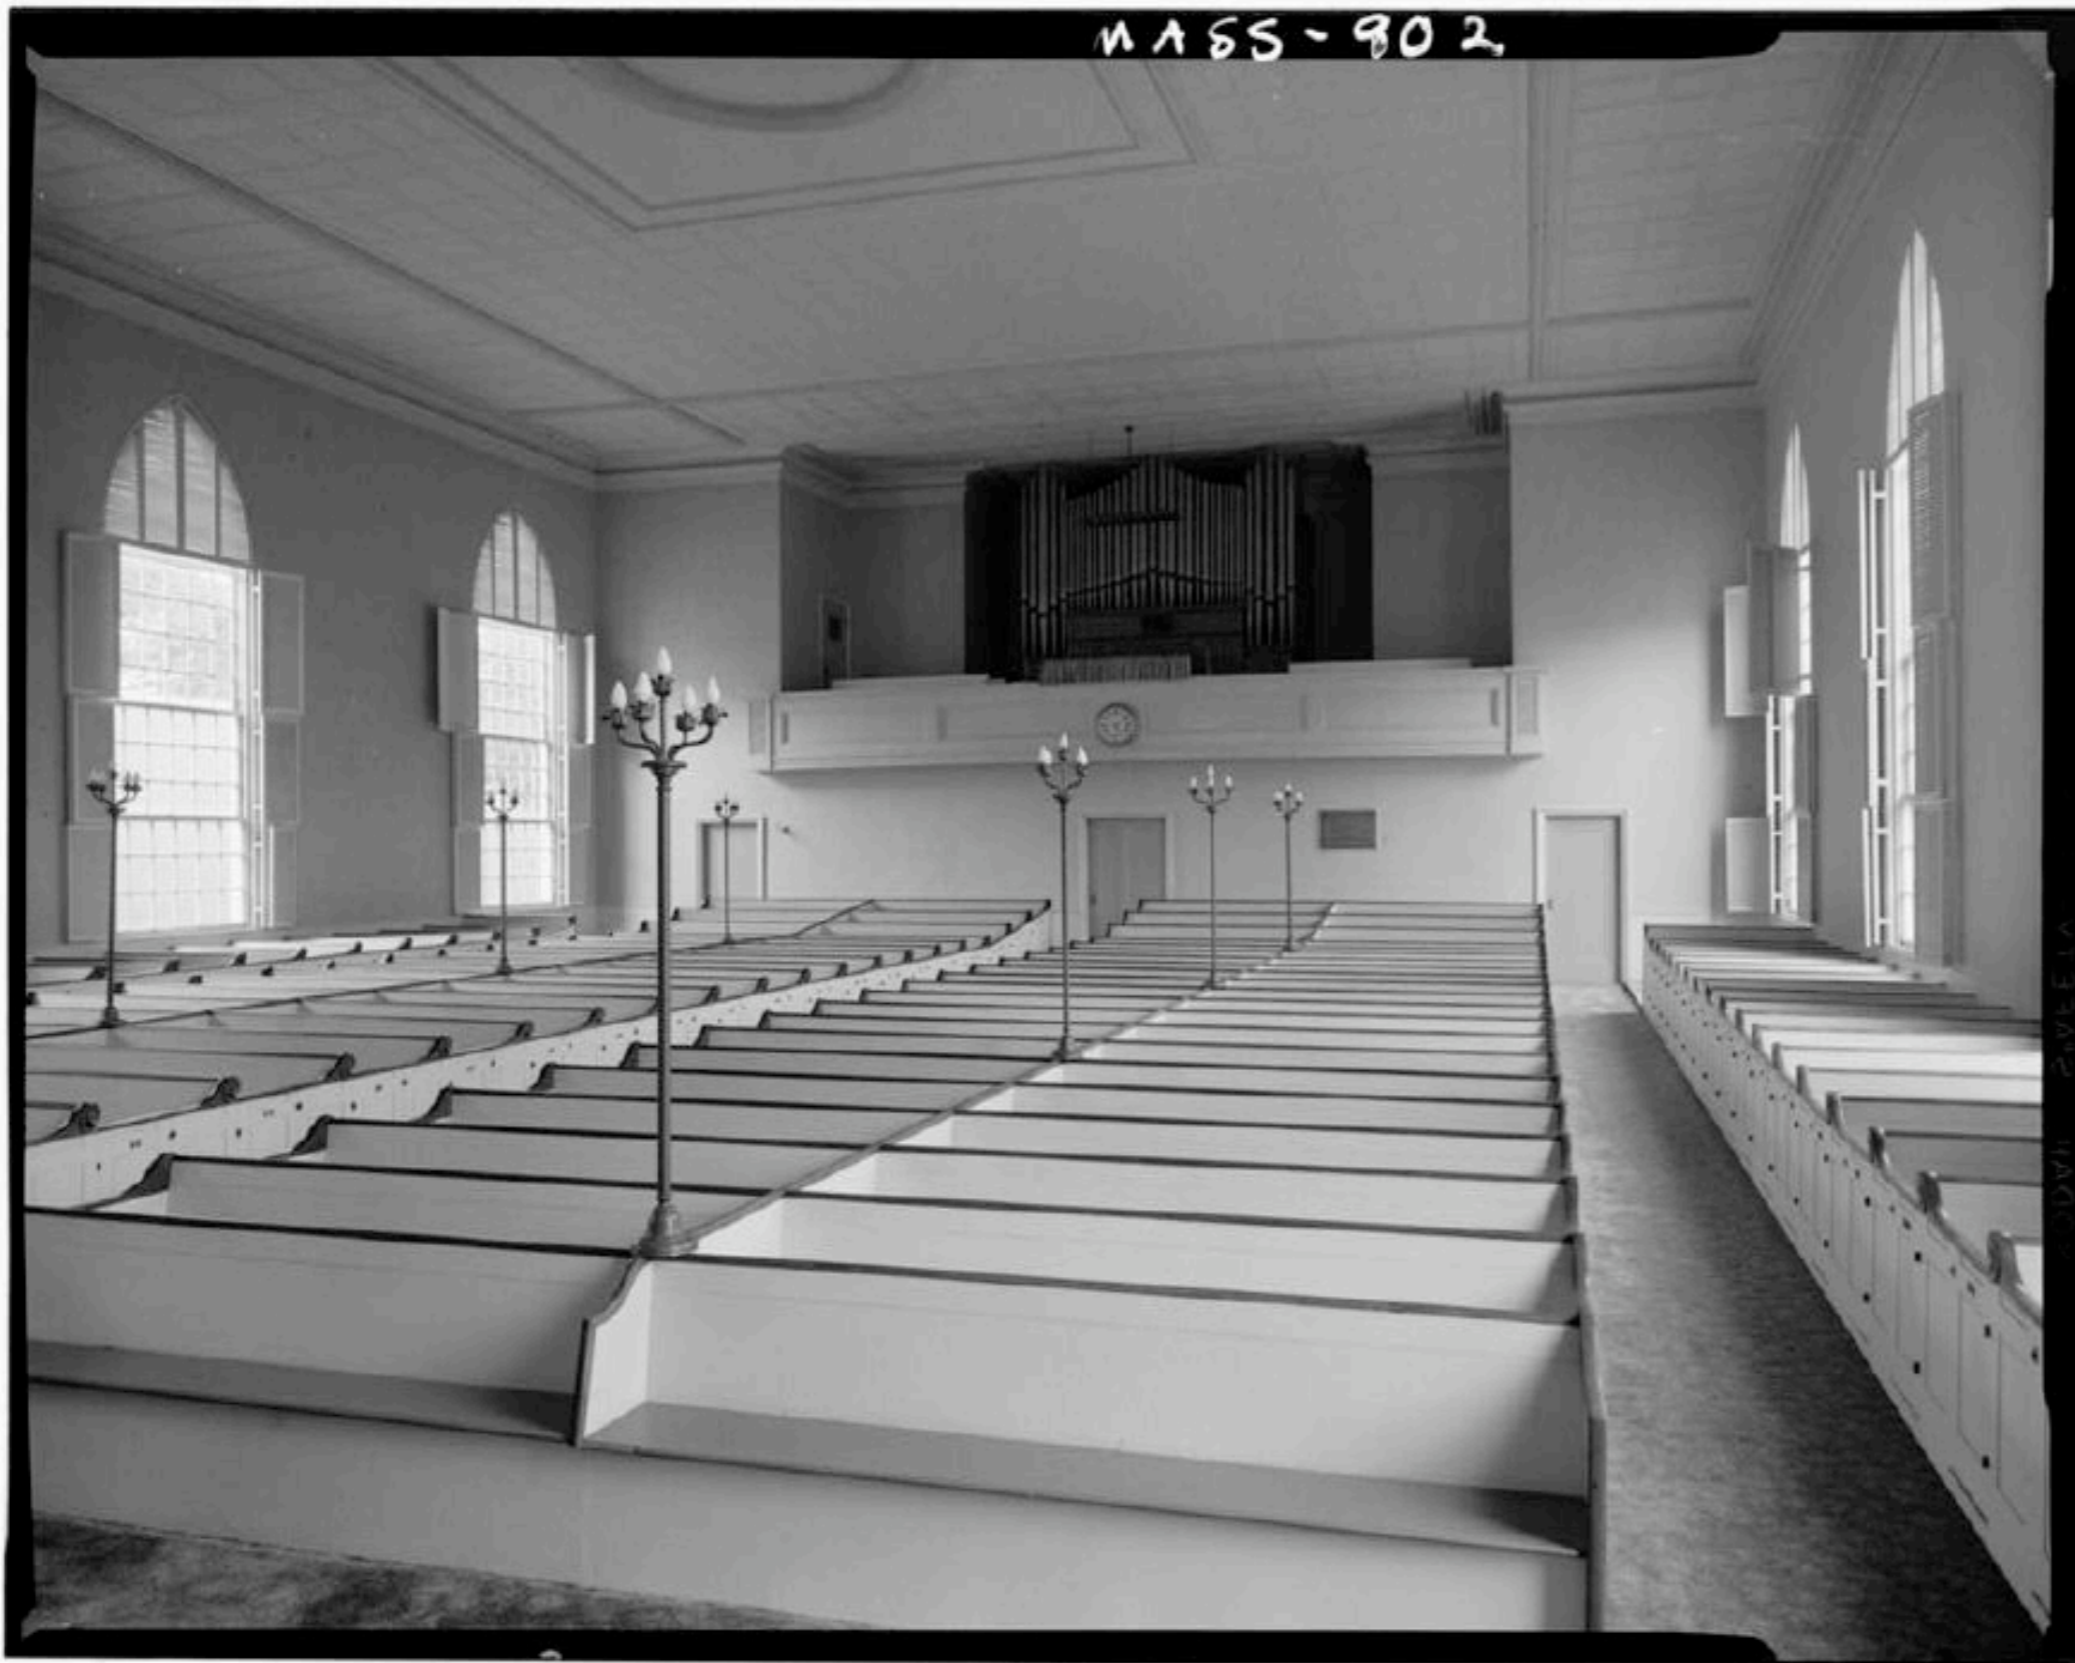
**1966, Sanctuary, looking east**

**7. Historic American  
Buildings Survey Cortlandt V.  
D. Hubbard, Photographer  
July 1966 INTERIOR, EAST  
END, BEFORE  
RESTORATION  
HABS MASS,10-NANT,26-7**

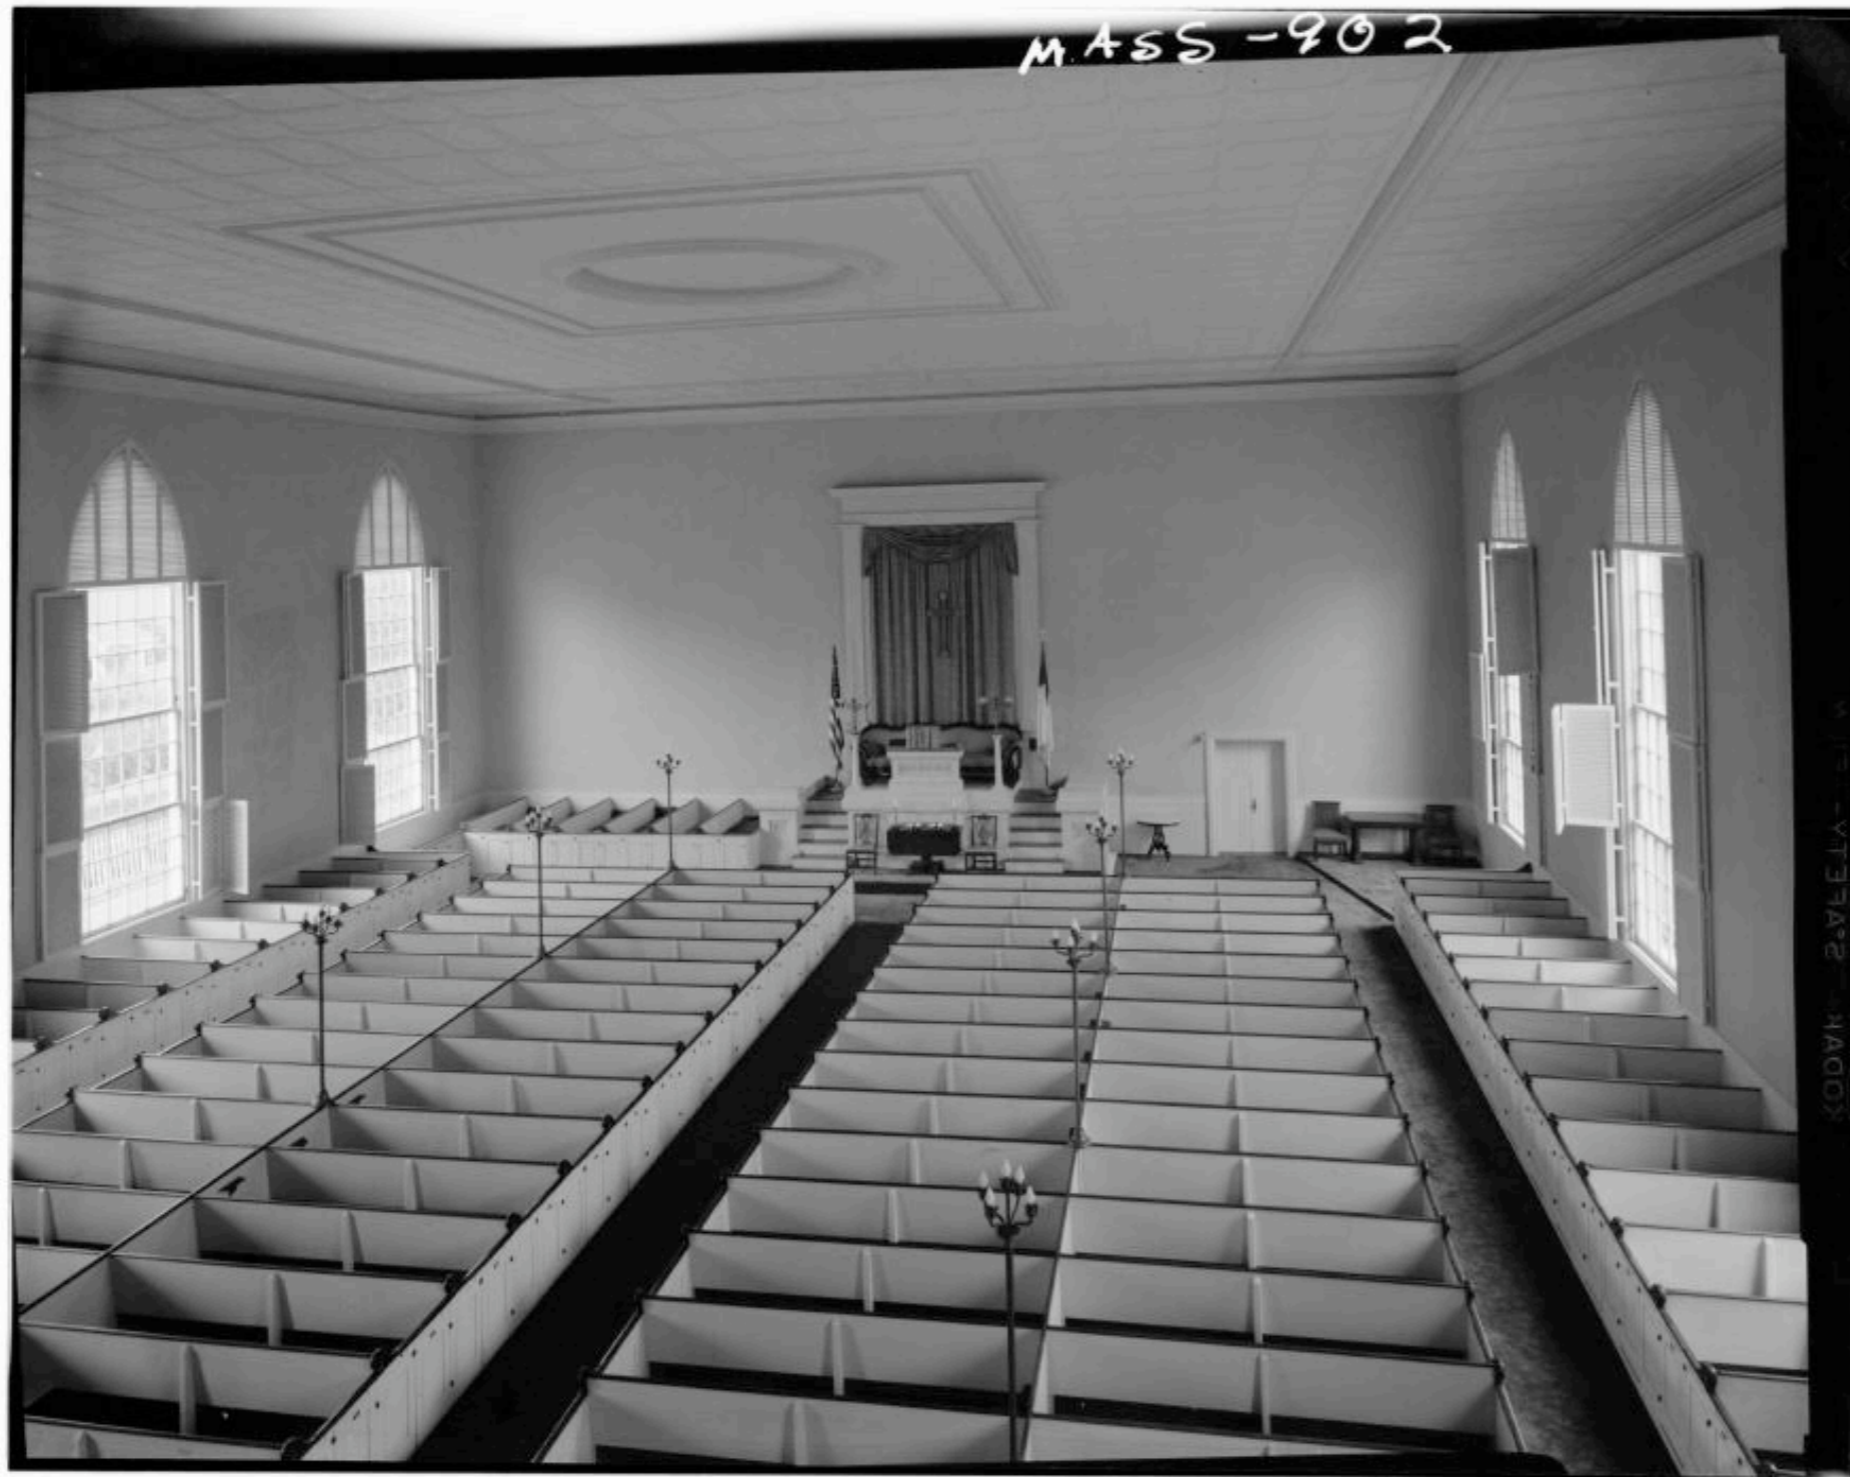
**1966, Sanctuary, looking west**

**7. Historic American  
Buildings Survey Cortlandt V.  
D. Hubbard, Photographer  
July 1966 INTERIOR, EAST  
END, BEFORE  
RESTORATION  
HABS MASS,10-NANT,26-7**

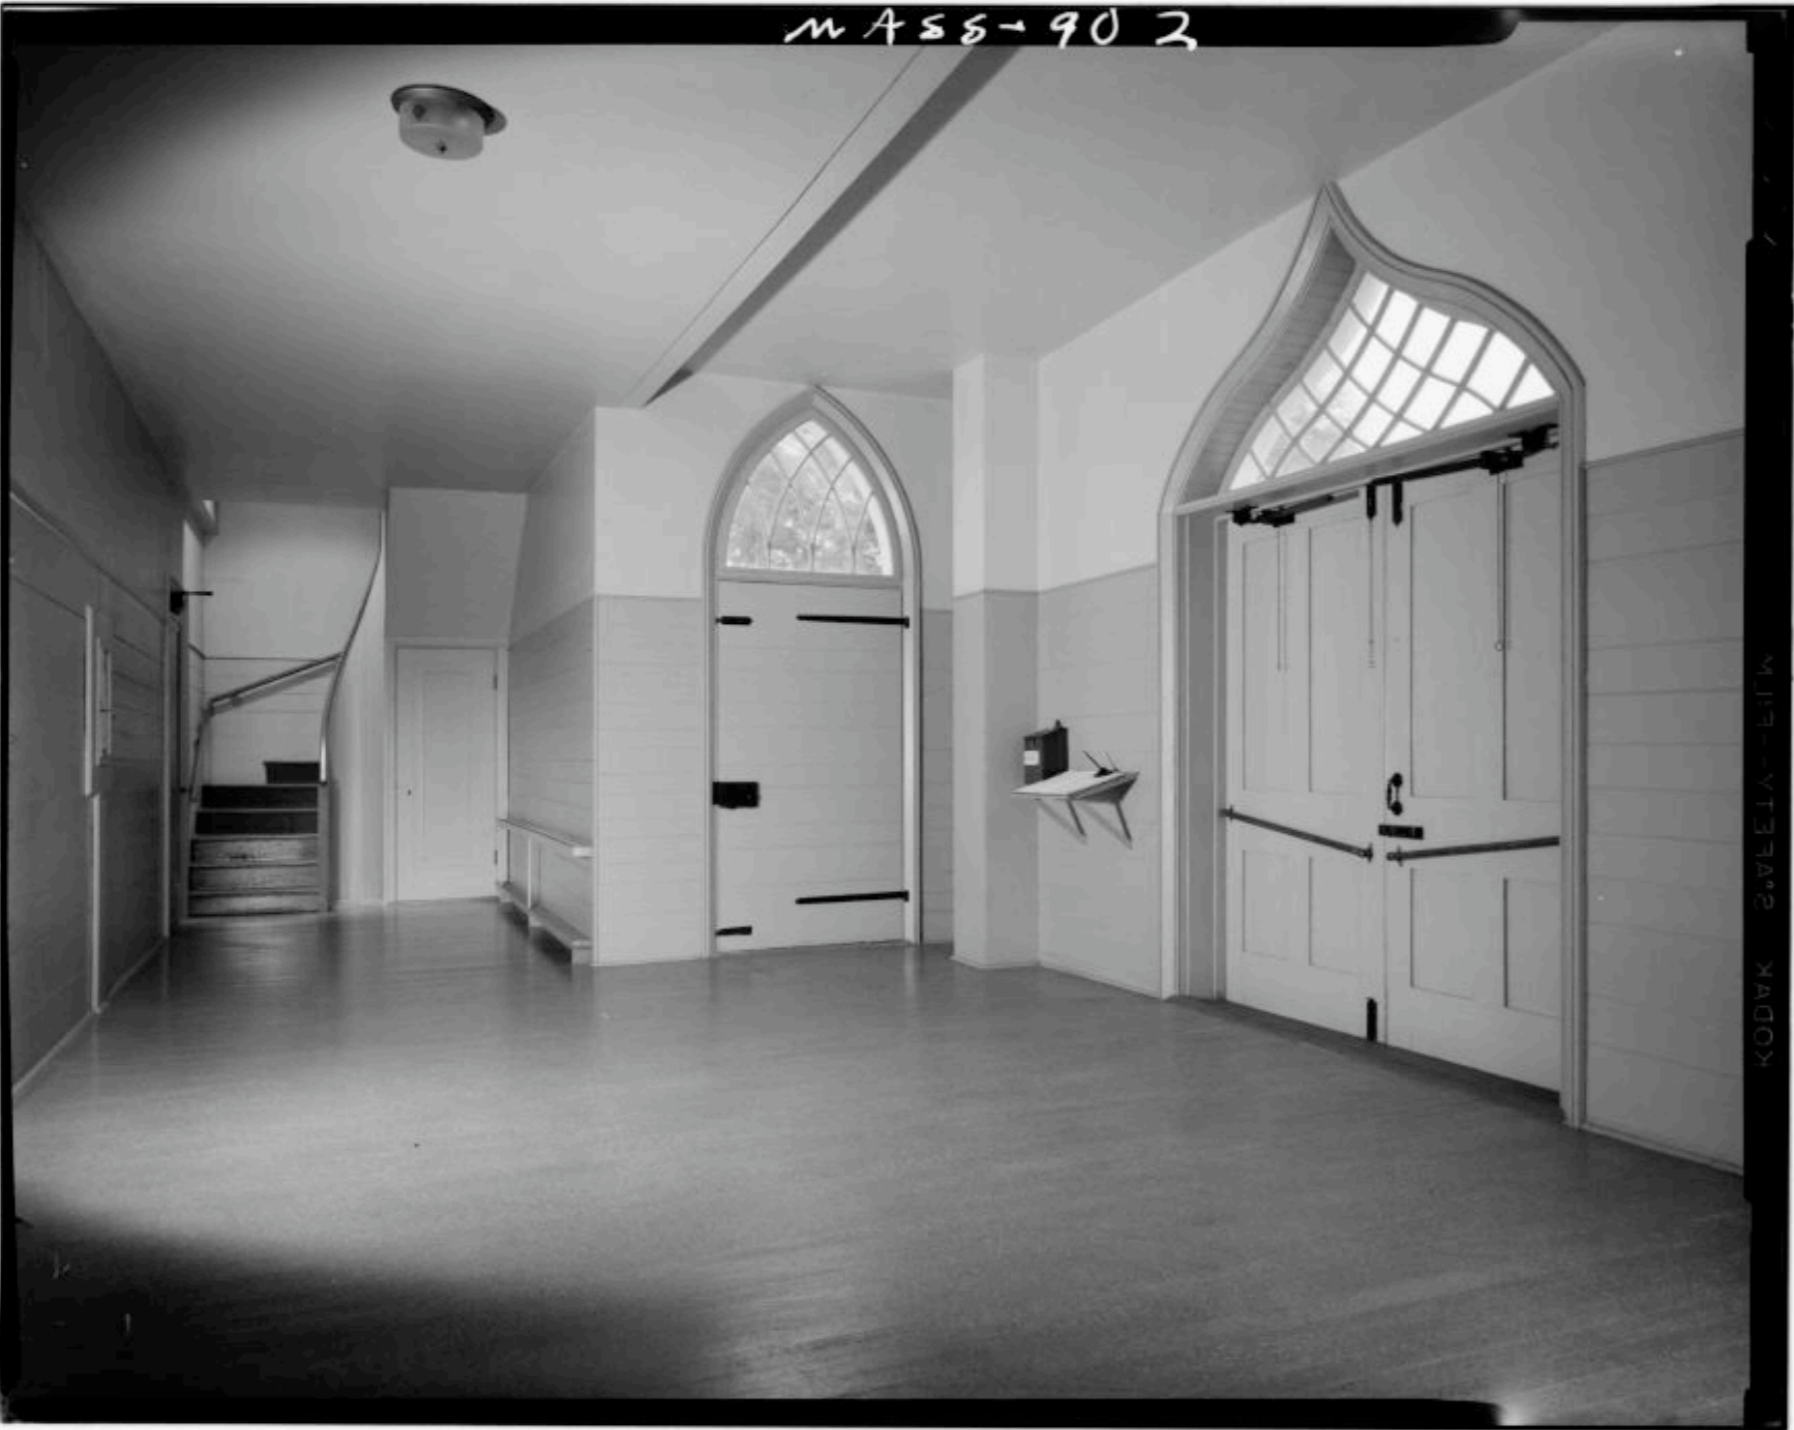
**1966, Vestibule, looking north**

**9. Historic American  
Buildings Survey Cortlandt V.  
D. Hubbard, Photographer  
July 1966 VESTIBULE,  
BEFORE RESTORATION  
HABS MASS,10-NANT,26-9**

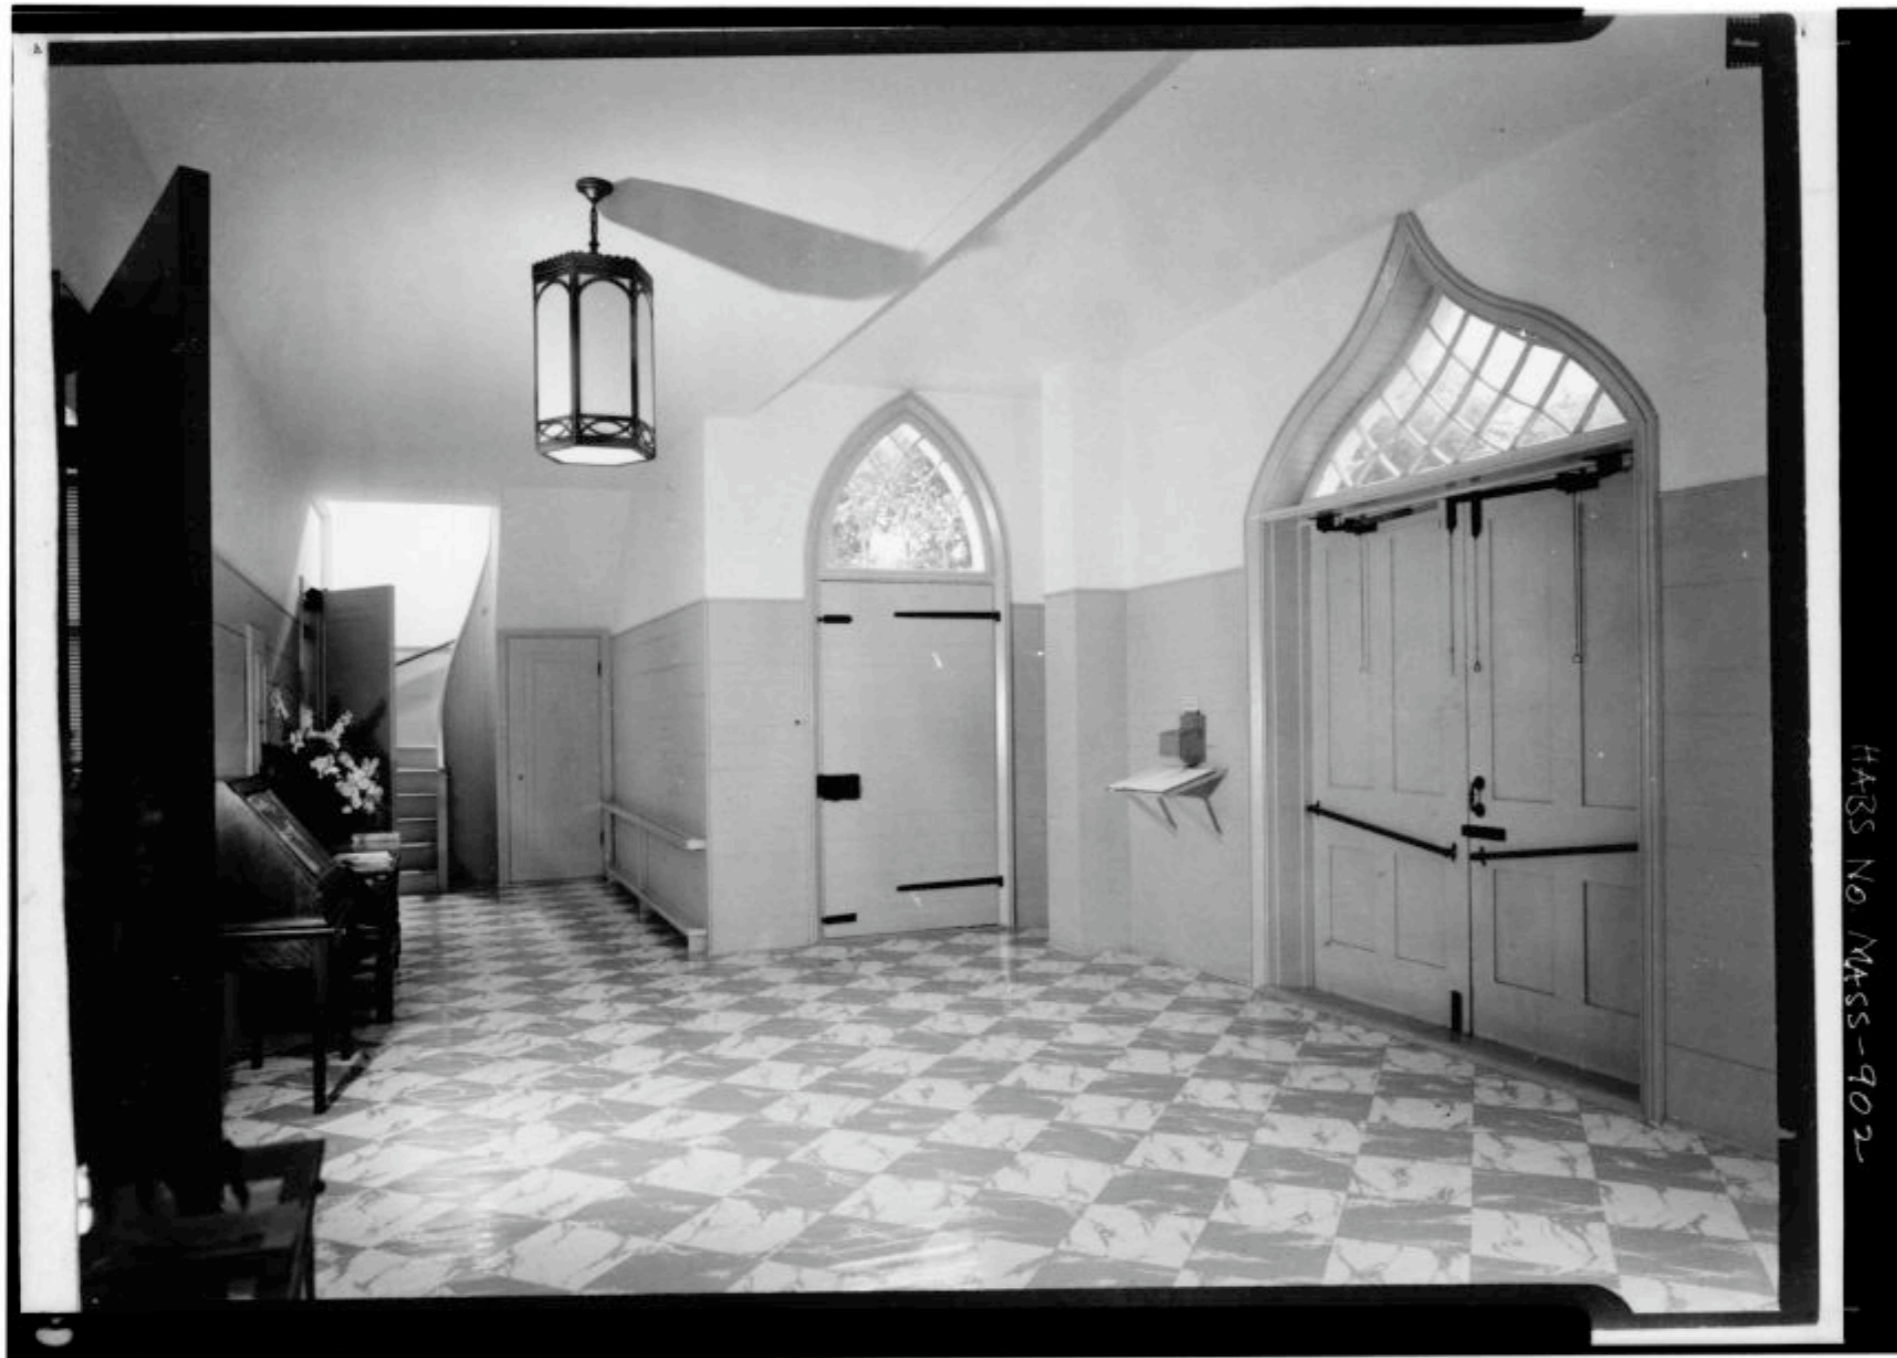
**14. Historic American  
Buildings Survey Jack E.  
Boucher, Photographer  
August 1970 VESTIBULE,  
AFTER RESTORATION  
HABS MASS,10-NANT,26-14**

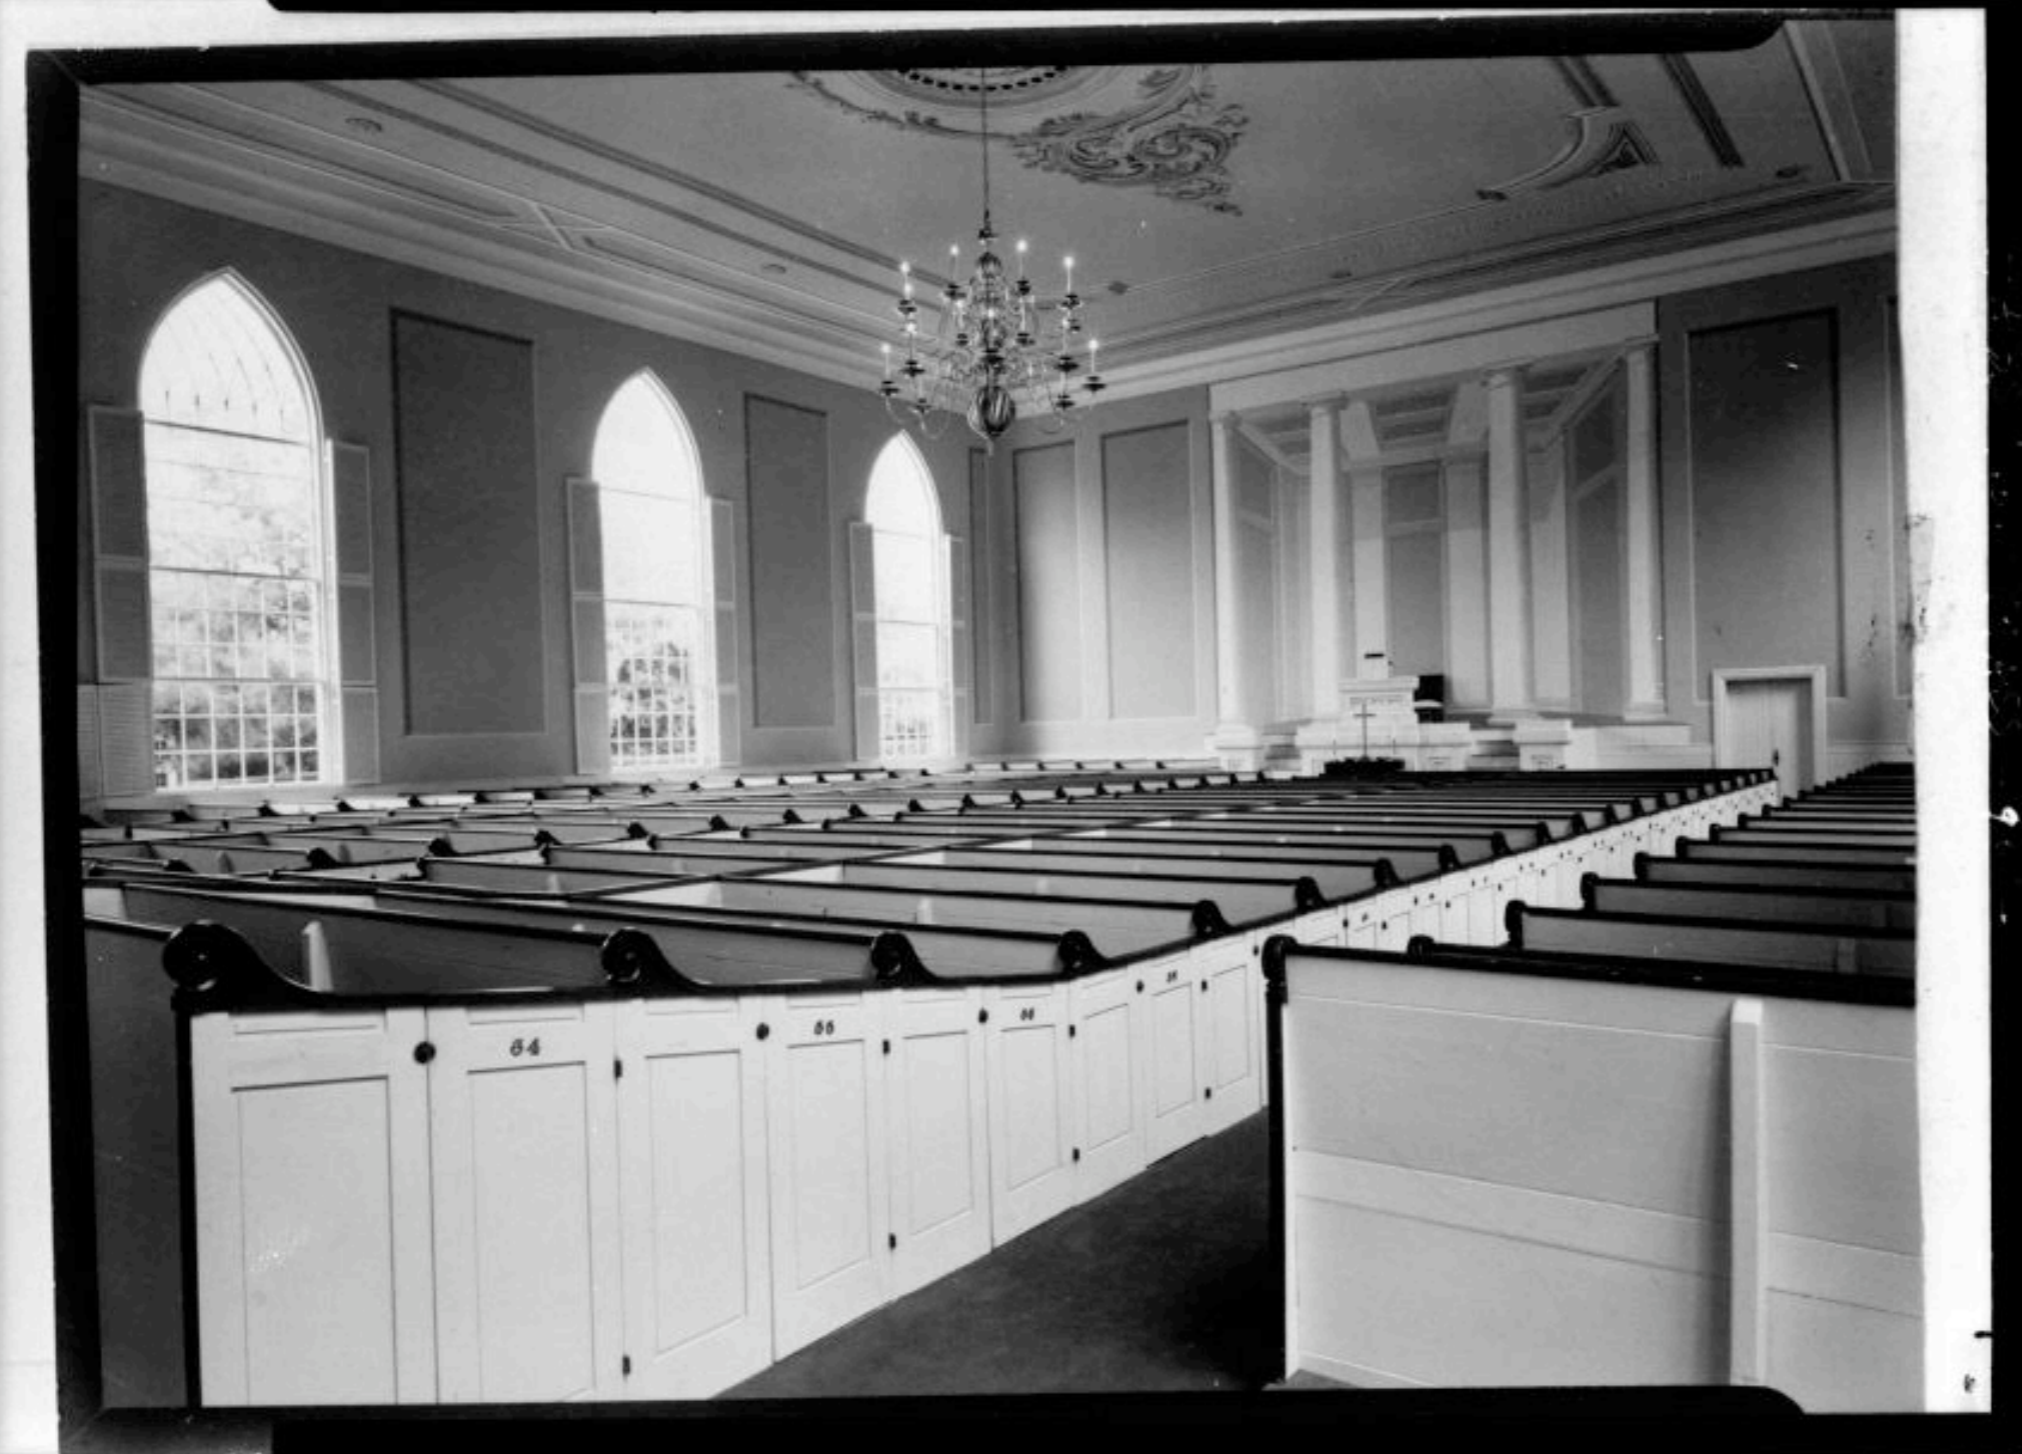
10. Historic American Buildings Survey Jack E. Boucher, Photographer August 1970 INTERIOR, TROMPE L'OEIL PAINTING ON WEST WALL HABS MASS,10-NANT,26-10

Church records indicate that the interior was painted in the trompe l'oeil manner in 1970, Artist Walter Sampson is recorded in the data and was presumably the artist who painted the interior. The c-1885 stereopticon by J. Freeman looks as if it was used for reference for the west wall.

1970, Sanctuary, looking south west

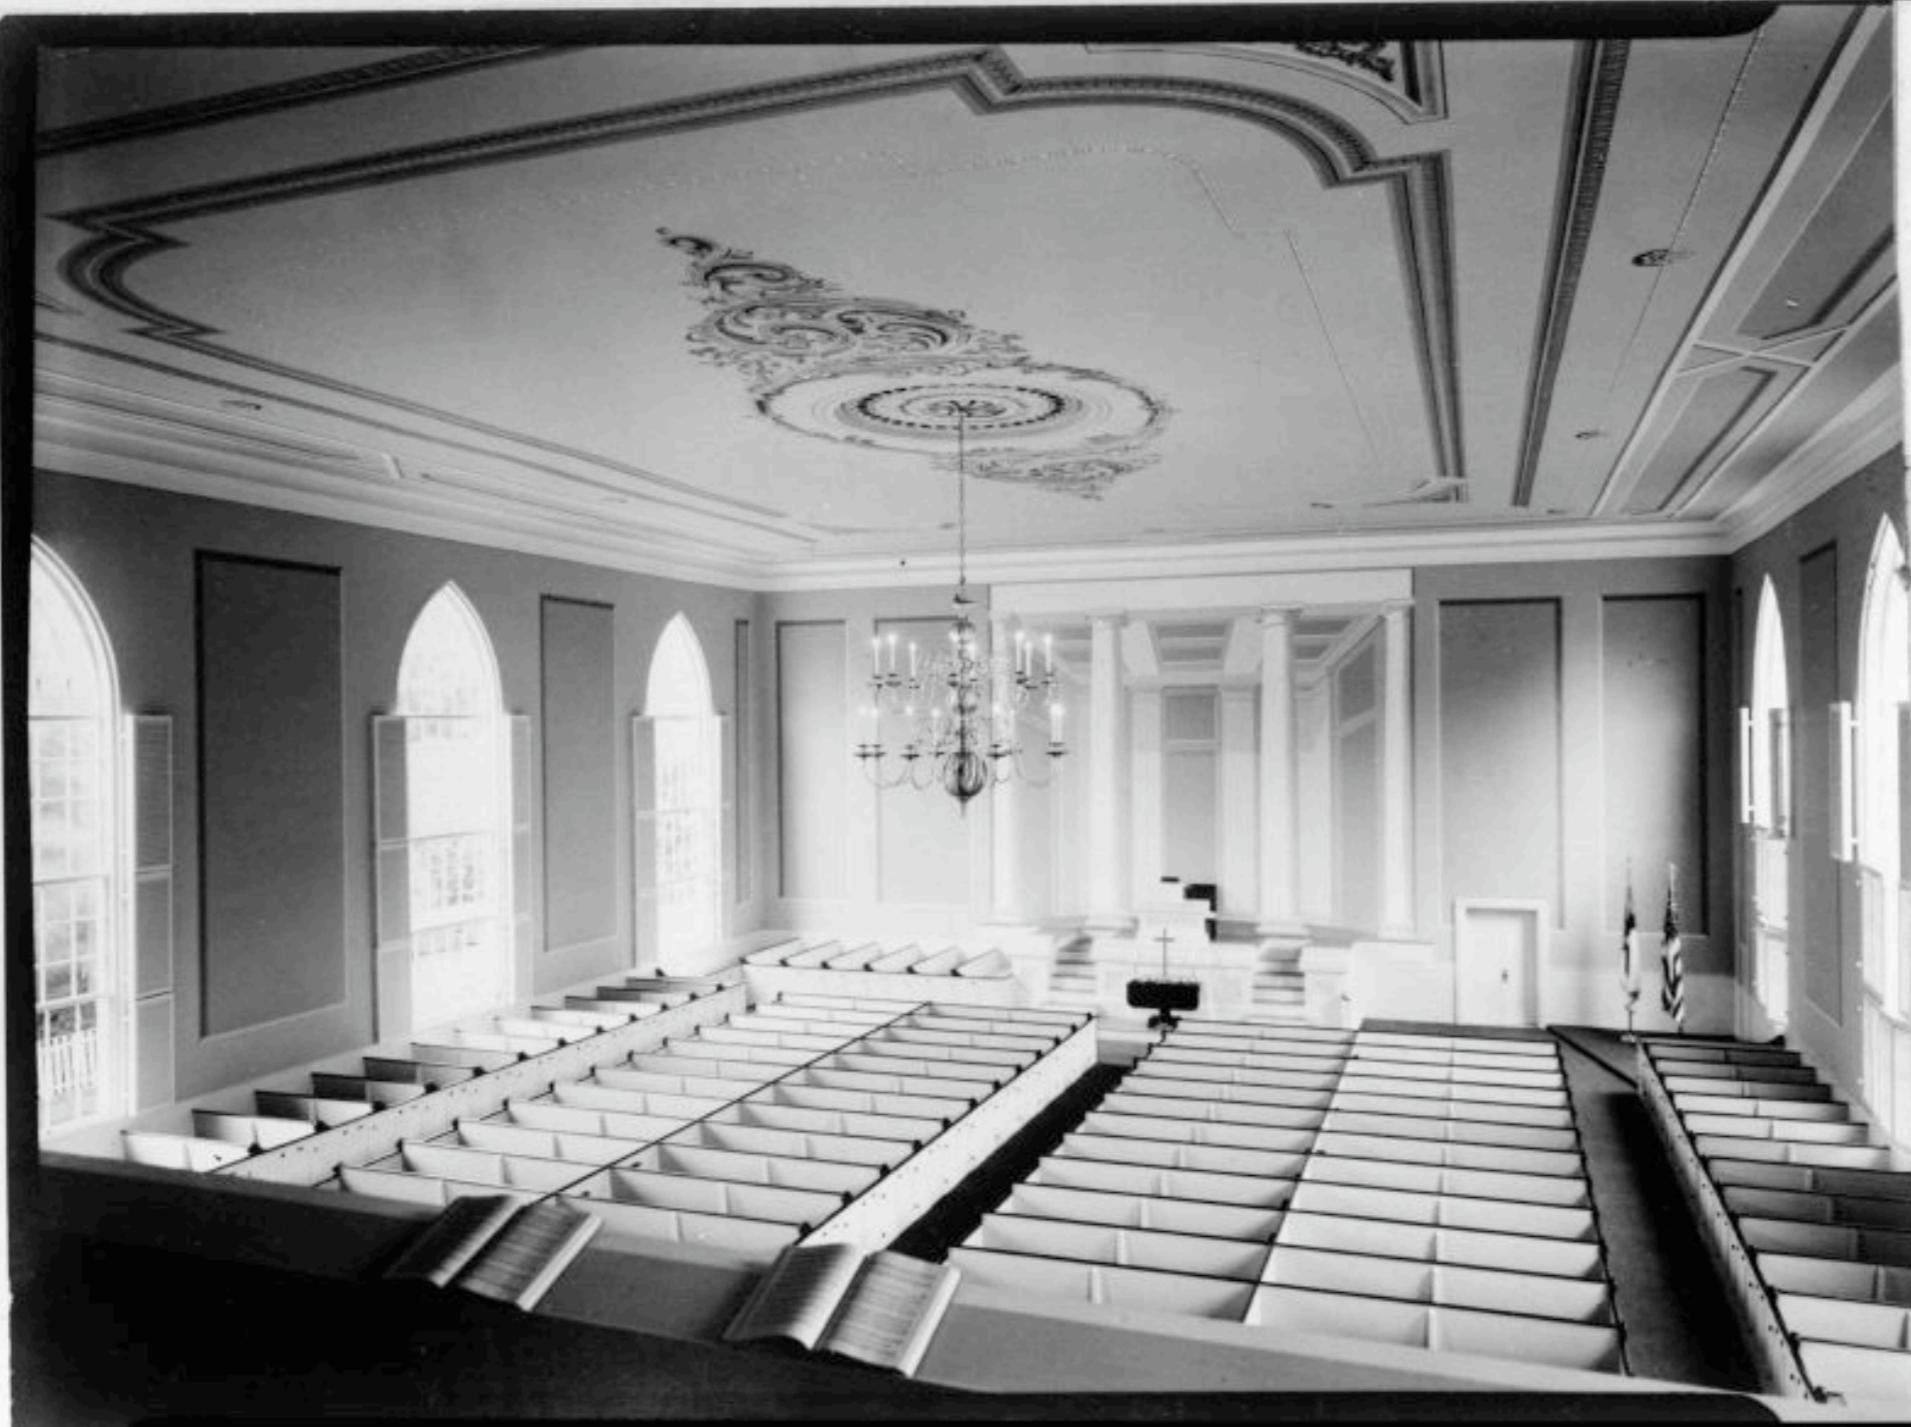
**1970, Sanctuary, looking south west**

**13. Historic American  
Buildings Survey Jack E.  
Boucher, Photographer  
August 1970 INTERIOR,  
TROMPE L'OEIL  
PAINTING  
HABS MASS,10-NANT,26-13**

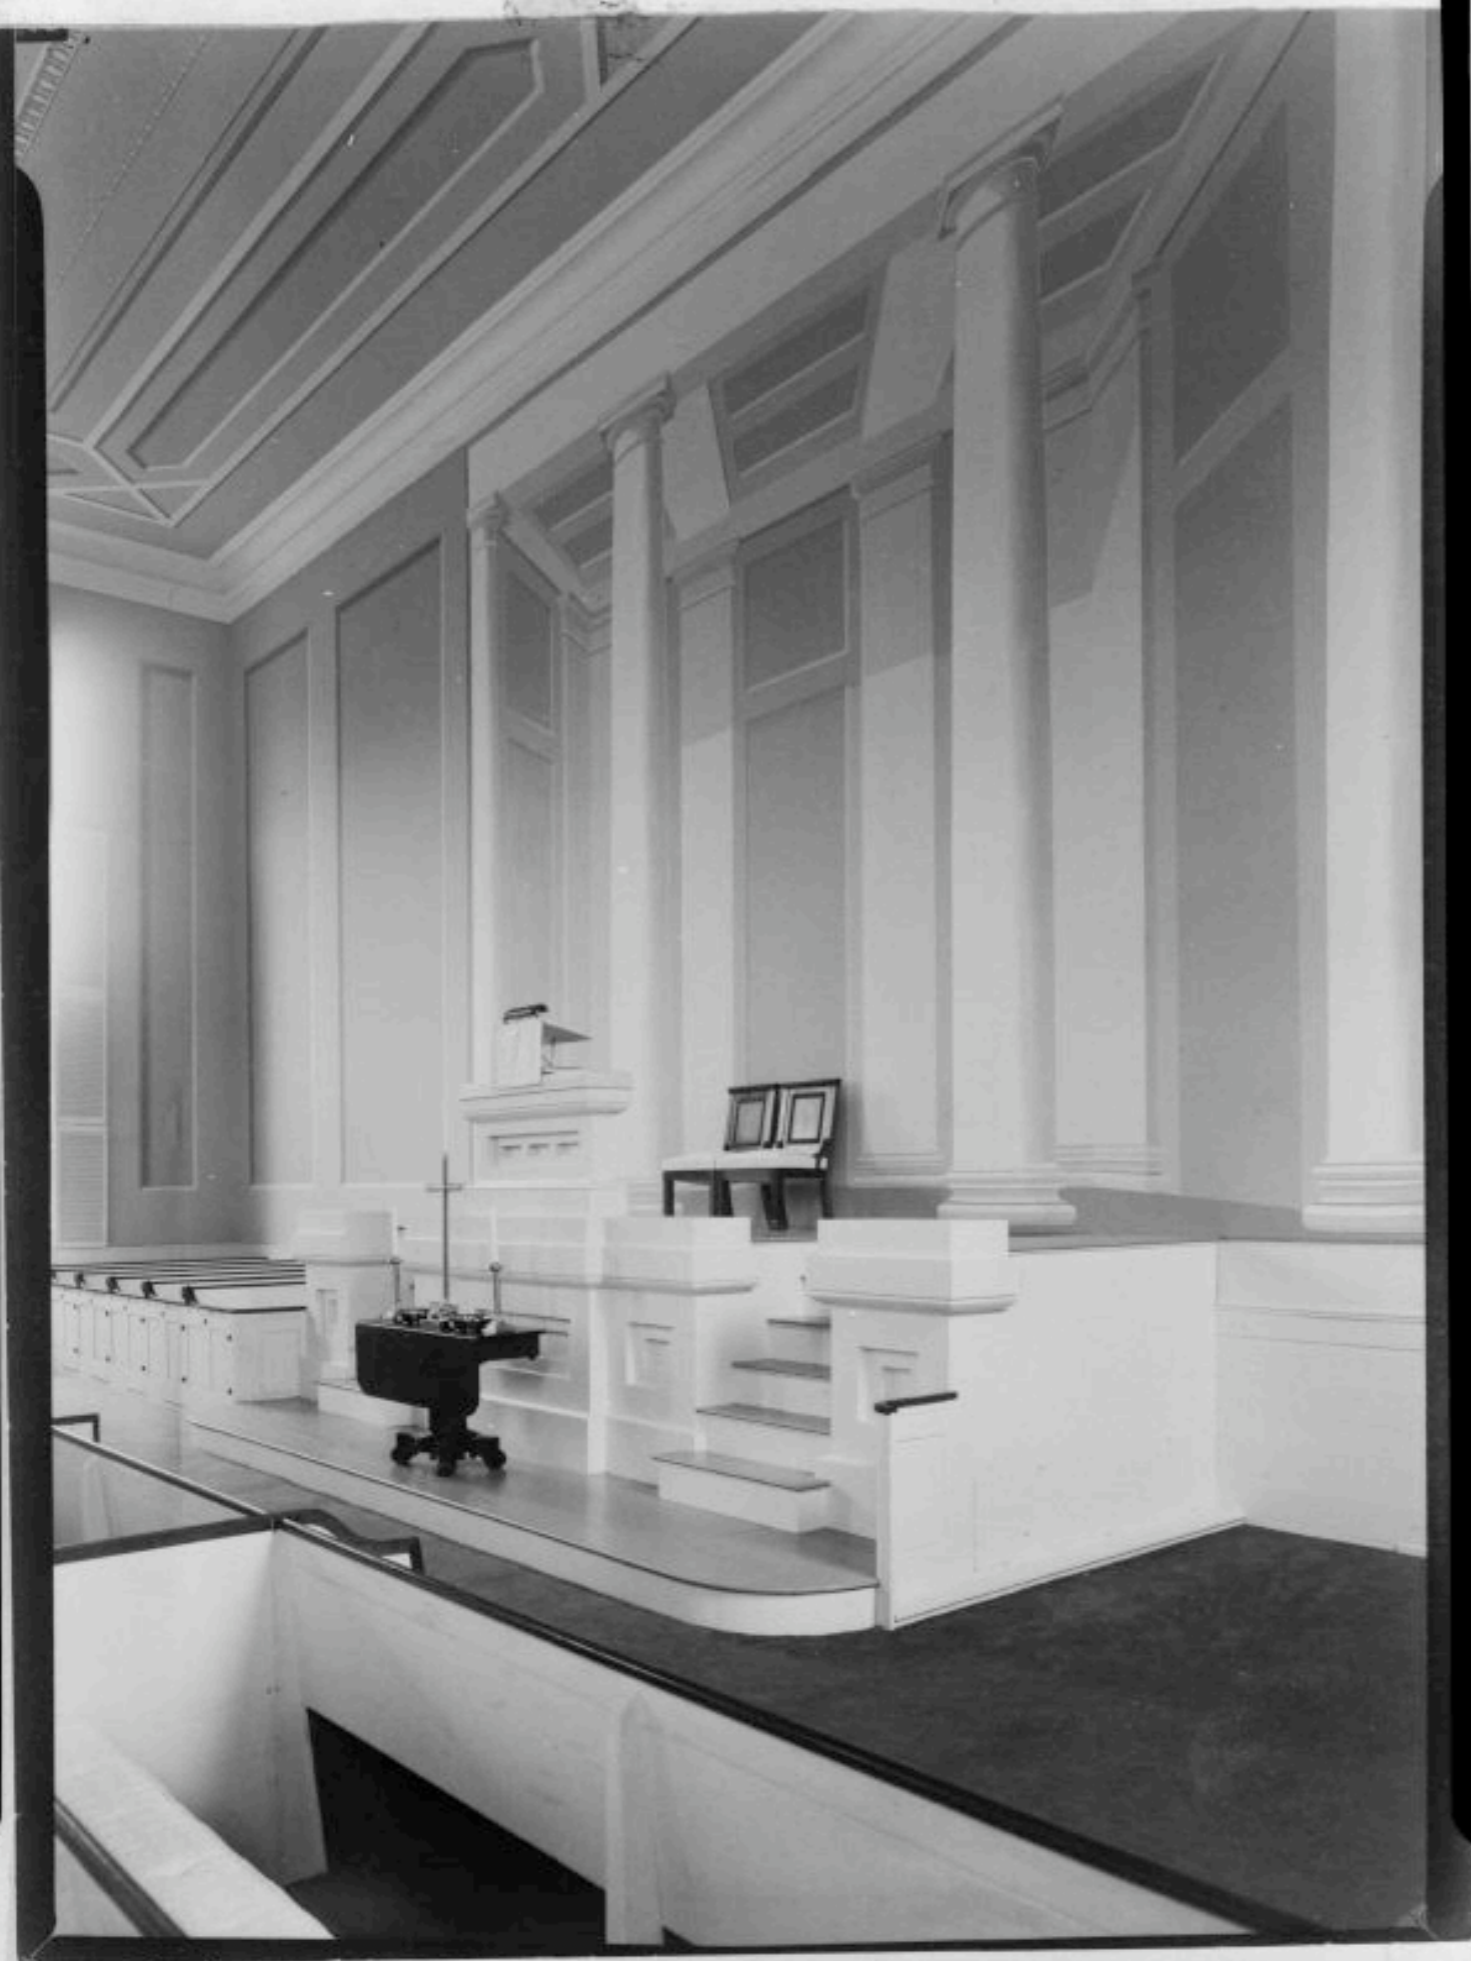
1970, Sanctuary, looking south west

12. Historic American Buildings Survey Jack E. Boucher, Photographer August 1970 INTERIOR, TROMPE L'OEIL PAINTING ON CEILING AND WEST WALL HABS MASS,10-NANT,26-12
