**First Congregational Church  
Nantucket, MA  
Interior Repairs, Restoration and Conservation**

**September 12, 2007 Revised October 29, 2008**

**DMH Enterprises, Architects  
104 Federal Street  
Salem, MA 01970  
617-745-2172**

**The following pages depict existing conditions as of 2007 and 2008 and recommendations for conservation/restoration.**

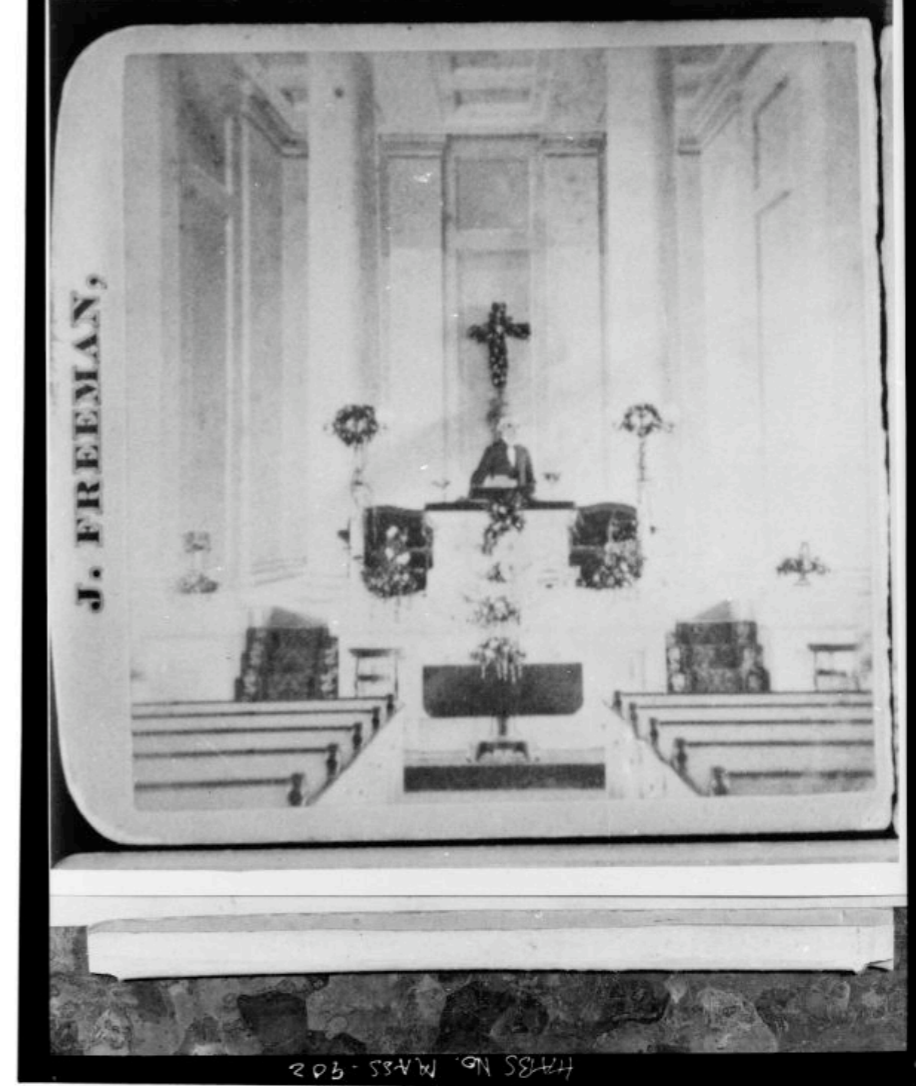
16. Historic American Buildings Survey COPY OF STEREOPTICON BY J. FREEMAN, C. 1885, OF WEST WALL WITH ORIGINAL TROMPE L'OEIL PAINTING HABS MASS,10-NANT,26-16

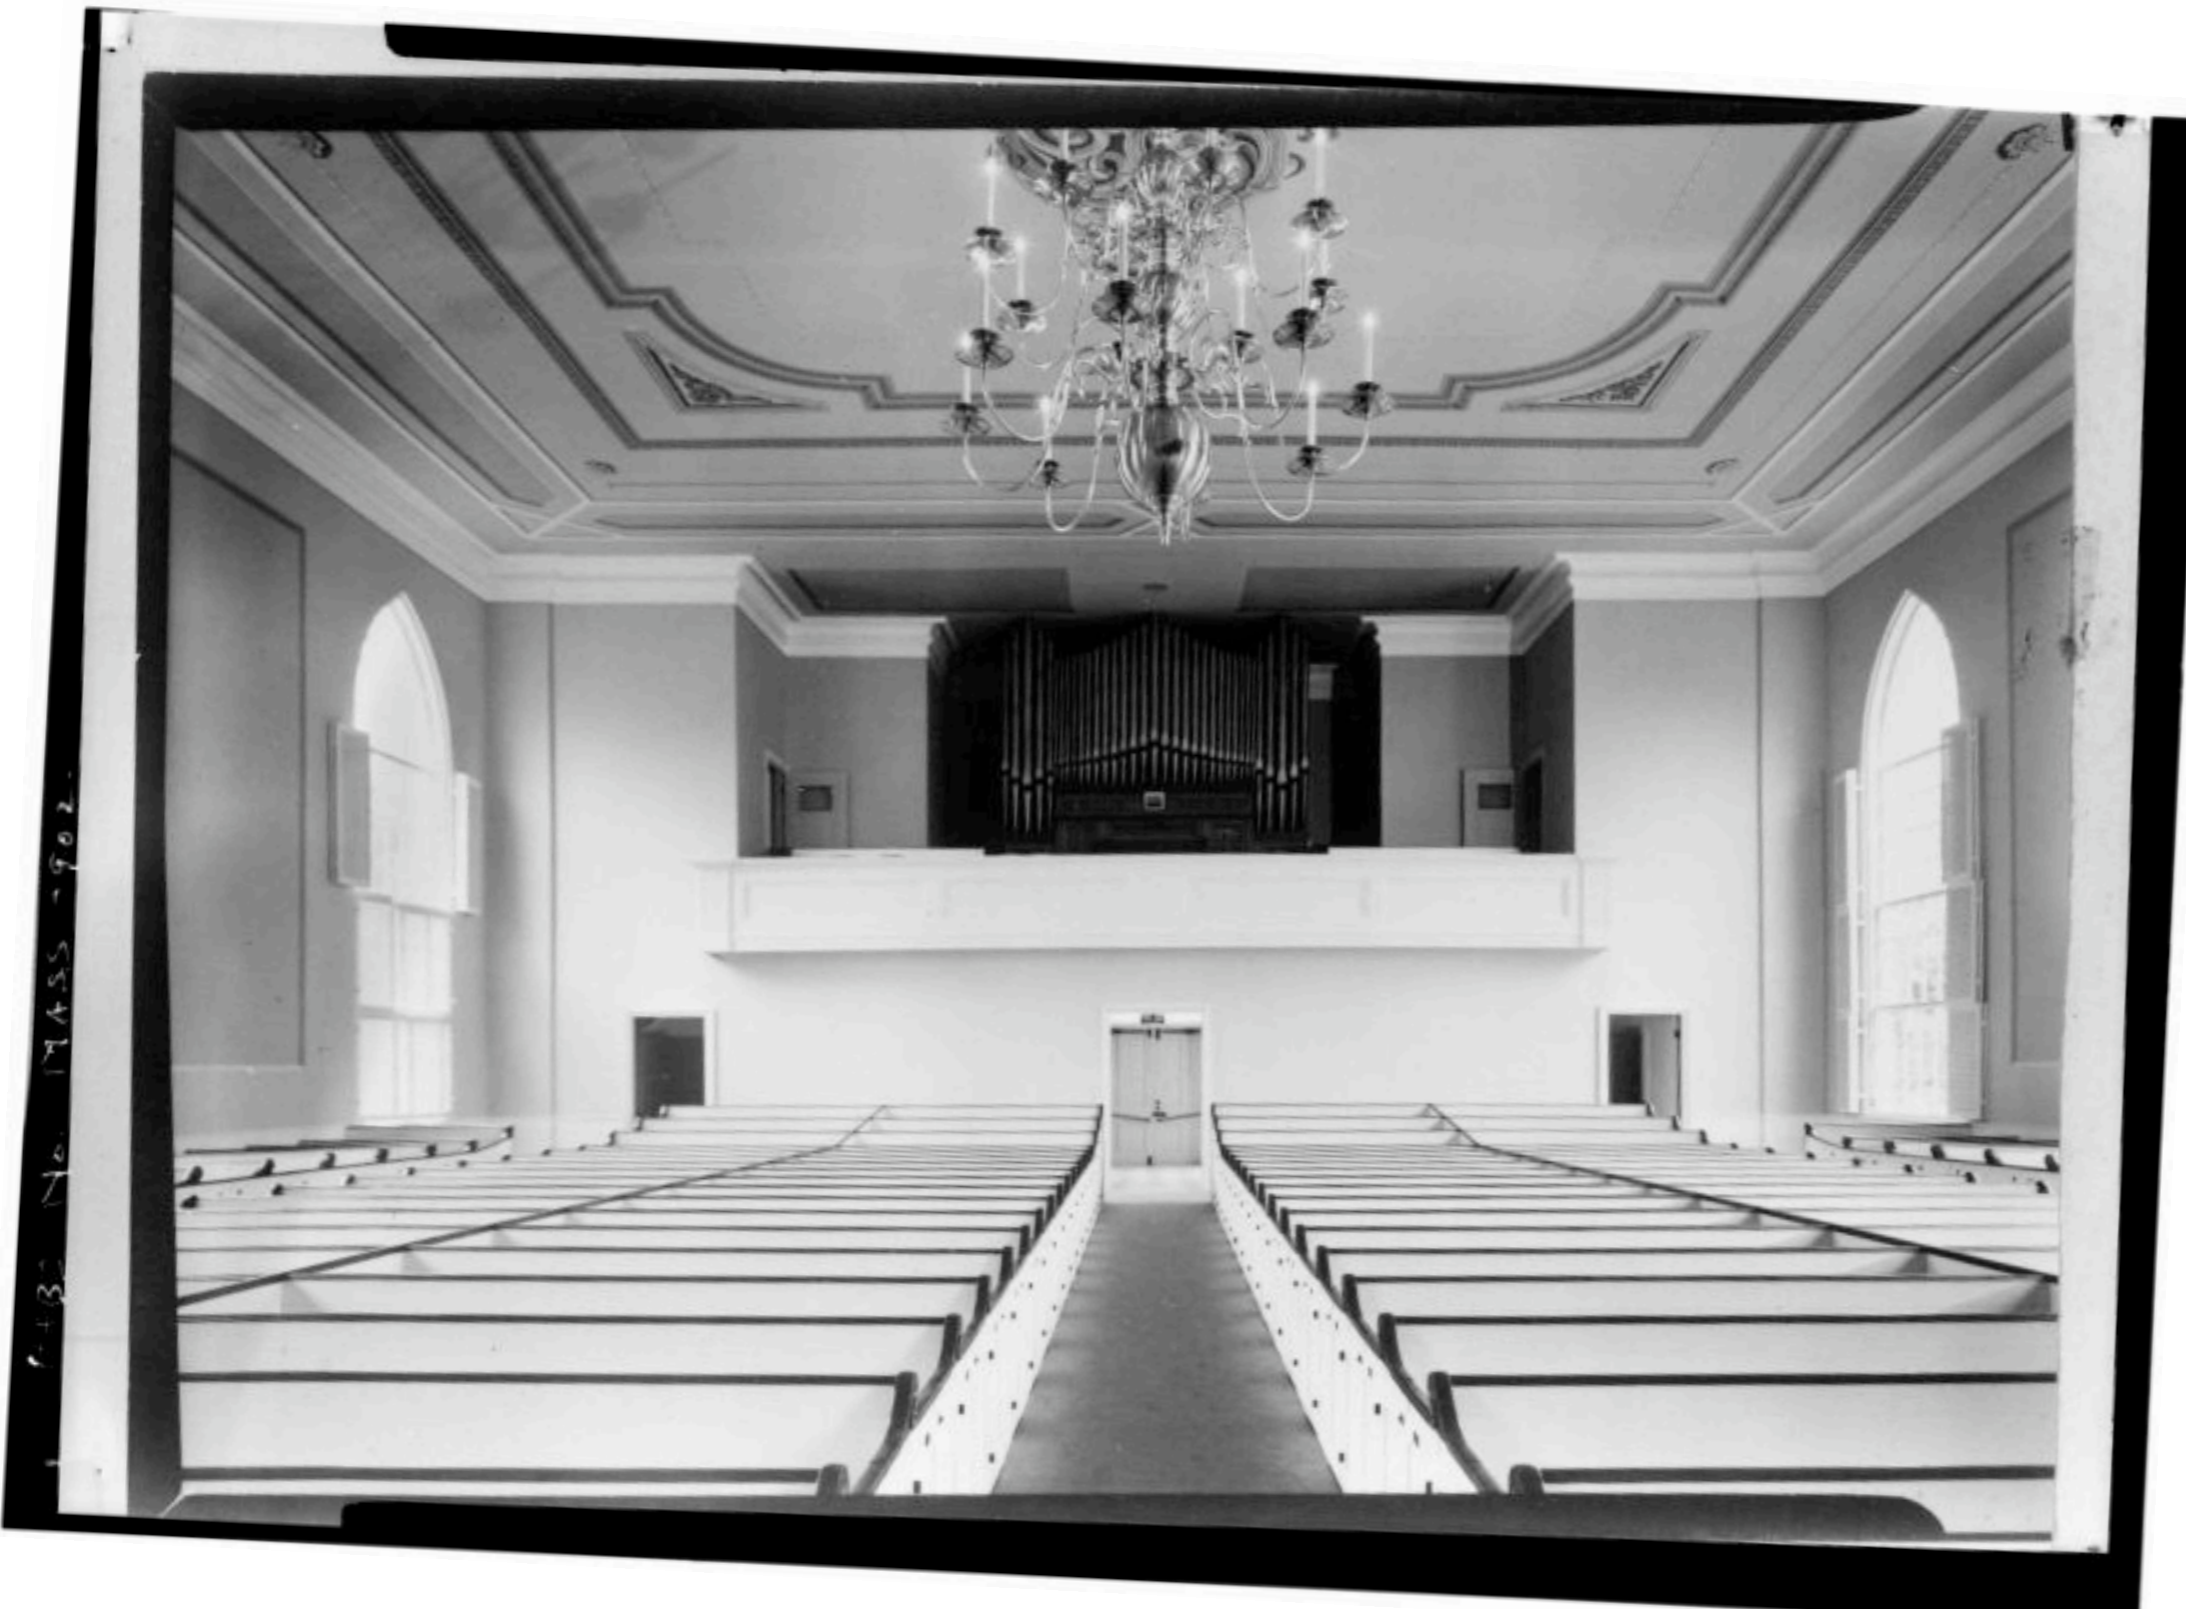
**1970, Sanctuary, looking east**

**11. Historic American  
Buildings Survey Jack E.  
Boucher, Photographer  
August 1970 INTERIOR,  
EAST END, AFTER  
RESTORATION  
HABS MASS,10-NANT,26-11**

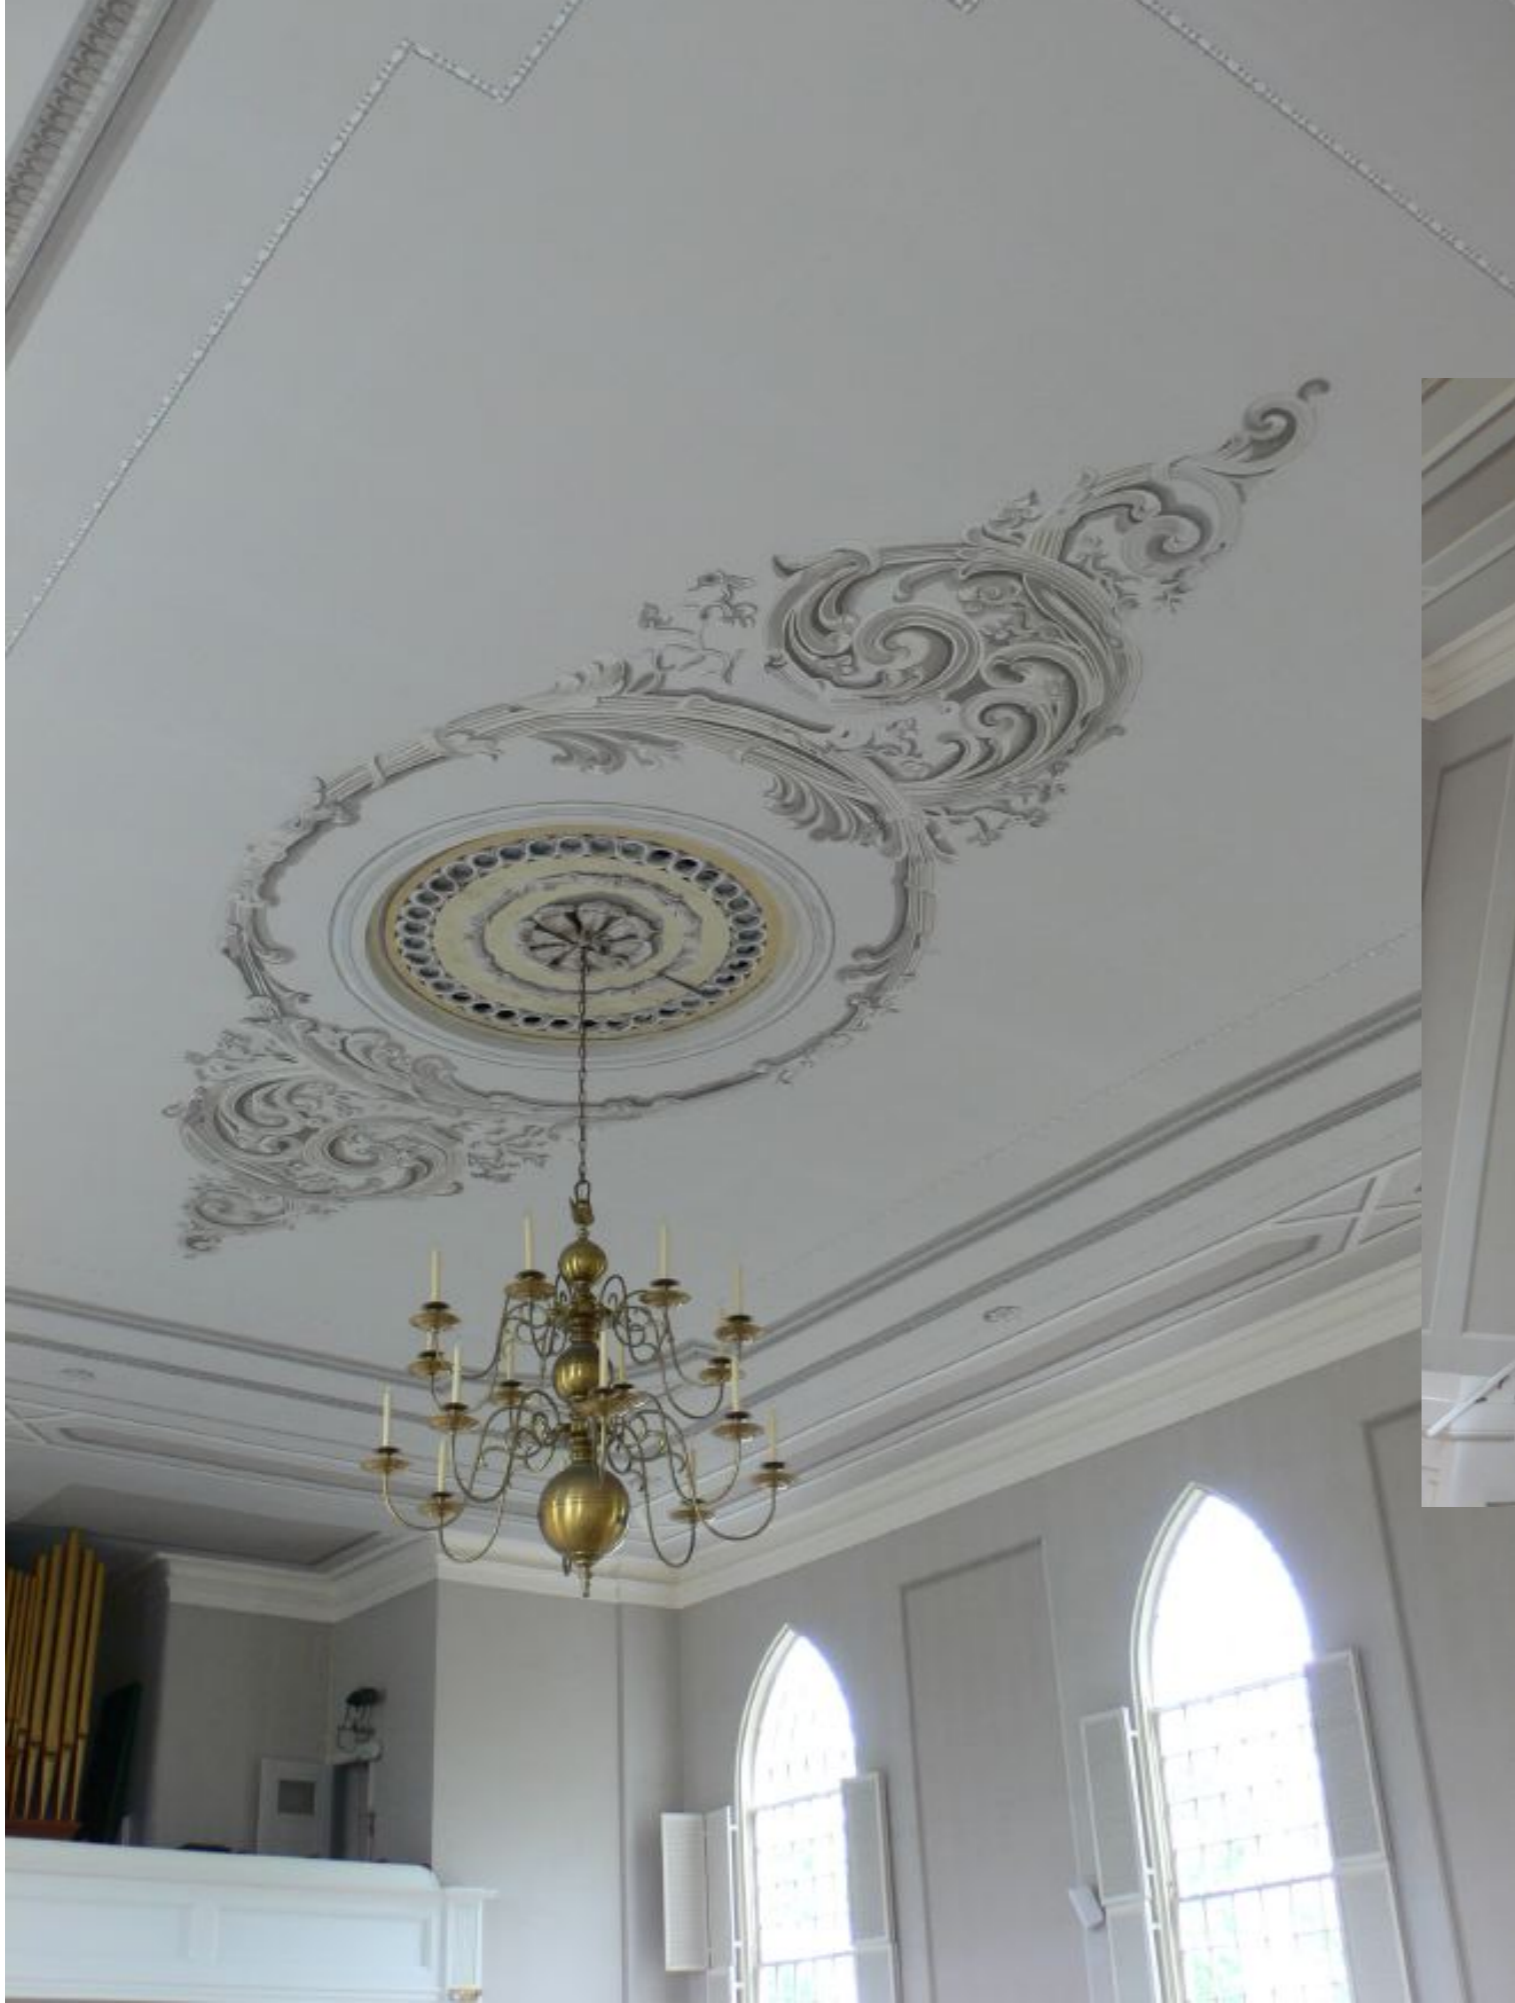
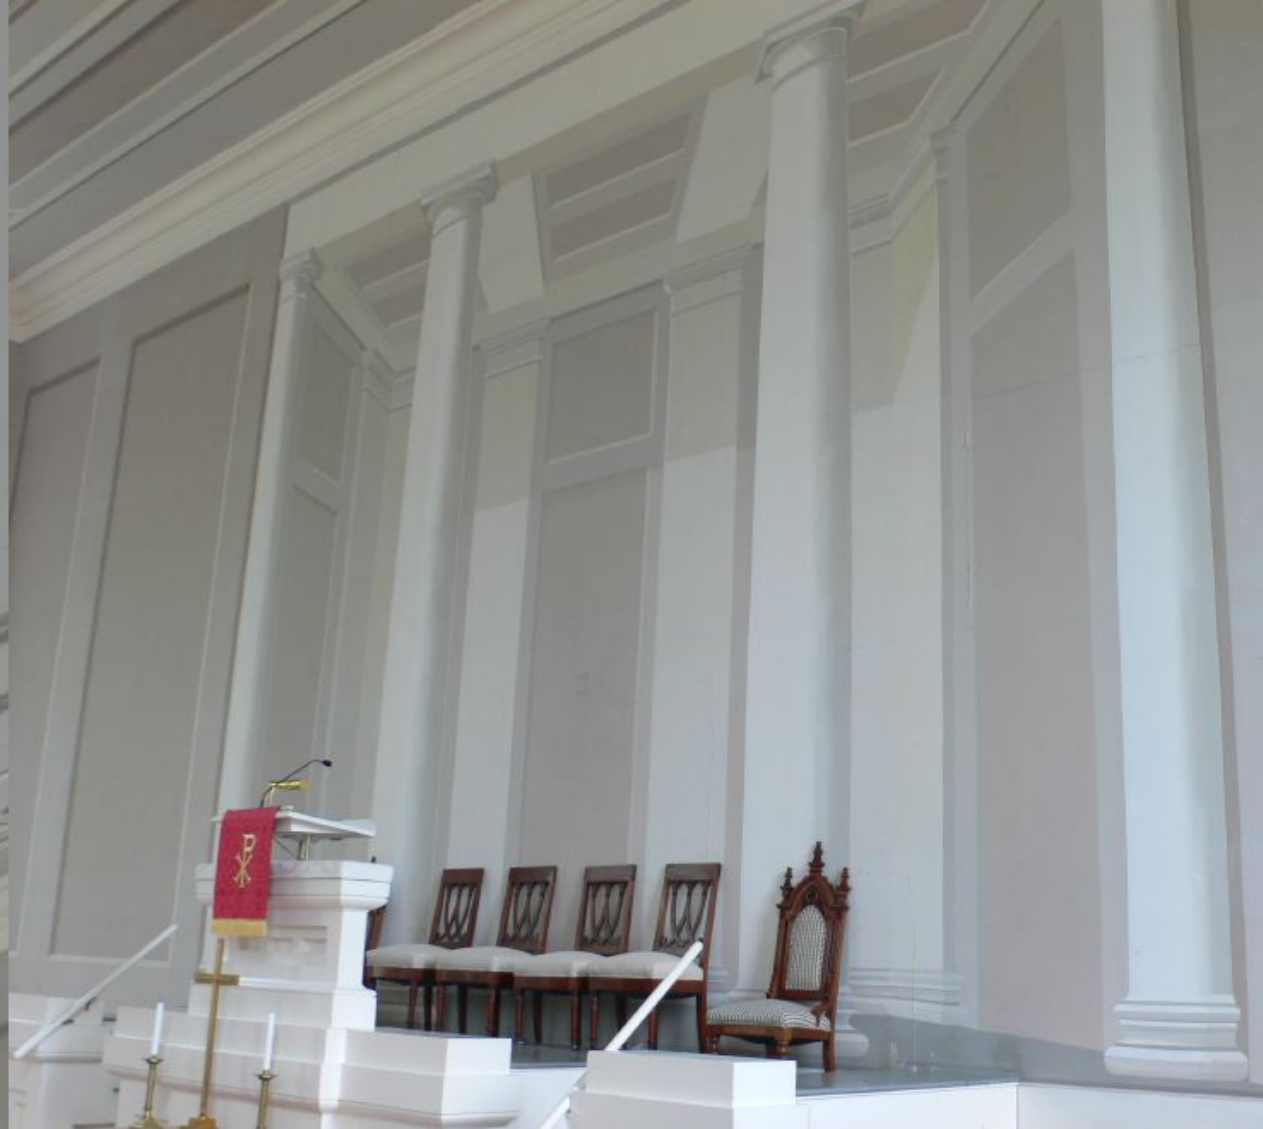
L1030675

**The central portion of the decoration may be rather early, as it appears to have been painted directly on wooden ceiling boards**

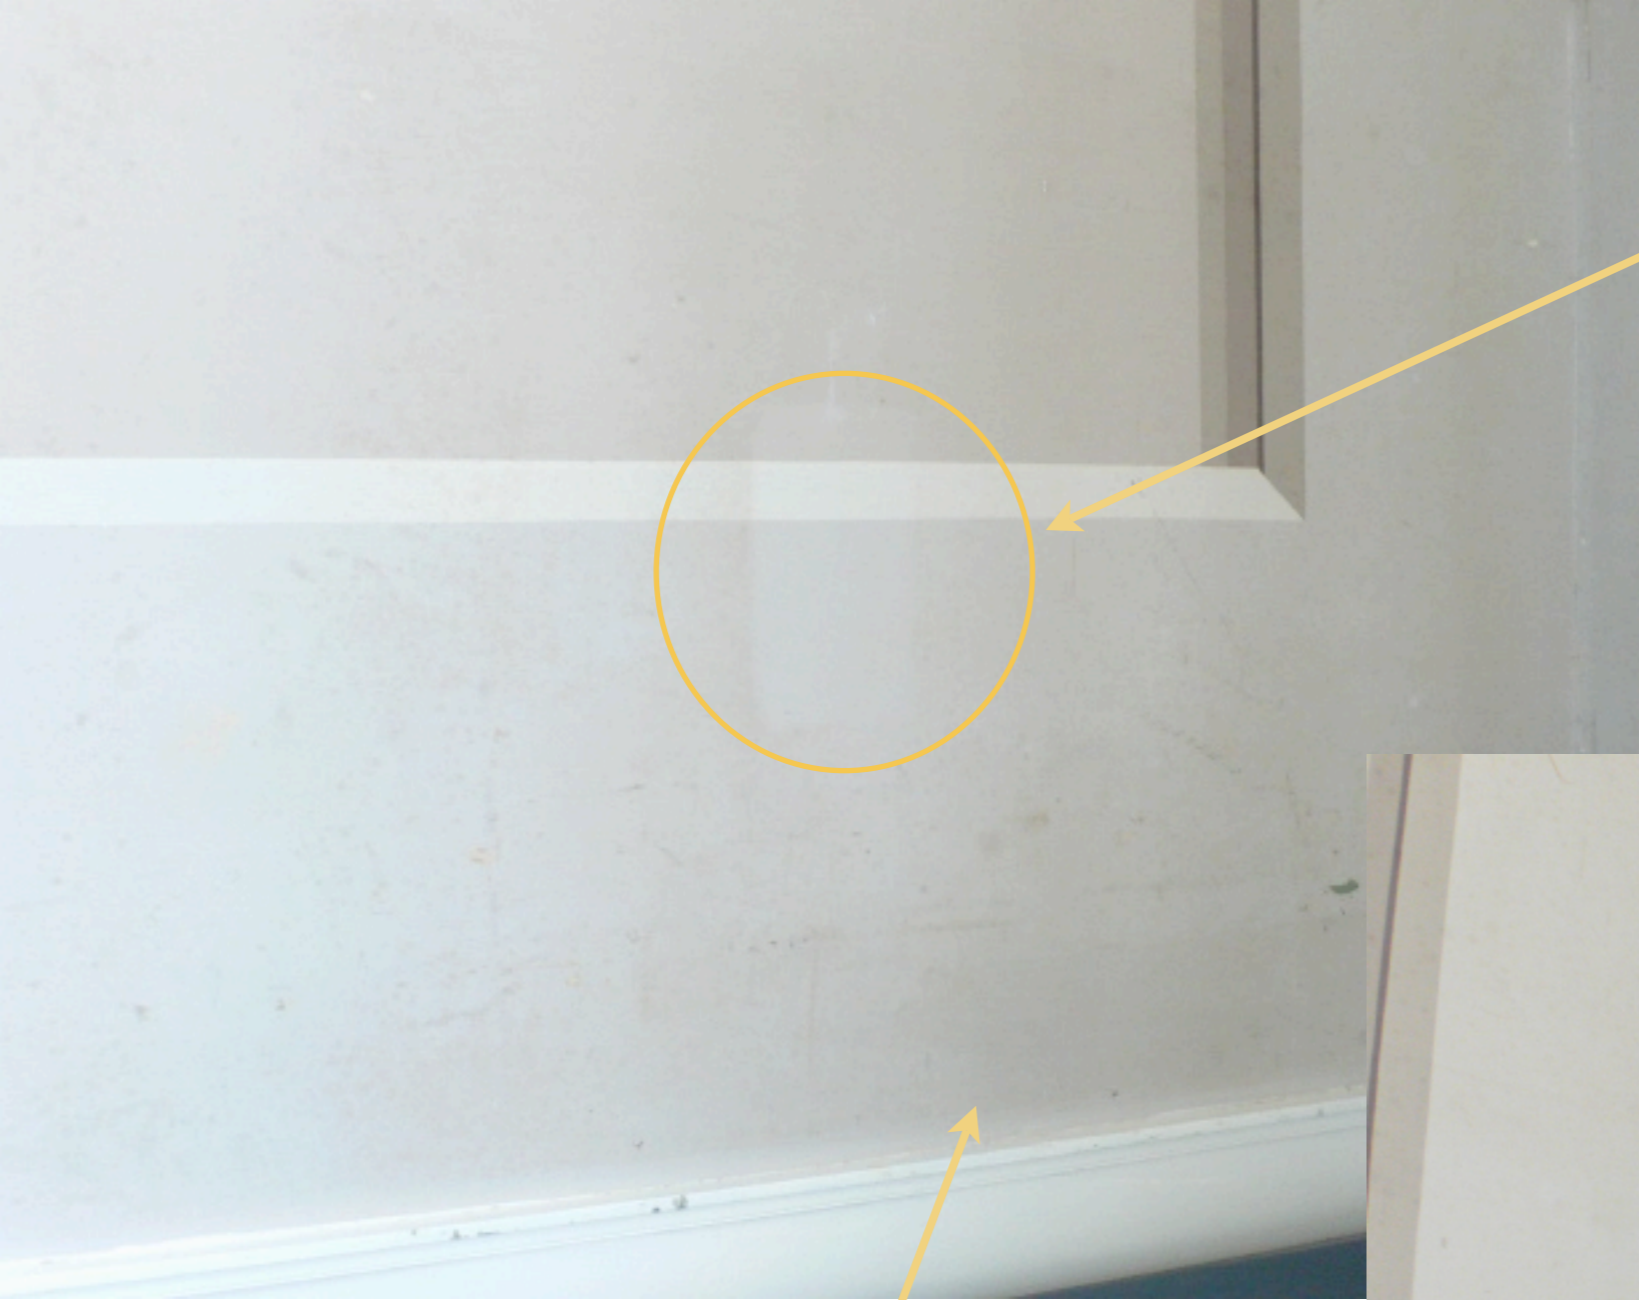
Morz091107.003

**Cleaning test 6/24/2008  
on trompe l'oeil**

**Typical wallboard tape  
failure**

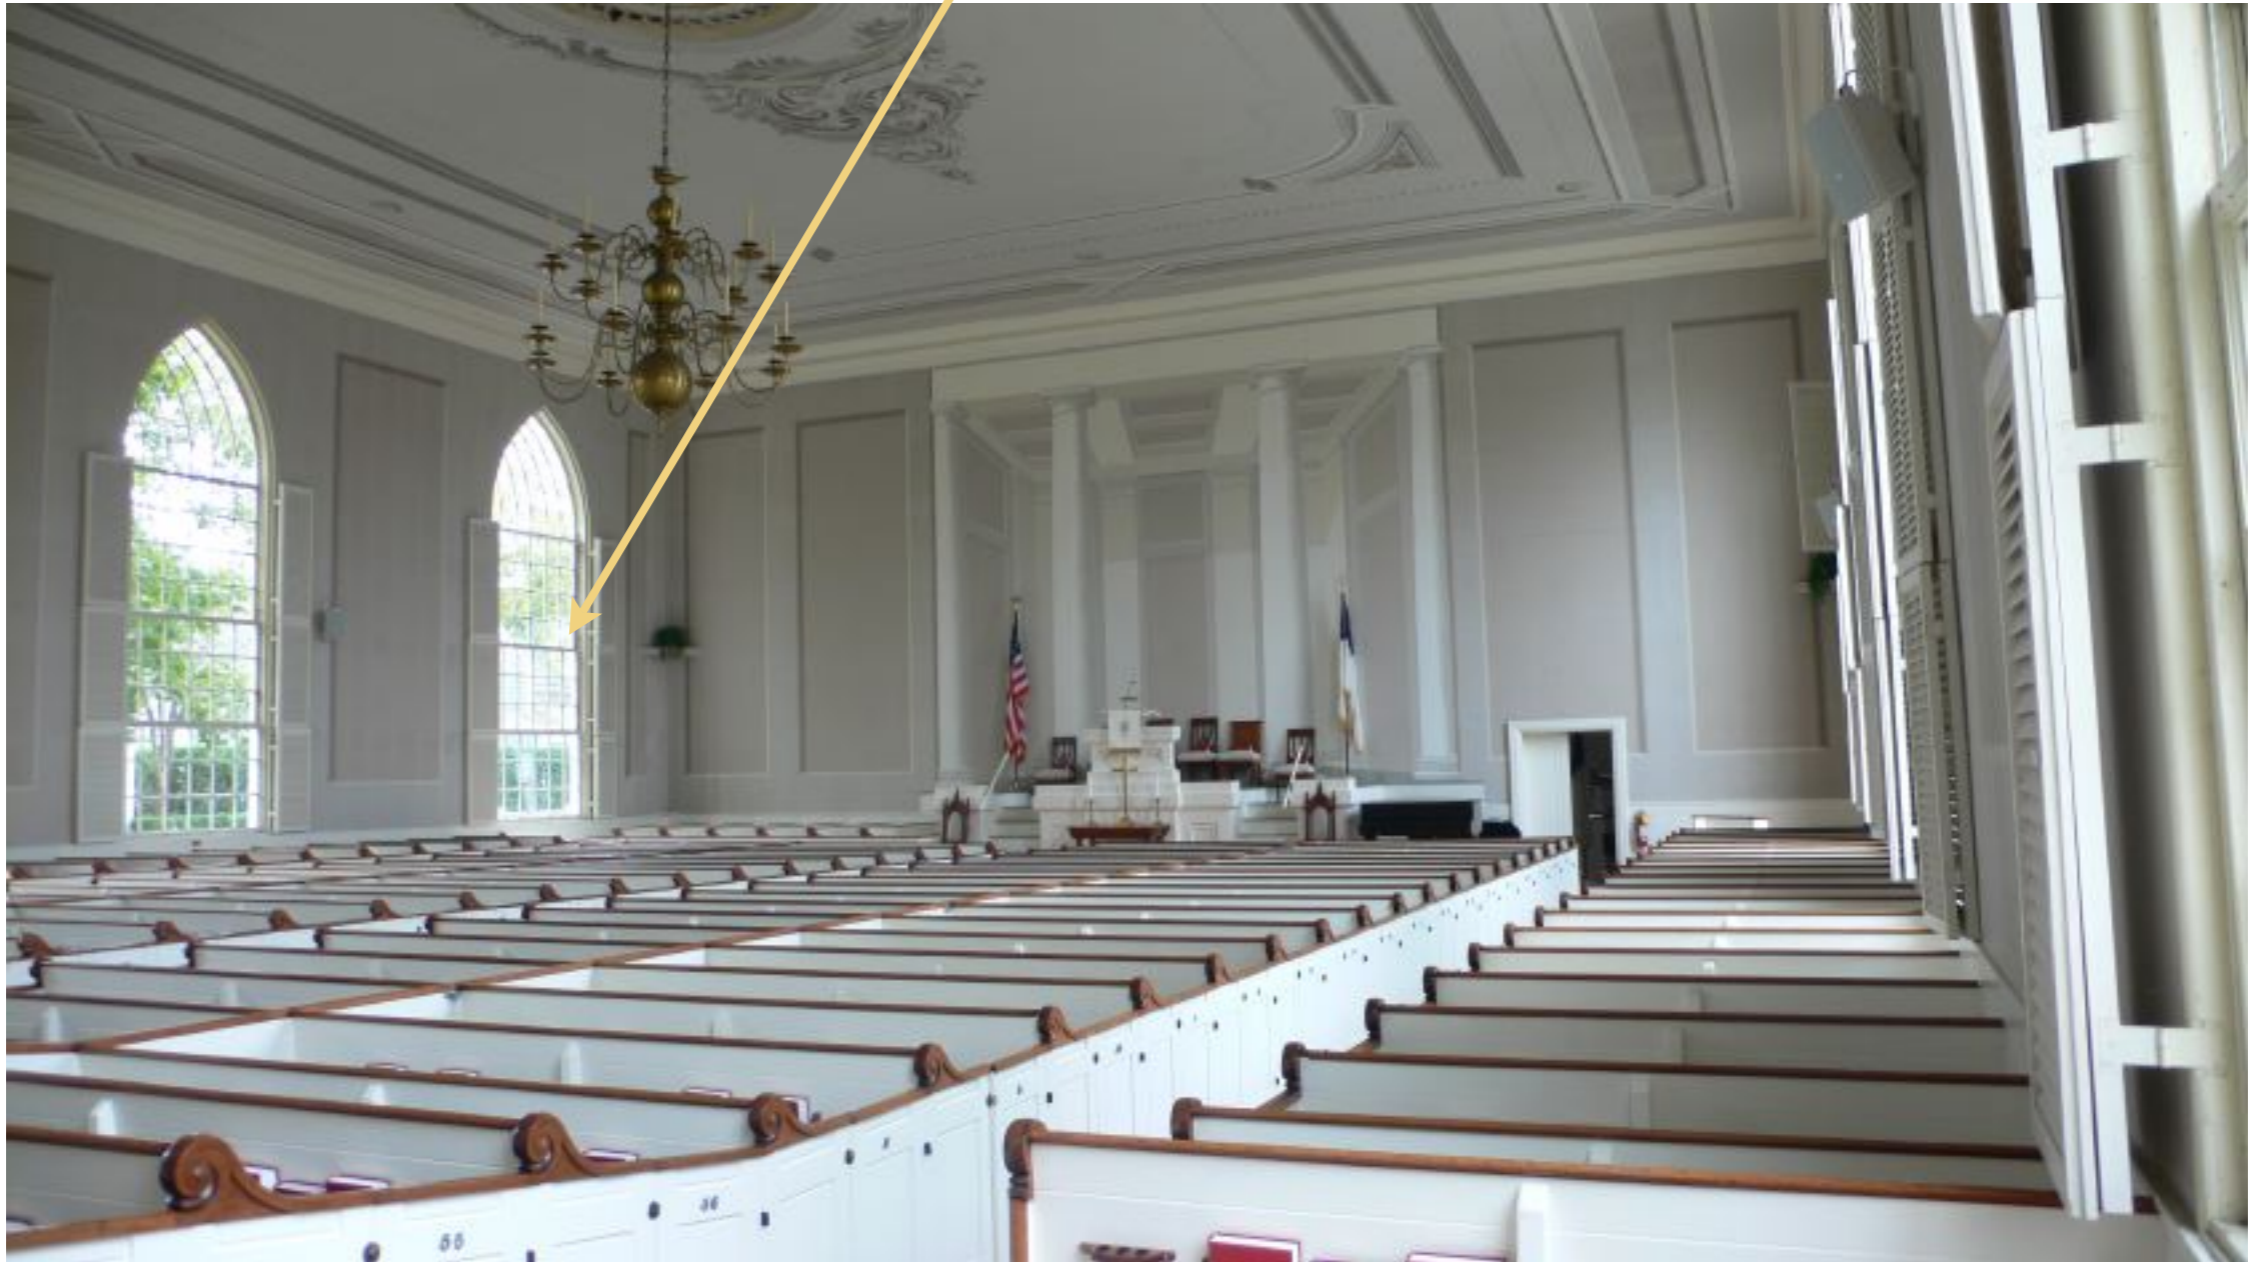
L1030184

**Interior of windows to be repaired and repainted**

**Sanctuary, looking west**

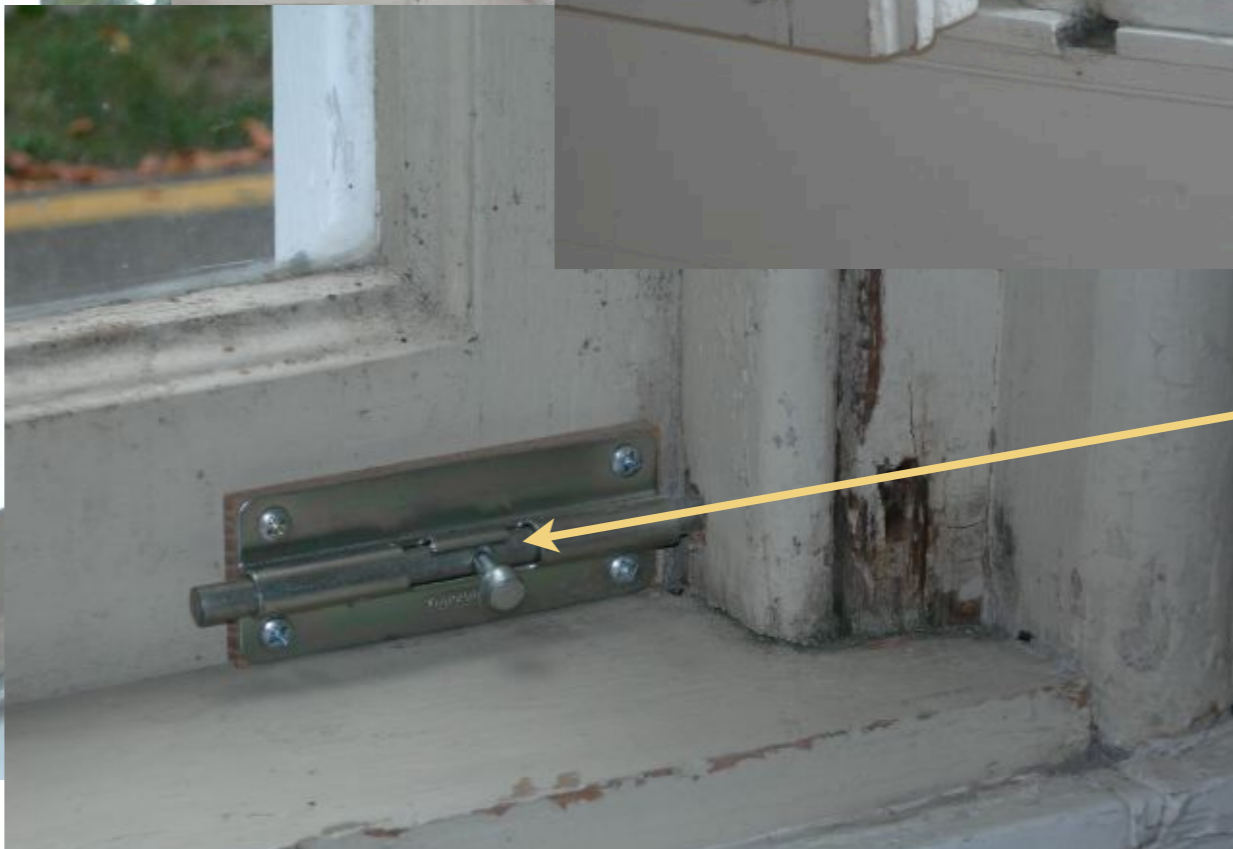
DSCN0570

**Detail of window sash and frame deterioration at interior of sanctuary to be repaired and repainted. Sash to be repaired, reglazed, lower sash re-roped.**

**Hardware to be installed that will automatically lock when sash is closed**

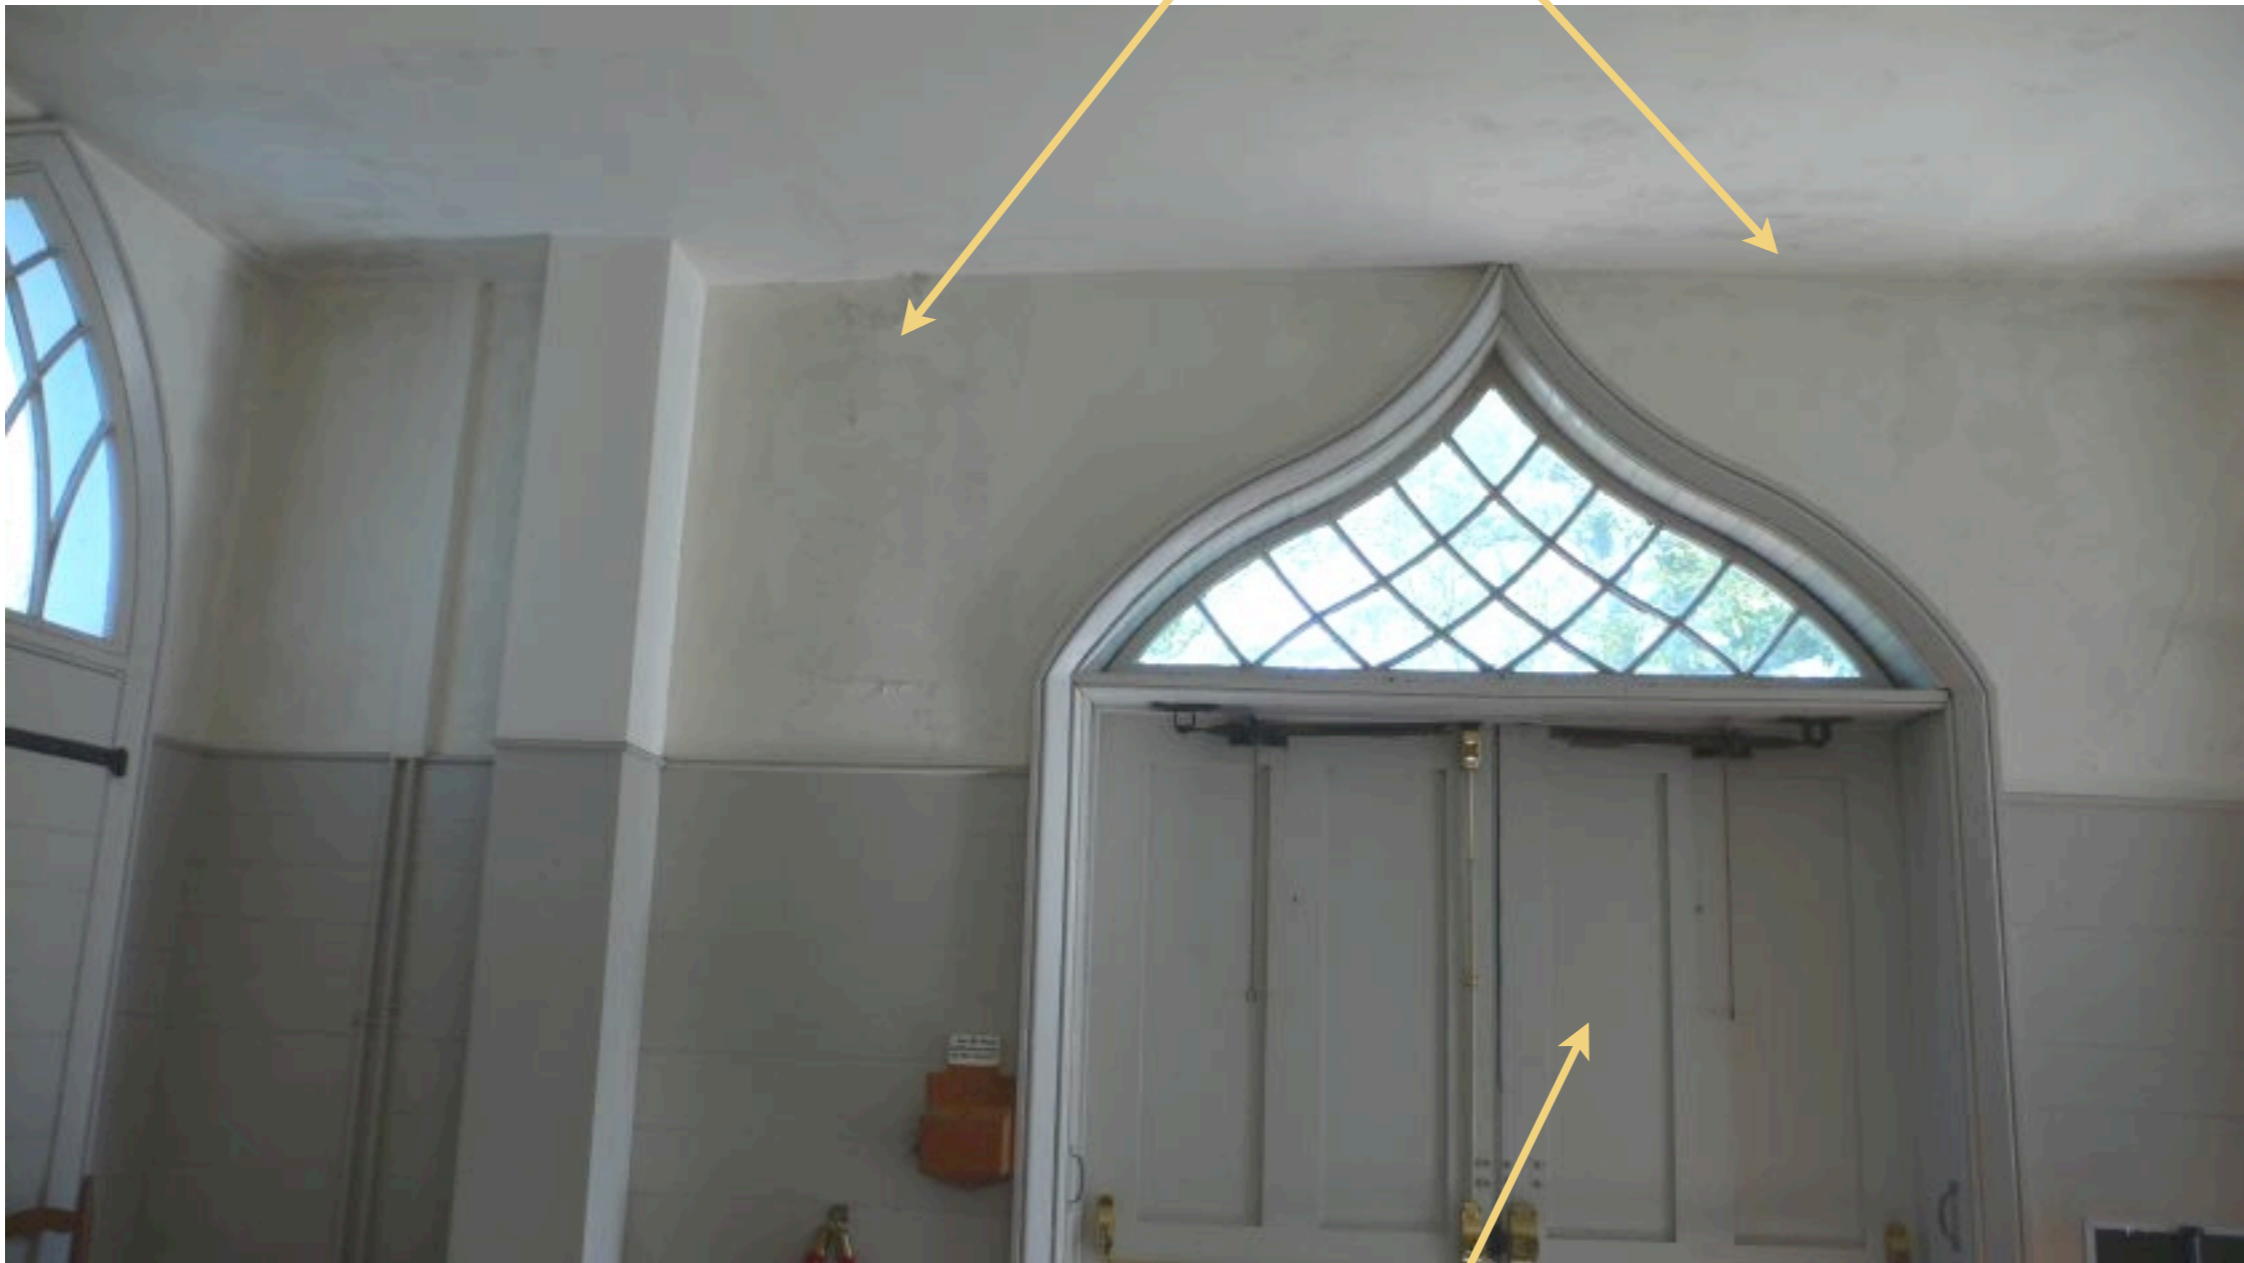
L1030211

**Narthex plaster wall and ceilings to be repaired and repainted**

**Narthex, looking east**

**Appropriate panic hardware installed on RH door**

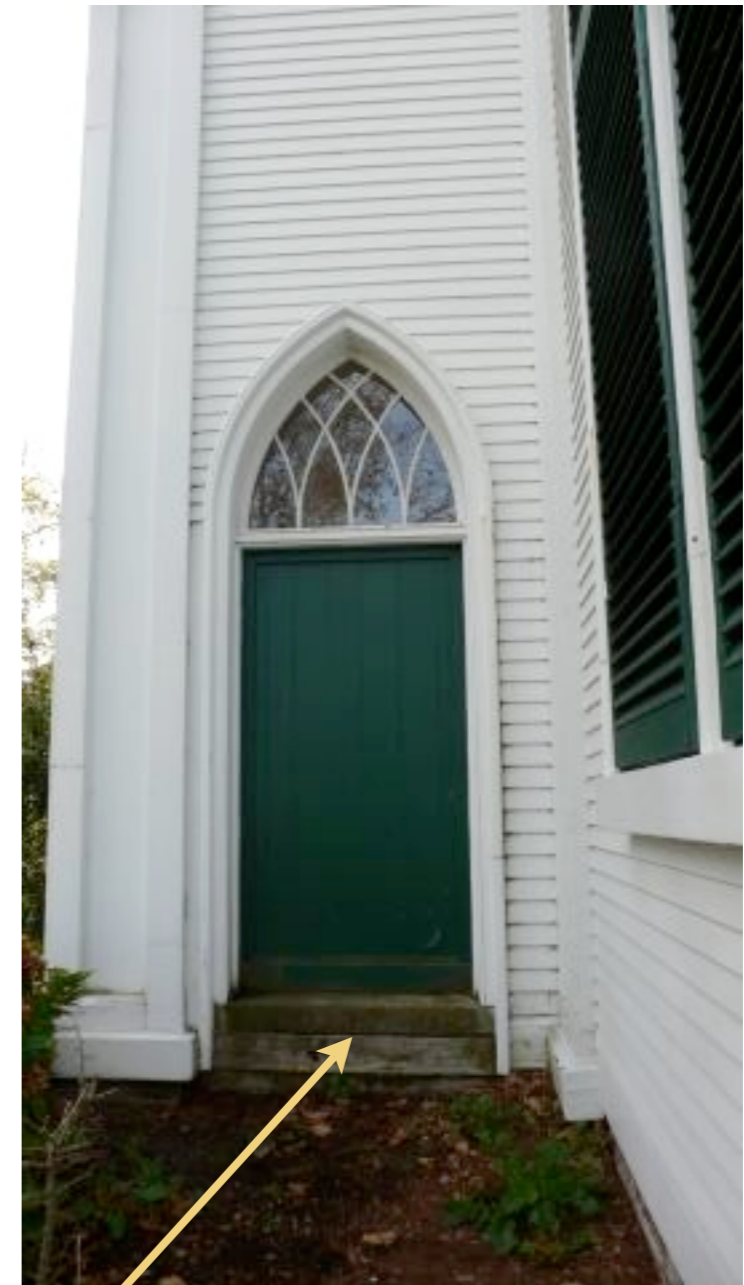
L1030220

**Exterior, south and north facades**

**Two exterior side doors to be repaired and panic hardware installed**

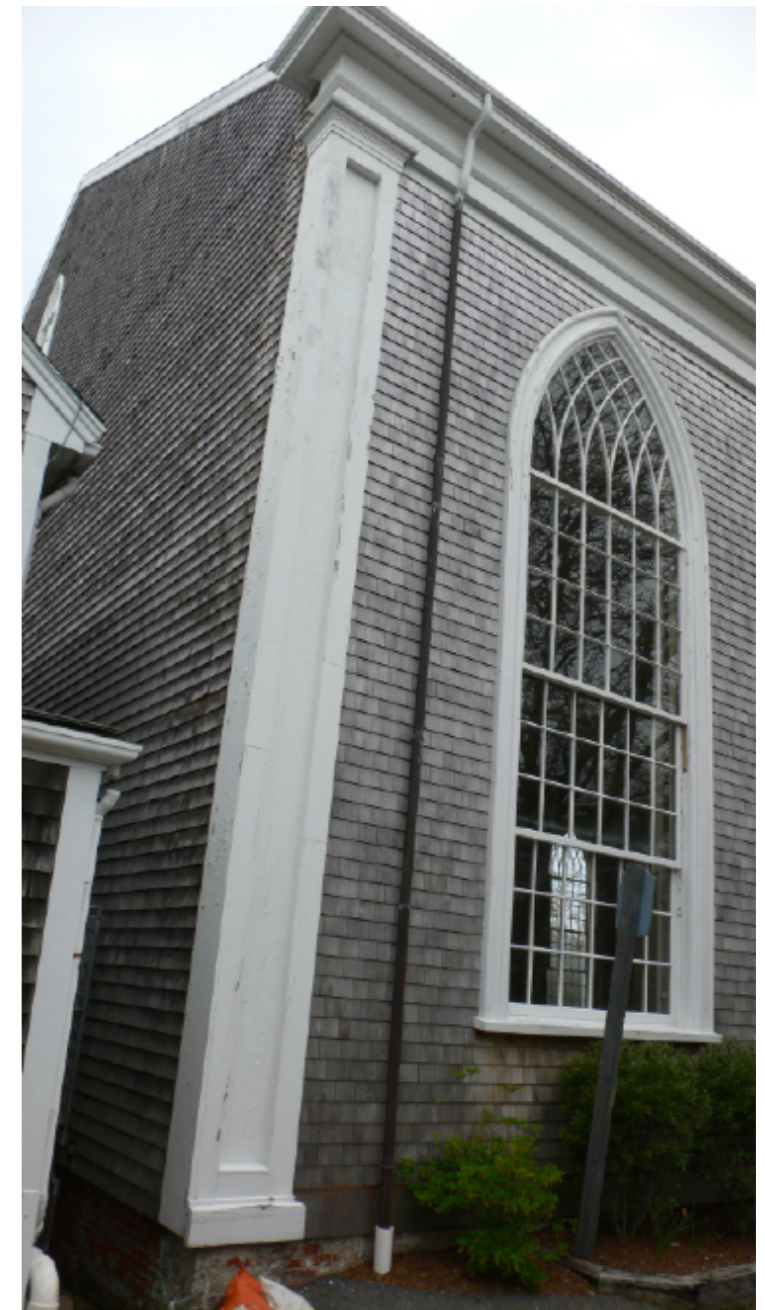
**South facade. Replace wooden trim and repaint**
