**First Congregational Church
Nantucket, MA
Exterior Tower Repairs, Restoration and Conservation**

Study photos

August 22, 2007

**DMH Enterprises, Architects
104 Federal Street
Salem, MA 01970
617-745-2172**

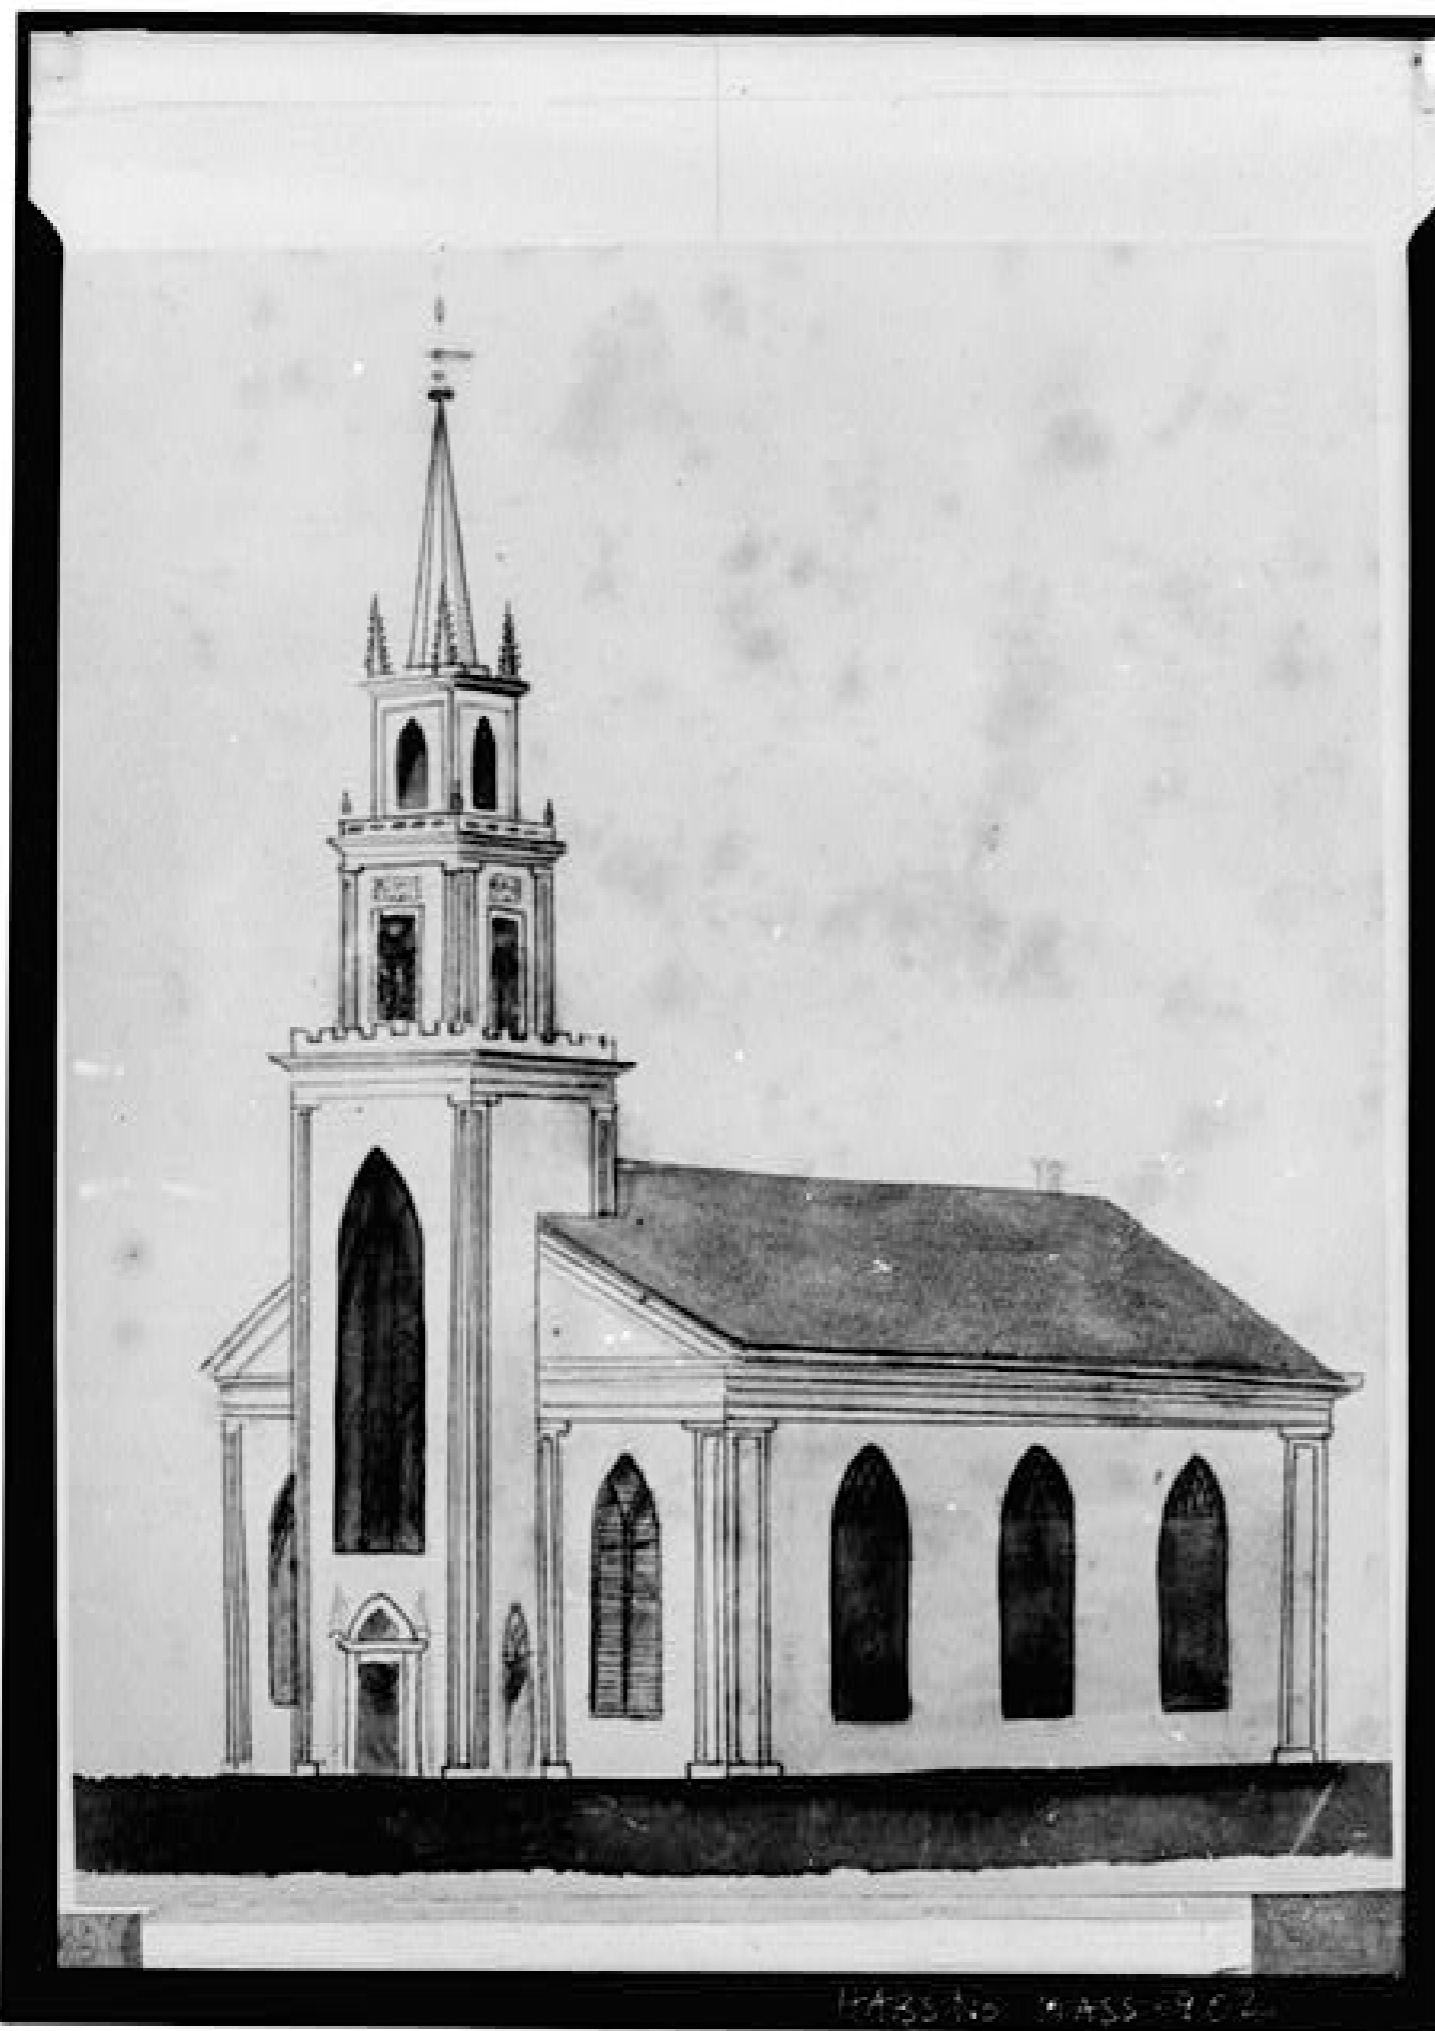
Library of Congress, HABS, unknown artist, unsigned, collection of FCC. The date of this drawing is unknown. Could be contemporary with the first rendition, or it could be 20th century, in which case it is probably conjectural.

Church reportedly erected in 1834 and lengthened and a fourth window added in 1841-1842

If this is the church, then the following observations apply:

The entire design is pretty close to the existing conditions of most photographs (without the second stage and spire and the crenellations).

Note the finials at the second and third stages.

Crenellations at first and second stages

The second stage and the spire appear to have been restored fairly accurately by Ames & Graves in 1968.

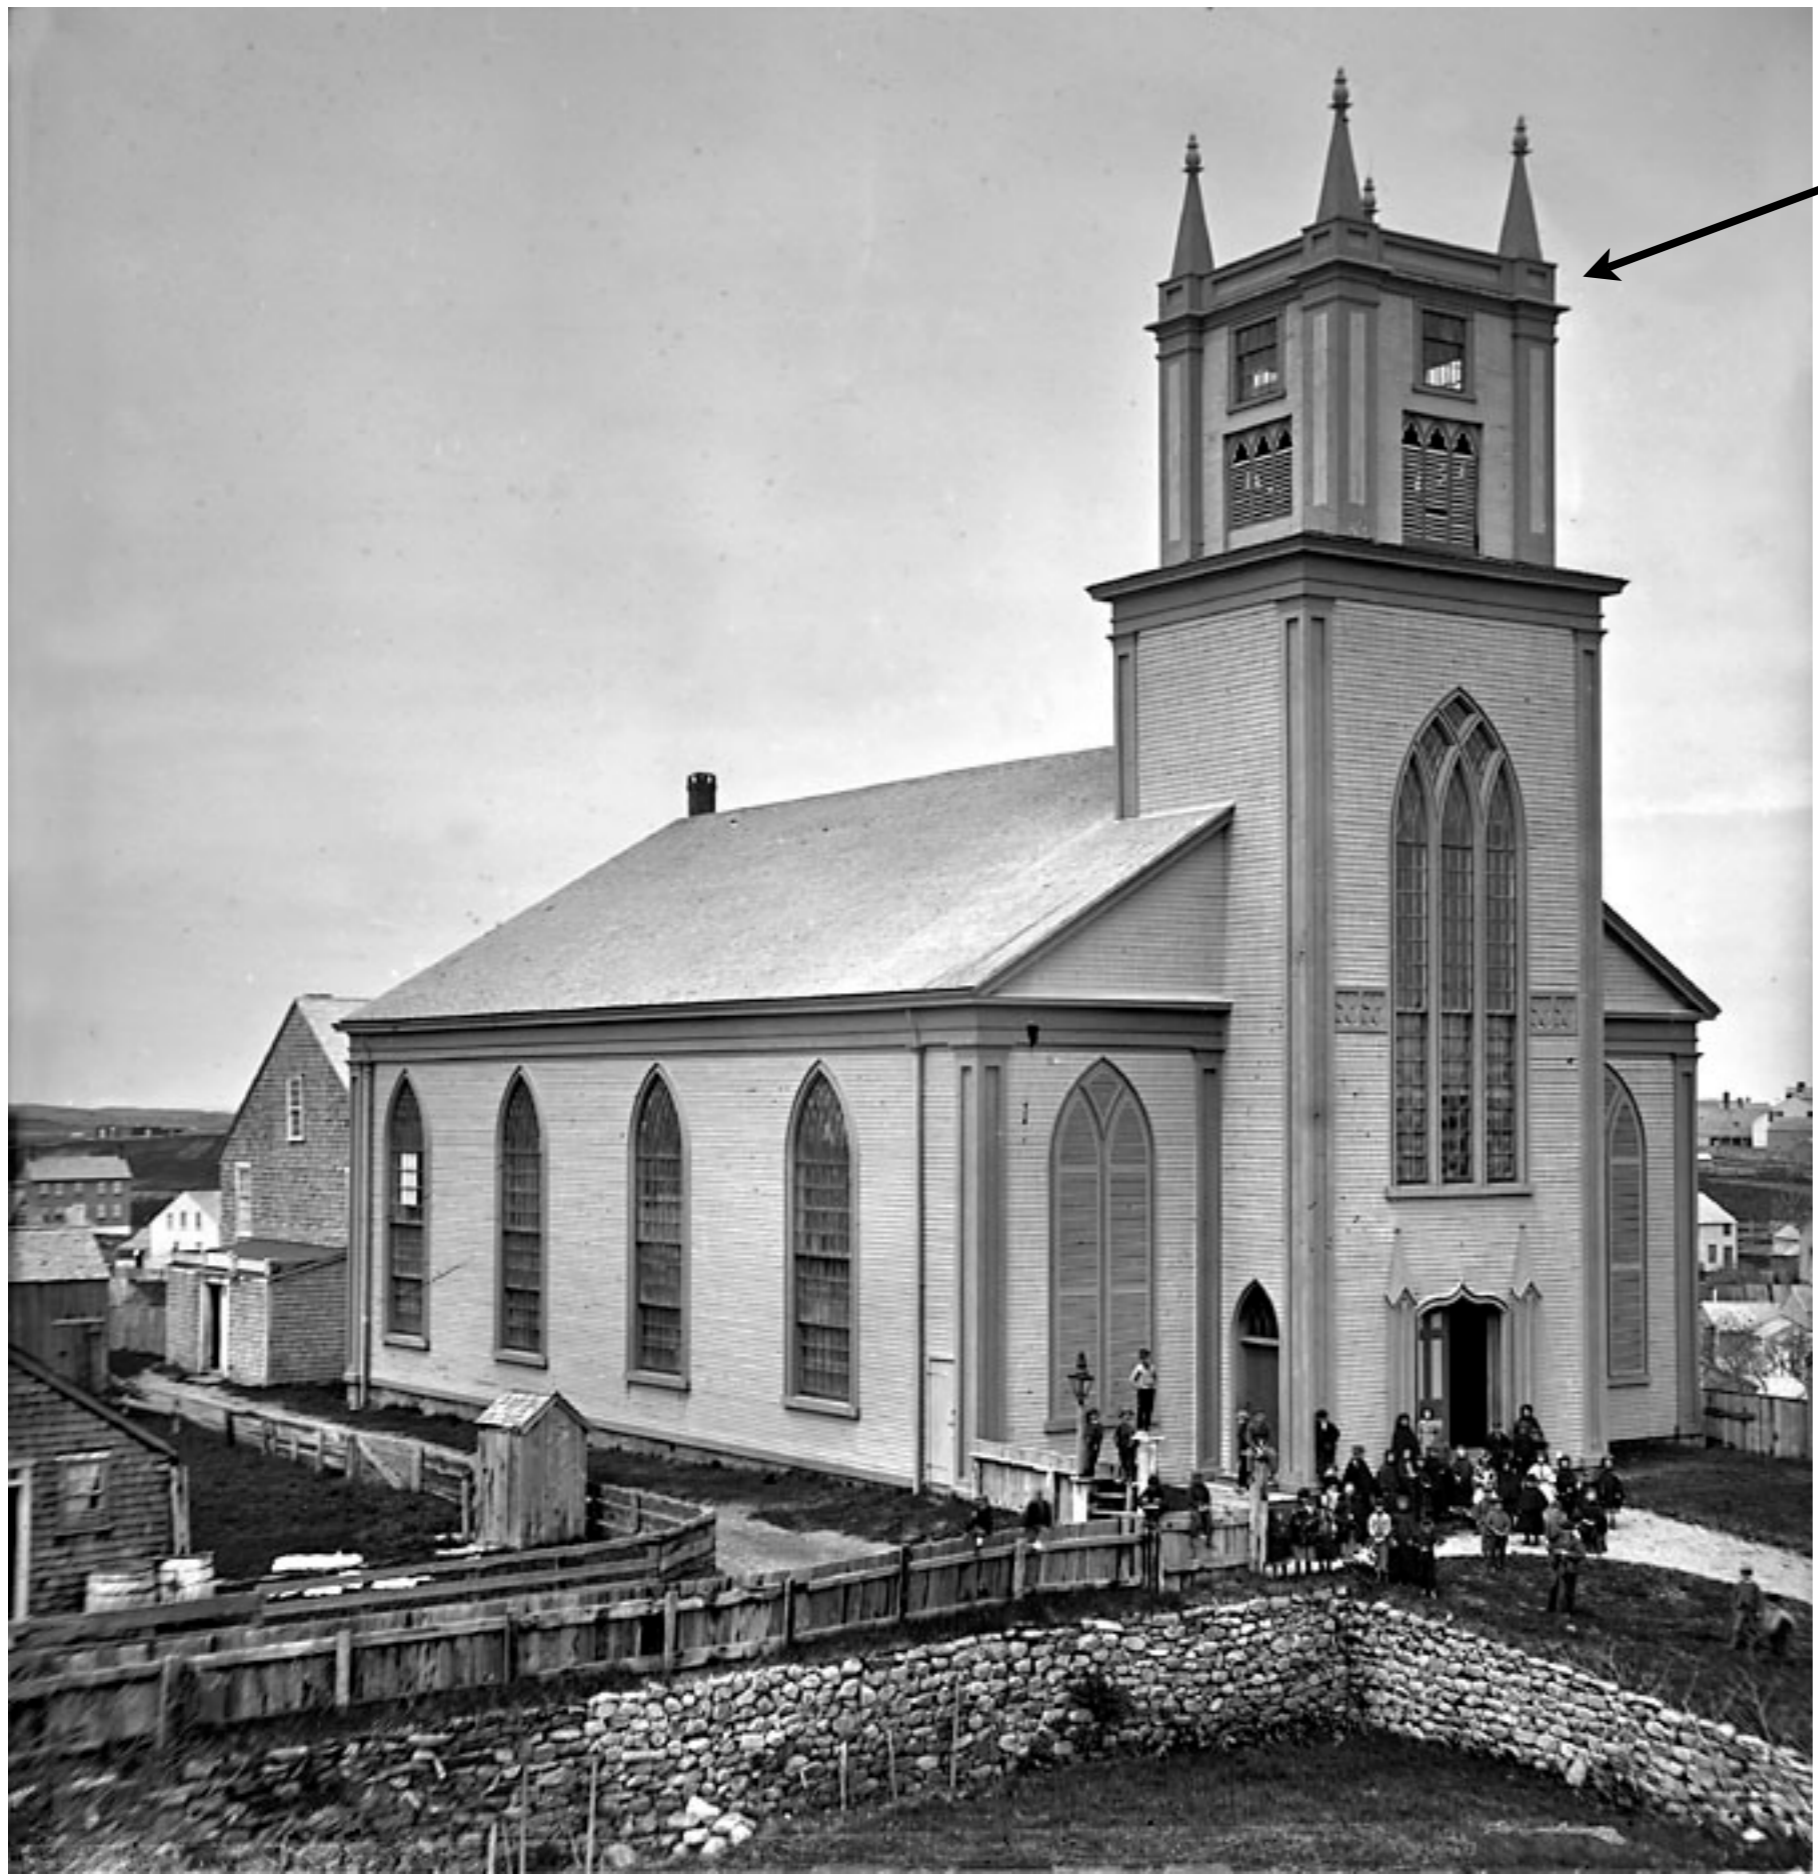
Charles N. Shute collection, N11, negative 298, c-1860, Old Time Photographs, Nantucket

Note Balustrade

The spire was apparently removed in 1849 (“Big Church steeple (spire) removed due to instability and danger in the wind. Minarets placed at corners of tower”). The record is silent on the removal of the second stage (if there was one).

Note door surround compared to c-1900 and 1966 version
