**First Congregational Church
Nantucket, MA
Interior Repairs, Restoration and Conservation**

September 12, 2007 Revised June 13, 2008

**DMH Enterprises, Architects
104 Federal Street
Salem, MA 01970
617-745-2172**

The following pages depict existing conditions as of 2007 and recommendations for conservation/restoration.

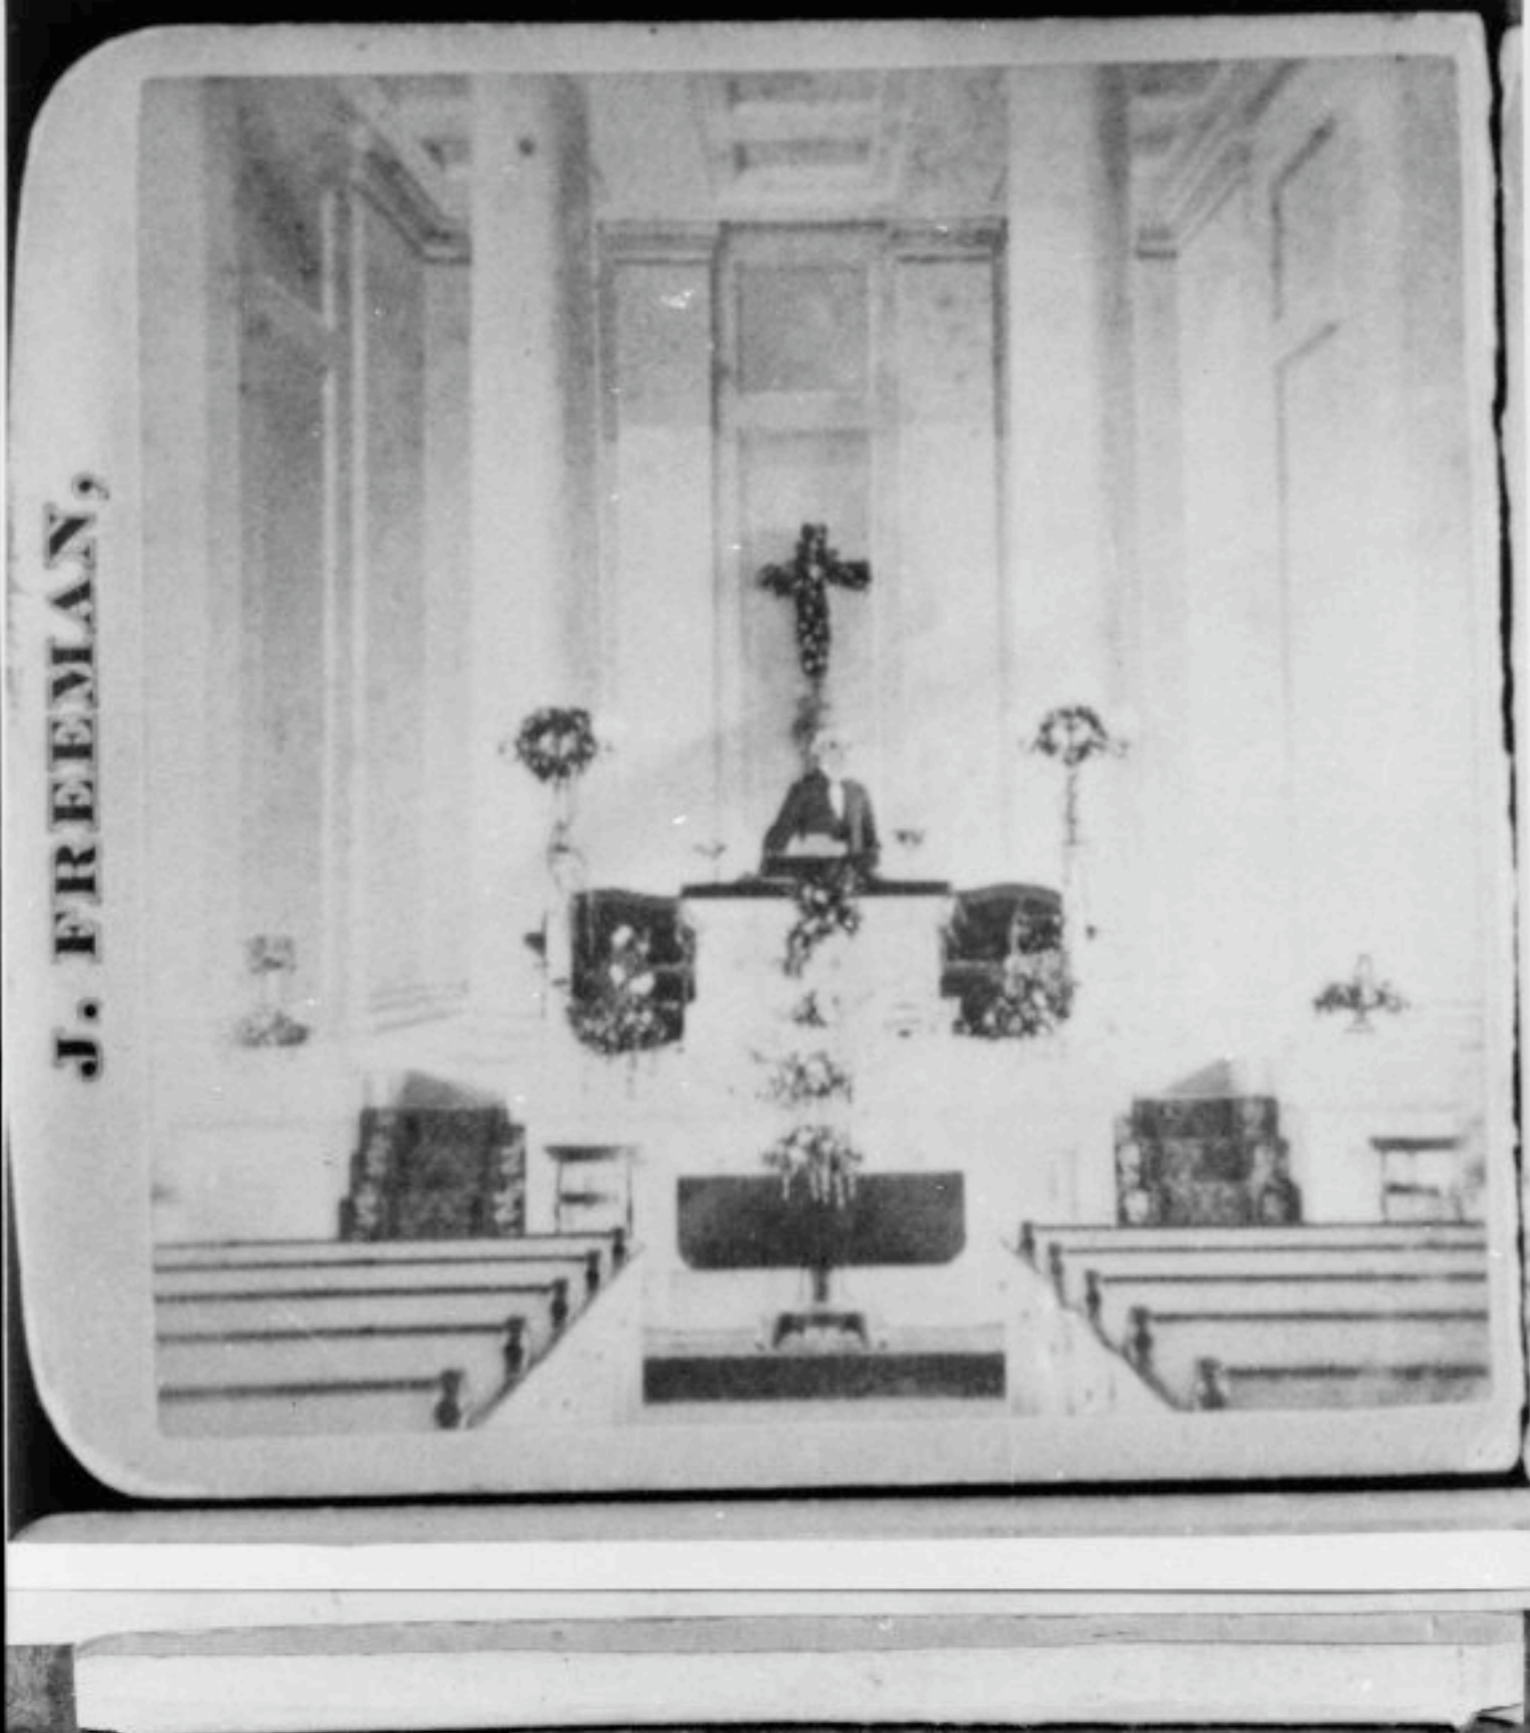
1885, Sanctuary, looking west

16. Historic American
Buildings Survey COPY OF
STEREOPTICON BY J.
FREEMAN, C. 1885, OF
WEST WALL WITH
ORIGINAL TROMPE
L'OEIL PAINTING
HABS MASS,10-NANT,26-16

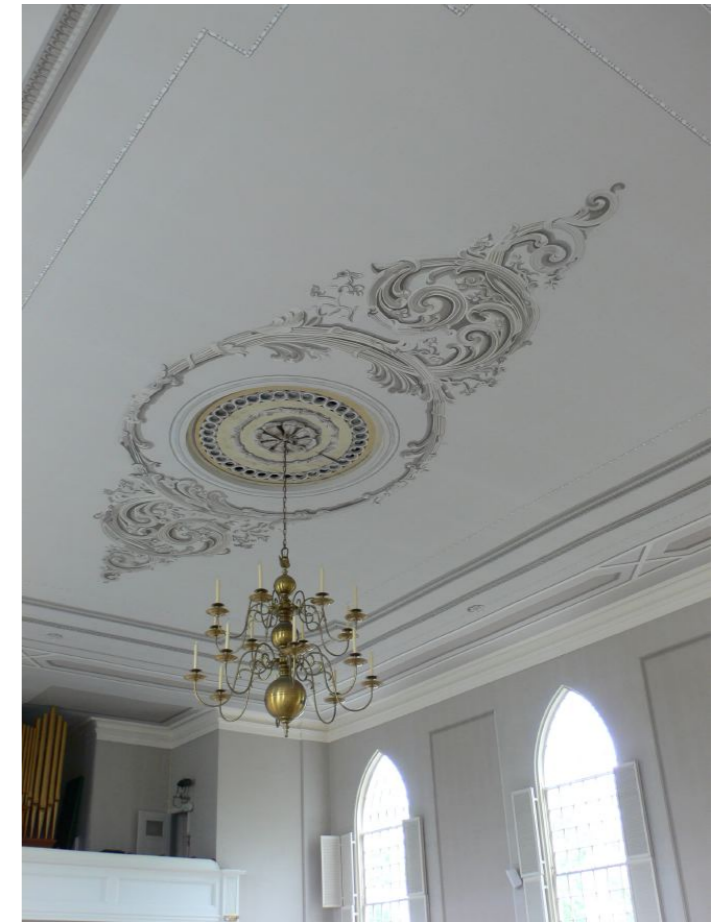
L1030676

The central portion of the decoration may be rather early, as it appears to have been painted directly on wooden ceiling boards

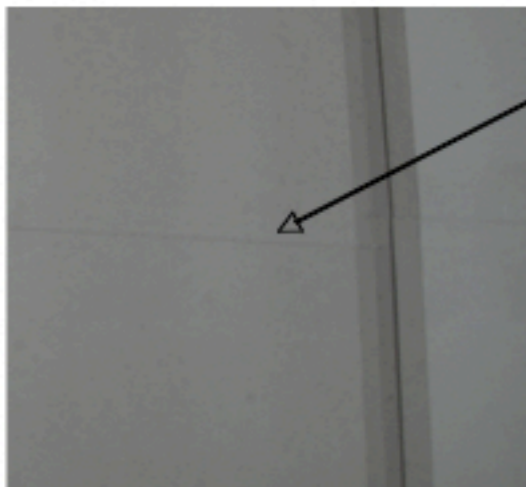
Morz091107.003

Interior Cracks and Peeling

Detail of walls and decorative trompe l'oeil to be repainted or conserved.
